JUNE 2020

EMERGENCY EVACUATION OF COMMERCIAL PASSENGER AEROPLANES

SECOND EDITION 2020

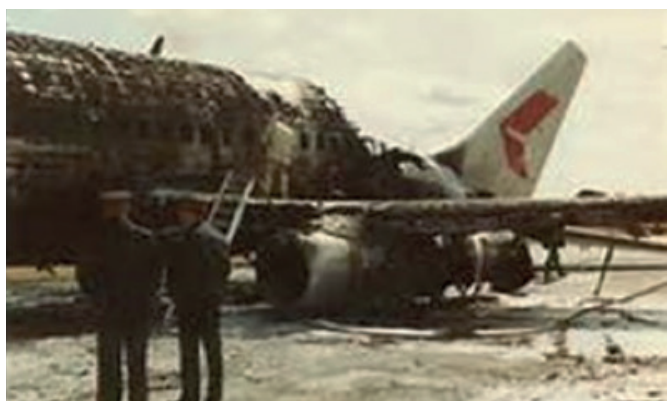
On 22 March 1984, a Boeing 737-200 operated by Pacific Western Airlines, (Flight Number 501), suffered an uncontained No 1 (left) engine failure during take-off at Calgary, Canada, when a compressor disc penetrated the left wing fuel tank resulting in leaking fuel being immediately ignited, causing a large external fire on the left side of the fuselage.

Fuselage burn-through of the Boeing 737 at Calgary and the Boeing 737 at Manchester are remarkably similar as shown in the photographs below, although burn-through on the Calgary accident fuselage extends forward of the left wing whilst in the Manchester accident aeroplane, it is only present seven windows aft of the left overwing Type III exit (L2).

Wreckage of the B737-200 after an uncontained engine failure and fire during take-off at Calgary in March 1984.

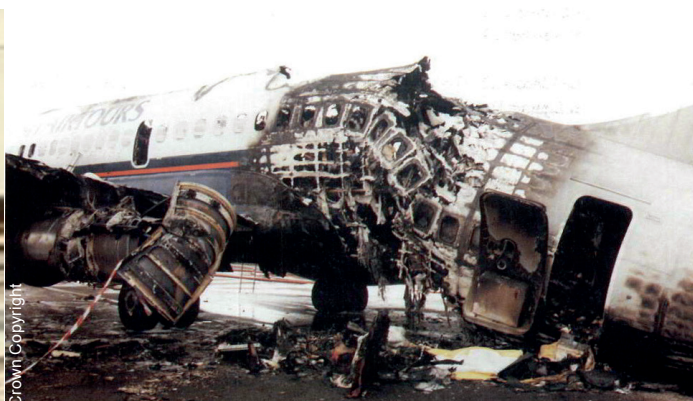
On 22 August 1985, 17 months after the Calgary accident, a Boeing 737-200 operated by British Airtours, (Flight Number 28M), was departing Manchester, UK. On board were 131 passengers, two flight crew and four cabin crew. During take-off the No 1 (left) engine suffered an uncontained failure when a section of the combustion can was forcibly ejected from the engine and punctured a hole in a left wing fuel tank access panel, discharging burning fuel onto the fuselage and the ground. This combined with the direction of a seven knot wind resulted in the fire rapidly burning through the fuselage and entering the passenger cabin.

In the emergency evacuation at Manchester, only three of the six emergency exits could be used due to the intensity of the external fire which mainly affected the rear of the fuselage, the left wing, and the rear of the passenger cabin. In this accident 53 passengers and two cabin crew died. The AAIB Accident Report stated: "The major cause of the fatalities was rapid incapacitation due to the inhalation of the dense toxic/irritant smoke atmosphere within the cabin, aggravated by evacuation delays caused by door malfunction and restricted access to the emergency exits" ⁽¹³⁾.

The aft left floor level Type I emergency exit (L3) was not opened during the evacuation due to the external fire. The aft right floor level Type I exit (R3) was opened by a cabin crew member some six seconds after the aeroplane came to a stop and the evacuation slide was deployed and inflated. However, due to the intensity of the external fire this exit was unusable.

Wreckage of the B737-200 after an uncontained engine failure and fire during take-off at Manchester in August 1985.

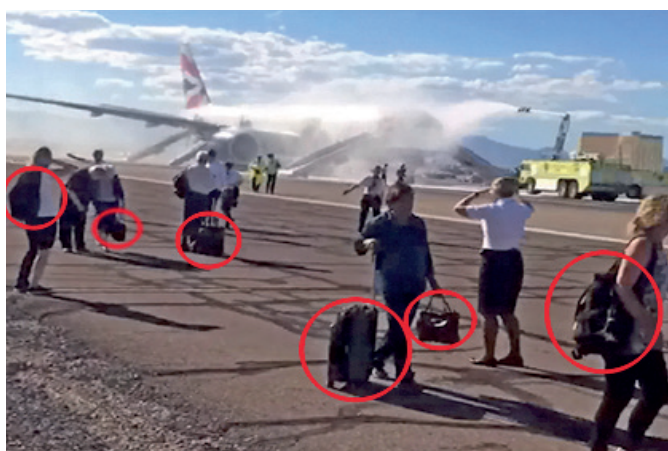
On 8 September 2015, a Boeing 777-200 operated by British Airways, (Flight Number 2276), suffered an uncontained failure of the No 1 (left) engine on take-off from Las Vegas, USA^(77&78). On board were 157 passengers, three flight crew and ten cabin crew. Photographic images show that some passengers evacuated the aeroplane with items including 'baggage with wheels', some the size of suitcases. The FOG is of the opinion that a significant issue in this evacuation was the number of passengers who took baggage with them. Although this did not adversely affect the evacuation, had the B777-200 been configured at its maximum passenger capacity of 440 seats installed and with that many passengers carried, the evacuation time might have been dangerously extended with potential risk to passengers.

Passengers with cabin baggage post-evacuation of a B777-200 at Las Vegas in September 2015.

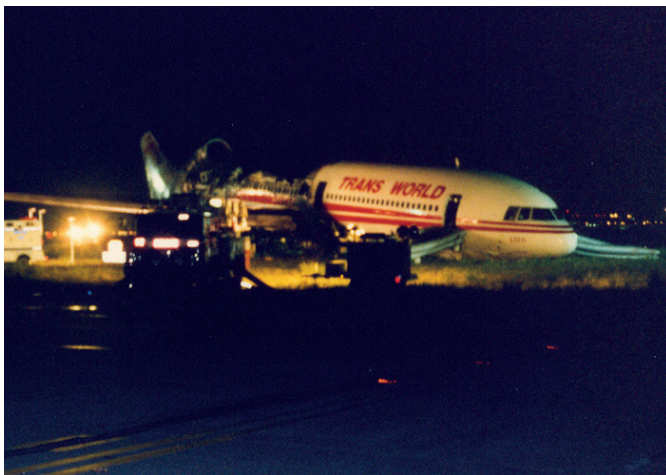
On 30 July 1992, a Lockheed L1011 TriStar, operated by Trans World Airlines (TWA), (Flight Number 843), aborted take-off immediately after lift-off from John F Kennedy International Airport at New York, USA. On board were 280 passengers, three flight crew and nine flight attendants. According to the NTSB Accident Report the aeroplane was airborne for approximately six seconds and came to rest upright and on fire about 100 metres to the left of the departure end of the runway. The aeroplane was immediately engulfed with fire and was totally destroyed.

Fire damage to the L1011 TriStar which crashed shortly after take-off at New York in July 1992

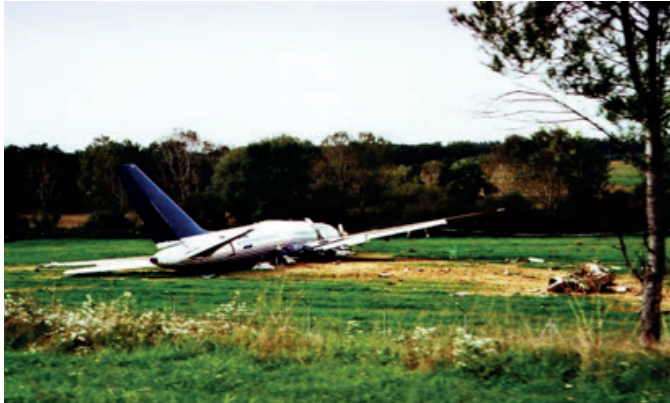
On 14 September 1999, a Boeing 757-200, operated by Britannia Airways, (Flight Number 226A), was on its second attempt to land in adverse weather conditions at Girona, Spain, when it suffered a main landing gear failure on touch-down. On board were 236 passengers, two flight crew and seven cabin crew. The aeroplane left the runway and travelled some 350 metres before hitting a mound, becoming semi-airborne and then hitting a number of small trees and a boundary fence. The Boeing 757 came to rest in a field off the airport.

The Boeing 757-200 after departing the runway at Girona in September 1999.

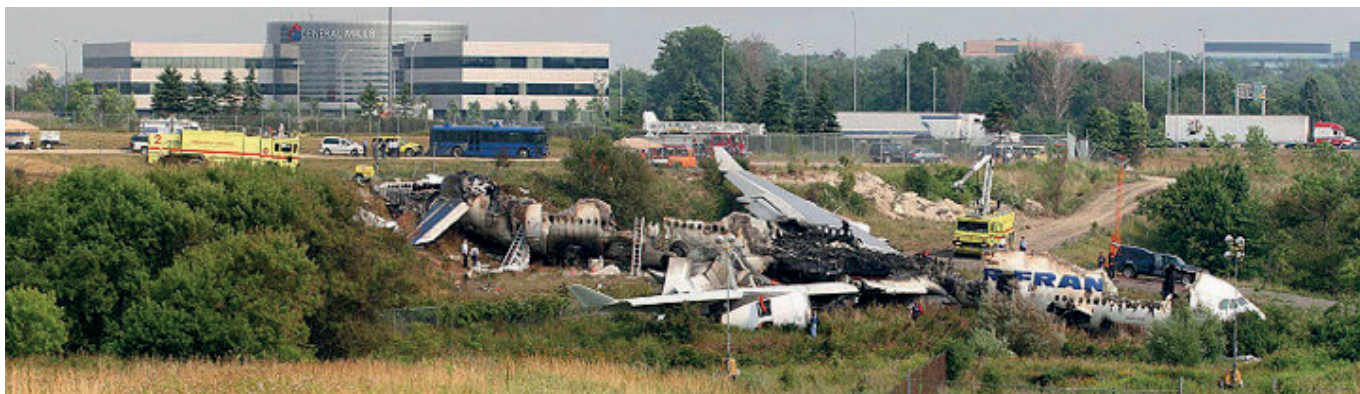
On 2 August 2005, an Airbus A340-300, operated by Air France, (Flight Number 358) touched down on runway 24L at Toronto, Canada, but according to the TSB Accident Report further along the runway than usual, and was unable to stop. It departed the end of the runway and came to rest in a shallow gully with its fuselage split into several pieces. Approximately four minutes later, the A340 fuselage erupted in flames. On board were 297 passengers, two flight crew and 10 cabin crew.

The fire-damaged wreckage of the Airbus A340-300 after departing the runway at Toronto in August 2005.

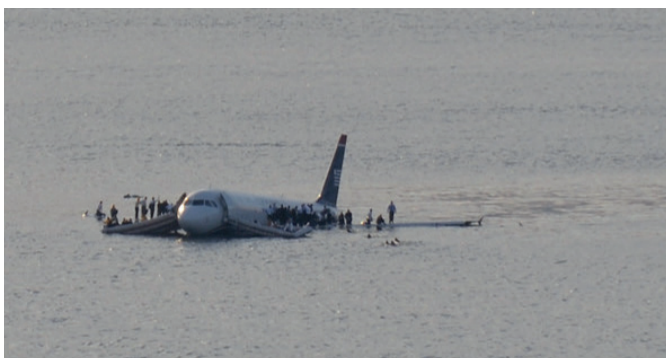
Several boats in the vicinity immediately went to the aeroplane to rescue the survivors. The first arrived at the aeroplane four minutes after the ditching. If the rescue boats had arrived later at the ditched aeroplane it is likely that some of the passengers would have drowned due to shock or inability to swim in the cold water. The water temperature was approximately 41°F (5°C).

The Airbus A320 ditched in the Hudson River, New York in January 2009.

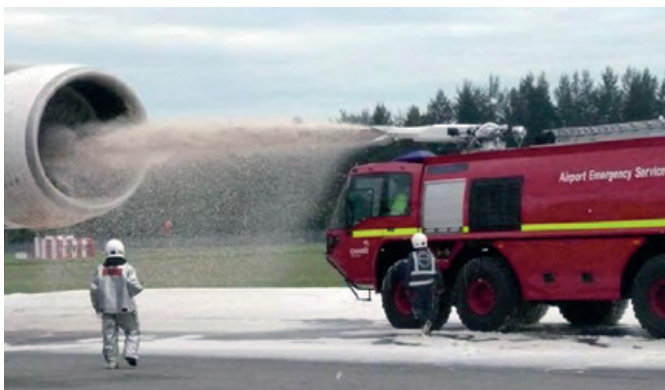
- Although the damaged No 2 (left inboard) engine and other engines were shut down after landing, the No 1 (left outboard) engine continued to run after normal shut-down procedures. It was finally shut-down some three hours after the landing by RFFS pumping water foam directly into the engine inlet.

- The left main landing gear brakes had reached a temperature of 900 degrees Celsius.
- Aviation fuel was leaking from the left wing.

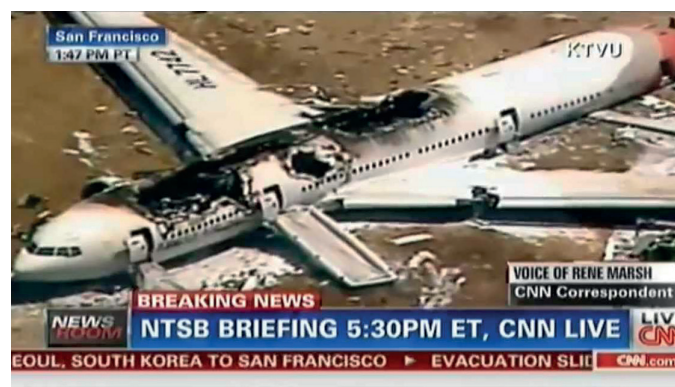
On 6 July 2013, a Boeing 777-200 operated by Asiana Airlines, (Flight Number 214), crashed on final approach to San Francisco, USA, with a descent below the glidepath resulting in an impact with a seawall. On board were 291 passengers, four flight crew and 12 flight attendants.

The wreckage of the Boeing 777-200 after crashing into the seawall at San Francisco in July 2013.

According to the NTSB Accident Report, the main landing gear impacted the seawall, and the tail plane separated from the fuselage at the aft pressure bulkhead. The impact forces exceeded certification limits. This resulted in two of the slide-rafts inflating inside the passenger cabin and initially trapping two of the flight attendants in their seats.

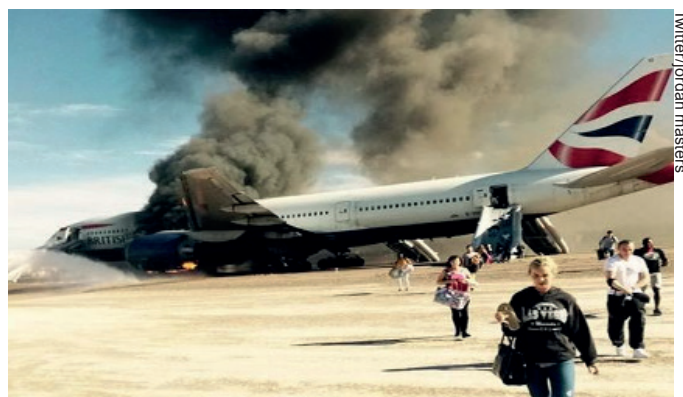
On 8 September 2015, a Boeing 777-200 operated by British Airways, (Flight Number 2276), suffered an uncontained failure of the No 1 (left) engine on take-off from Las Vegas, USA. On board were 157 passengers, three flight crew and ten cabin crew.

The Boeing 777-200 with the No. 1 engine on fire at Las Vegas in September 2015.

The commander aborted the take-off and sent one of the First Officers into the passenger cabin to assess the situation. It is understood that the First Officer had difficulty getting to L2 because passengers were standing in the aisle. A significant fire was identified in the No 1 engine at the area of L2 and the commander ordered the evacuation.

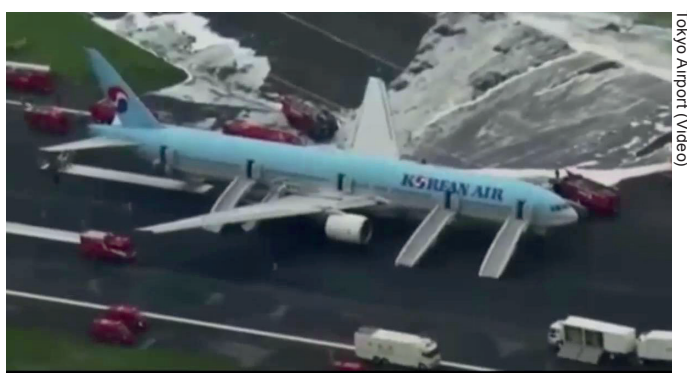
On 27 May 2016, a Boeing 777-300 operated by Korean Air, (Flight Number 2708), suffered an uncontained failure of the No1 (left) engine resulting in a rejected take-off from Tokyo, Japan. On board were 302 passengers, two flight crew and 15 cabin crew. The Boeing 777-300 has five pairs of Type ‘A’ emergency exits installed (i.e. ten Type ‘A’ exits).

The Boeing 777-300 after a rejected take-off from Tokyo in May 2016.

In the emergency evacuation five emergency exits on the right side of the aeroplane were opened as well as exit L1. The cabin crew member at L1 identified RFFS vehicles in the proximity of the tail end of the evacuation slide and determined that the slide was not useable. The evacuation slide at Door R5 inflated but deployed underneath the aeroplane fuselage and was not useable during the evacuation. The Japan Transport Safety Board Accident Report identified that there were no fatalities but that some 40 passengers sustained minor injuries.

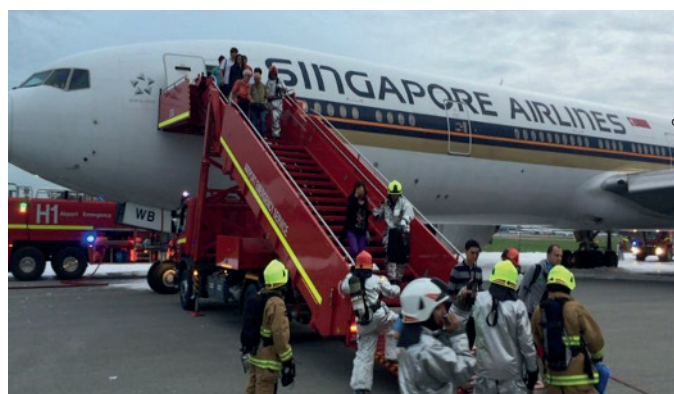
Disembarkation of the Boeing 777-300 using the forward left Type 'A' emergency exit.

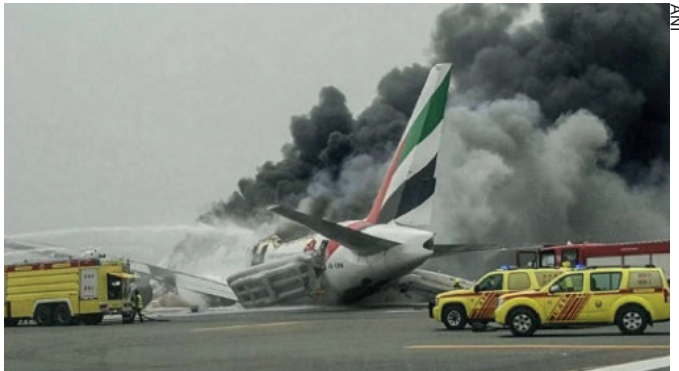
On 3 August 2016, a Boeing 777-300 operated by Emirates, (Flight Number 521), crash landed on the runway at Dubai, UEA, after an attempted 'go-around'. On board were 282 passengers, two flight crew and 16 cabin crew. As the aeroplane slid along the runway, the No 2 (right) engine separated from the wing and there was an intense fuel in this area, as well as fire to the No 1 (left) engine.

The Boeing 777-300 after crash landing at Dubai in August 2016.

After the aeroplane came to a stop the commander ordered the evacuation, but because of the high winds and the external fire there were several issues with the evacuation.

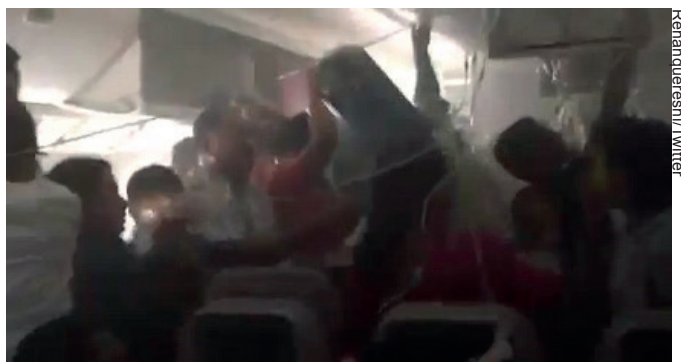
This was another accident in which passengers evacuated with cabin baggage. Images taken by passengers on mobile phones show overhead bins being open to retrieve baggage even though the evacuation had already commenced and a degree of urgency was obvious due to smoke in the cabin and the external fire. The Emirates General Civil Aviation Authority Final Accident Report, stated: "The cabin crew attempted to convince passengers to leave their carry-on baggage behind, but a number of passengers evacuated with one or more pieces of carry-on baggage which prolonged the evacuation."

Passengers opening overhead bins to retrieve baggage in the B777-300 accident at Dubai in August 2016.
