Managing a Complex Aircraft Systems Investigation

Barry Holt – Western Region Senior Technical Investigator – Transportation Safety Board of Canada

David Fisher – Manager, Air Safety Investigations – Commercial Aircraft, Bombardier Air Safety Investigation

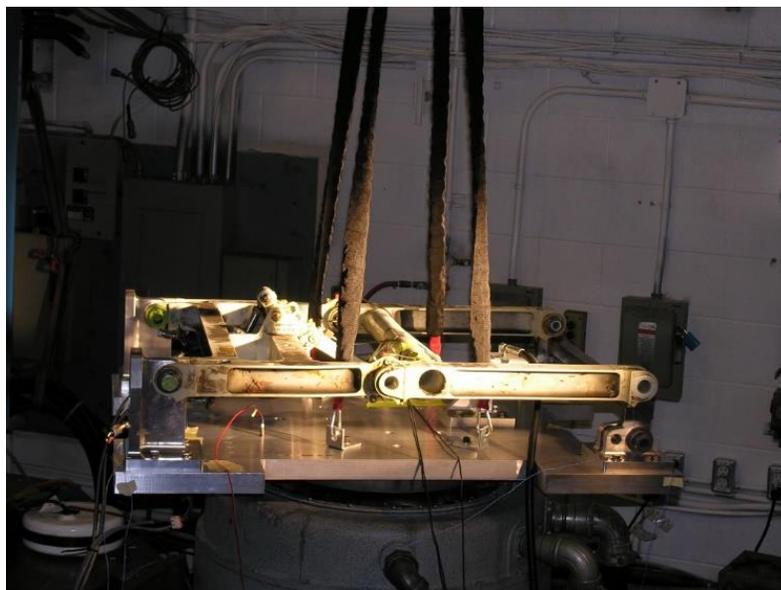
Next, the Horizontal Stabilizer Brace underwent the same sequence of testing to see if vibration could induce a loss of the locked state. As the vibration frequencies and amplitude approached what was seen on the accident aircraft, some of the investigation group could see a noticeable vibration. Many members could not see or admit to this happening. Most of those were from various design groups. Once again the

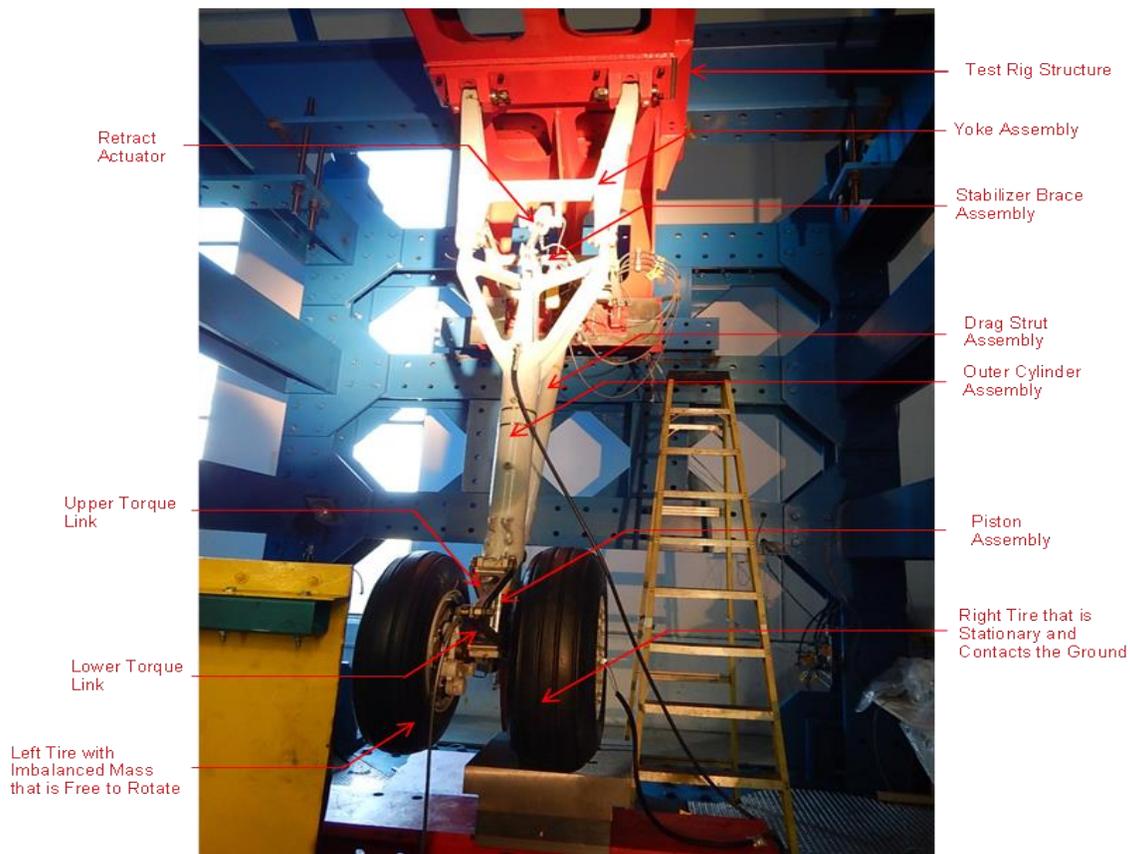
Bombardier and UTAS then agreed to develop a full-scale landing gear test rig in order to examine the behavior of the Landing Gear, Solenoid Sequence Valve and Horizontal Stabilizer Brace and PSEU during concurrent vibrating and dynamic conditions. This process and testing was also not a certification requirement and had never been done before. Exploration of possible investigative techniques and allowances to simulate the actual landing conditions were examined at length. Testing models of all the involved components were developed and agreed to by all attached to this part of the investigation. The imbalance and resulting vibration that had occurred had to be factored in and test run protocols established. A full landing gear test rig had to be designed and agreed to by all the principal team members. This was a challenge however everyone pulled together and channeled their efforts into the one goal.

There were over 70 runs conducted. In the end and as it turned out, the gear unlocked under the same conditions (no hydraulic pressure on the unlock actuator) as were encountered during the landing phase of the accident. There was a great amount of jubilation when we found that we had accurately replicated the accident conditions and achieved a same result. The team continued to test different configurations including lesser stabilizer brace over-center conditions and oleo compression; however, during a later test with full oleo compression, both the drag brace shear pin and the spin-up machine broke. We had broken our rig for good, but we did have all the data needed to come out with important modifications to several components of the gear.

The team determined that in order to accommodate for a highly imbalanced tire or a single impulse event hydraulic pressure would need to remain on the unlock actuator at all times. This could be solved by a simple modification to the current PSEU logic.

Early PSEU's could be modified by a software upgrade and new aircraft starting at production serial number 4554 would be equipped with a new -602 PSEU. Airworthiness Directive CF-2016-31 was introduced and PSEU's modified.
