forum

The International Society of Air Safety Investigators

*Proceedings
of the
Eleventh International
Seminar
of the
International Society of
Air Safety Investigators*

September 30–October 2, 1980

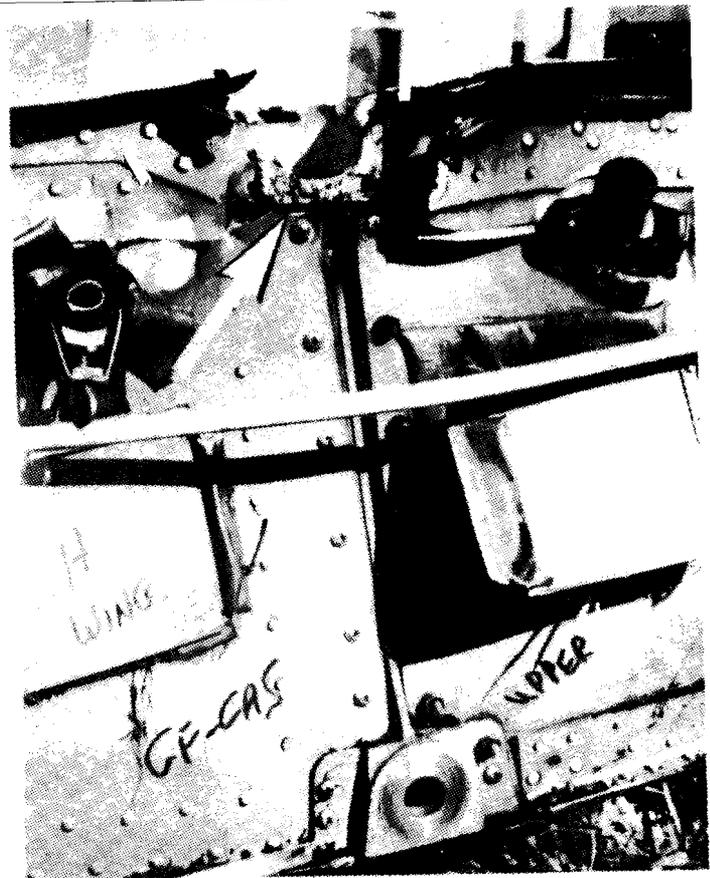
Figure 3 - Suspect wing attach fitting (arrowed).

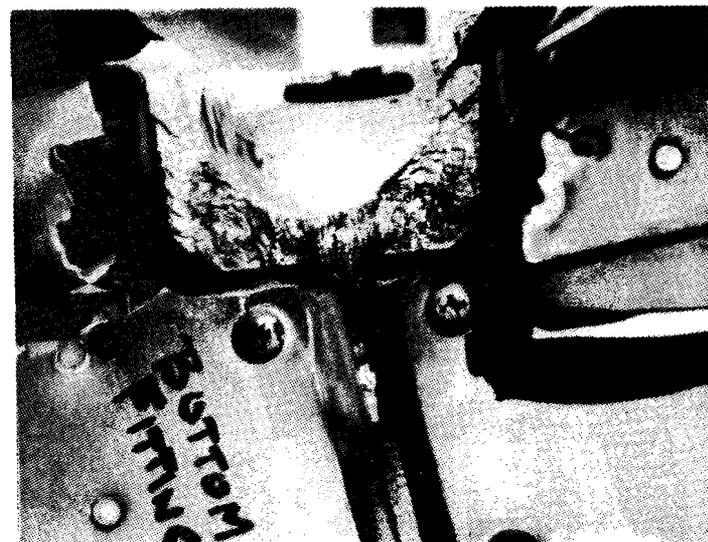
Figure 4 - Discoloured fracture face of fitting.

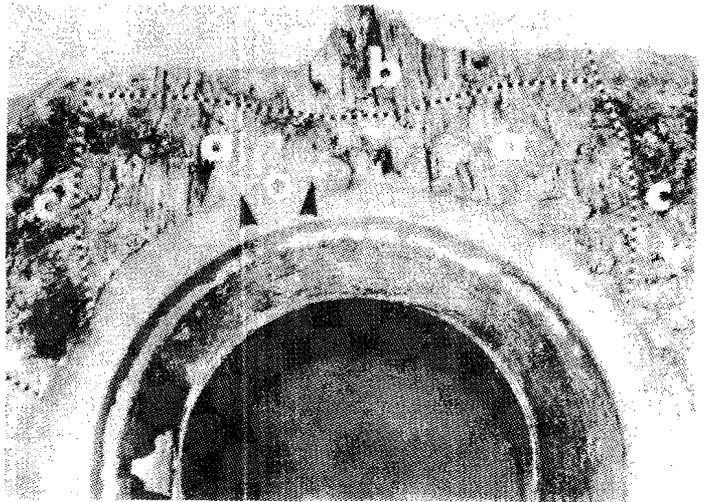
Figure 8 - Three pre-crack zones disclosed by SEM analysis.

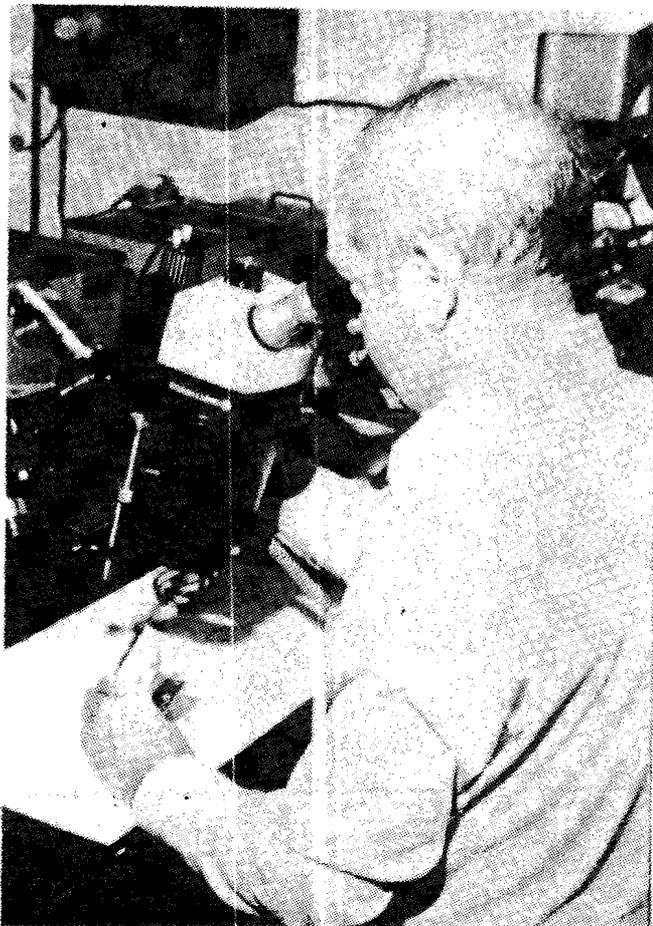
Figure 6 - Stereo-macroscopic examination of fitting failure.

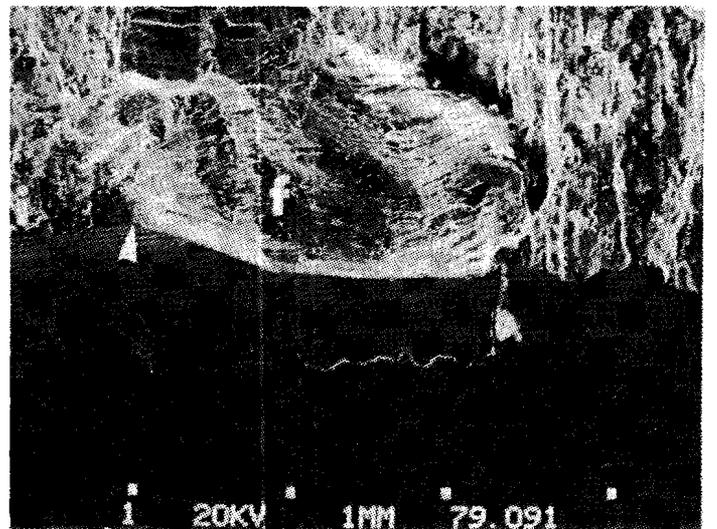
Figure 9 - SEM image of intergranular origin at left with fatigue zone initiating at arrow. Intergranular secondary crack clearly evident below the fatigue zone. (X25 approx).

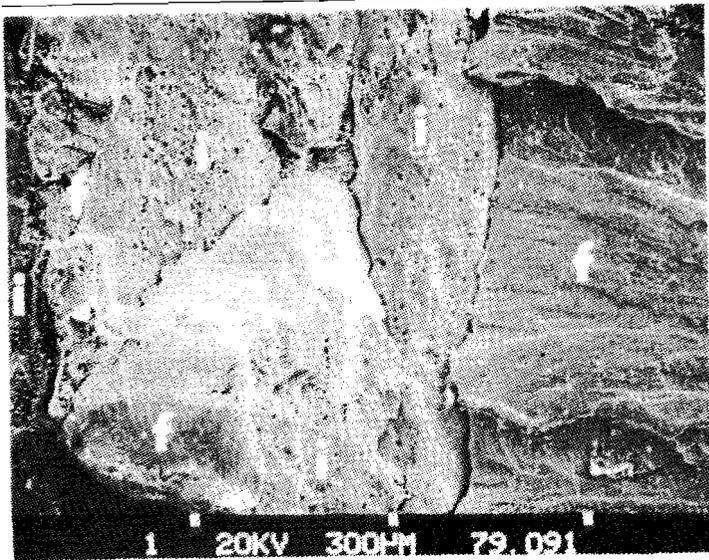
Figure 10 - Mixed intergranular and fatigue fracture in Zone "A". Holes evident on intergranular fracture areas. (X100 approx.)

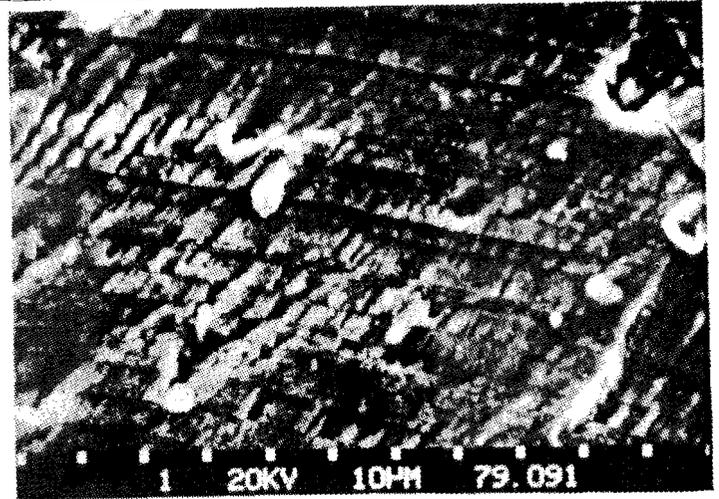
The fatigue facets were then examined in detail with the SEM finding clearly defined striations (Figure 12) all transgranular in nature. The variable crack arrest line spacing was typical of operational loading induced fatigue crack growth. The intergranular facets however showed no striations in the SEM. Replicas were then taken of the intergranular zones to produce transmission electron microscope (TEM) samples. Even at TEM magnifications, an order of magnitude greater than possible with SEM (100,000X vs 10,000X), no evidence of crack arrest lines was observed in any area of intergranular fracture. Therefore, *intergranular* fracture was *dominant* in zones (a) and (b) with islands of fatigue fracture present in zone (a), whereas *transgranular* fatigue cracking was *dominant* in zone (c) with essentially no intergranular cracking in evidence.

Figure 12 - SEM image of area in fatigue Zone "C". (X1000)

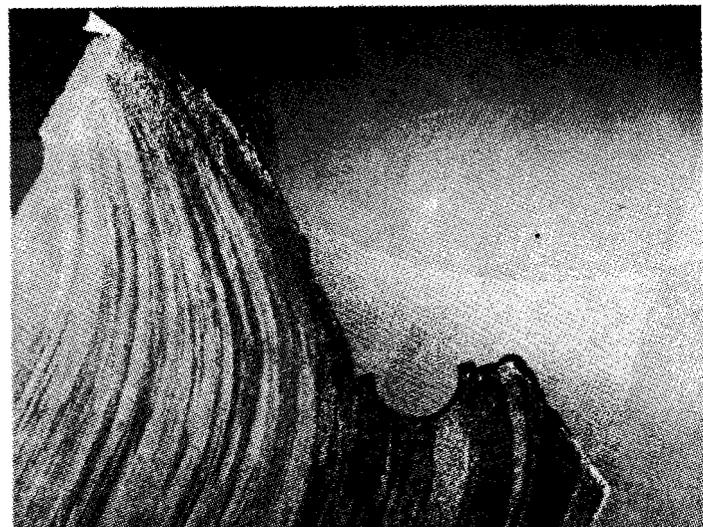
Figure 14 - Macrosection of failed fitting. Intergranular trend of crack growth from origin (arrow) disclosed. (X3 approx.)

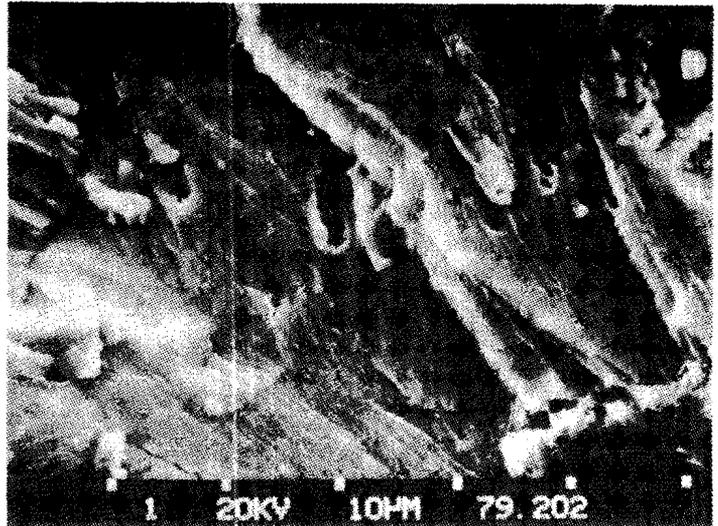
Figure 23 - SEM image of fine striations typical of fatigue. (X1750 approx.)

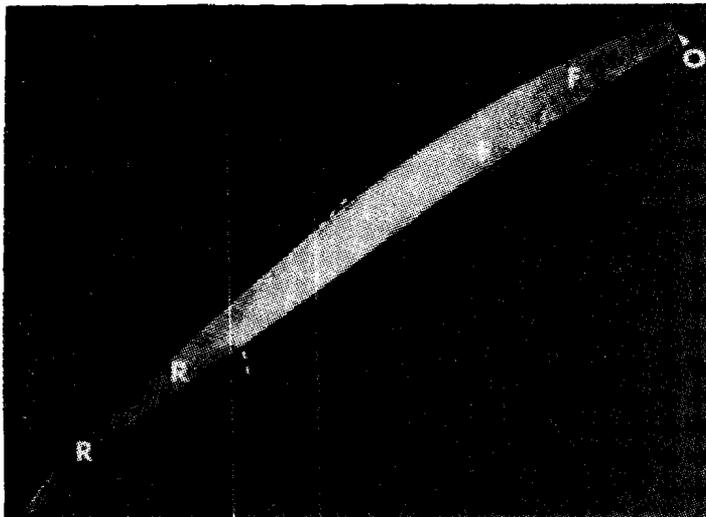
After cleaning the fracture face in an ultrasonic cleaner containing 1, 1, 1-trichloroethane solvent, very faint beach marks indicative of a fatigue mode of failure were apparent on the flat portion of the fracture face. The fracture face was next examined in the scanning electron microscope. The origin displayed a faceted cleavage-like mode of failure typi-

Figure 21 - Stereo-macroscopic examination with flat Zone "F" and ductile angled Zone "R" disclosed. Origin is at "O".

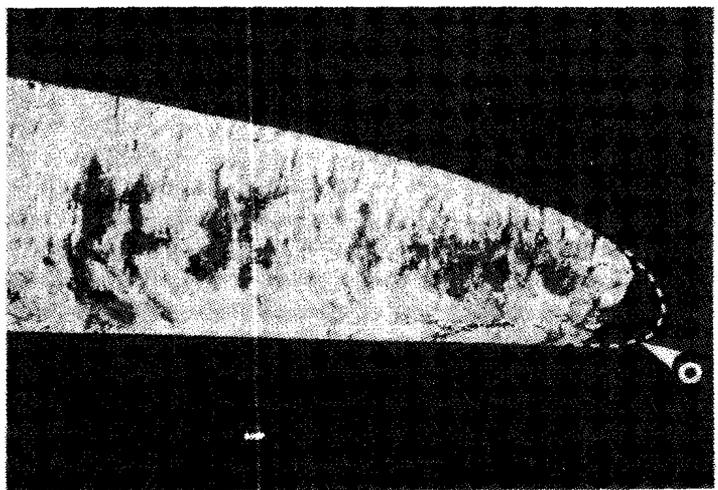
Figure 24 - Origin of fatigue apparently removed by repair of previous damage. Dotted line gives original shape of leading edge.

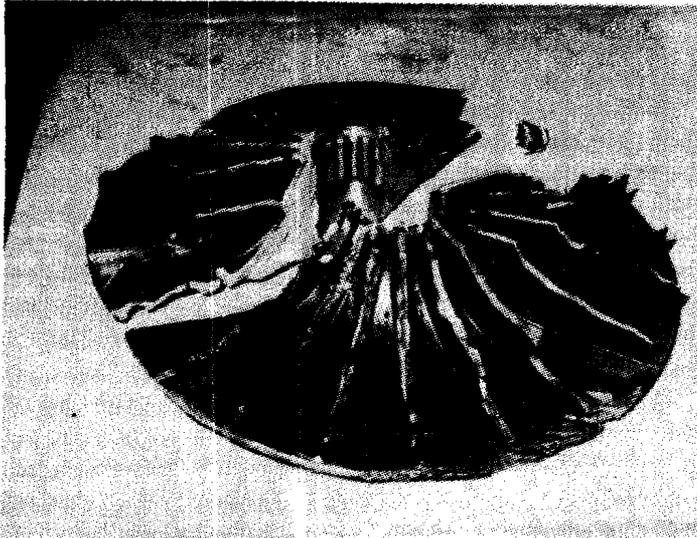
Figure 27 - Diametral burst of low pressure first stage centrifugal compressor impeller.

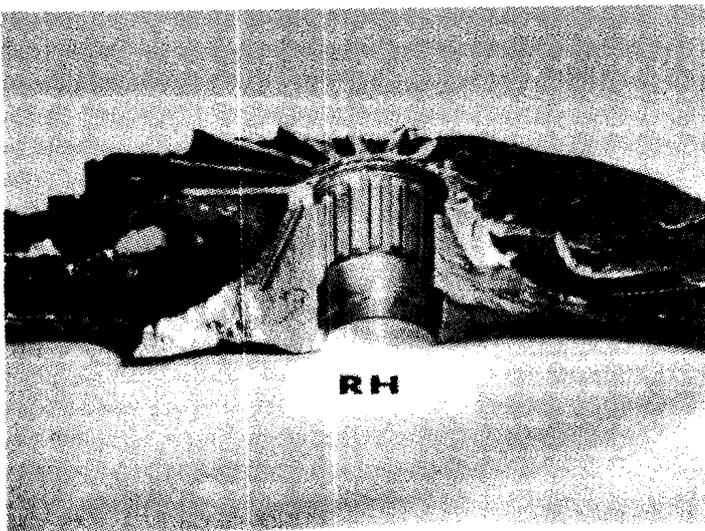
Figure 28 - Fracture face of failed impeller.

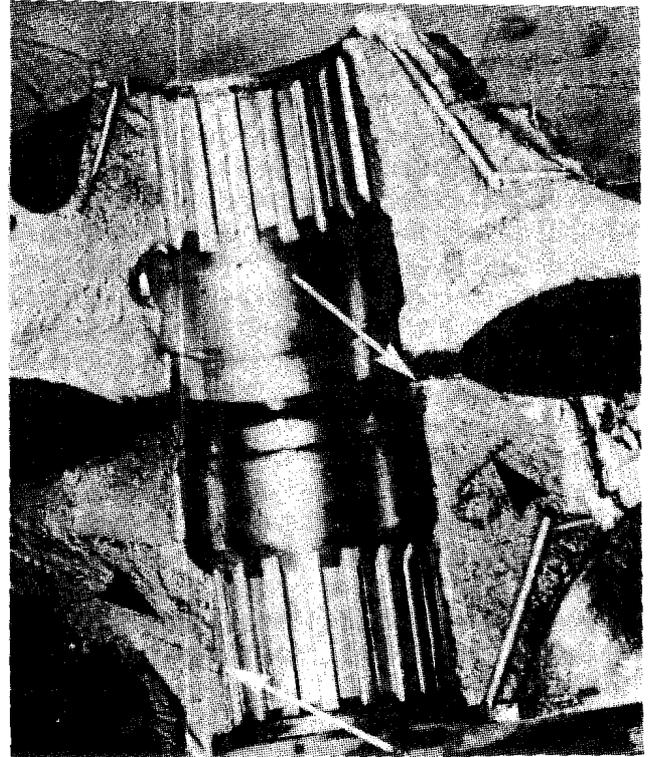
Figure 29 - River markings (black arrows) on fracture running back to origins (white arrows).

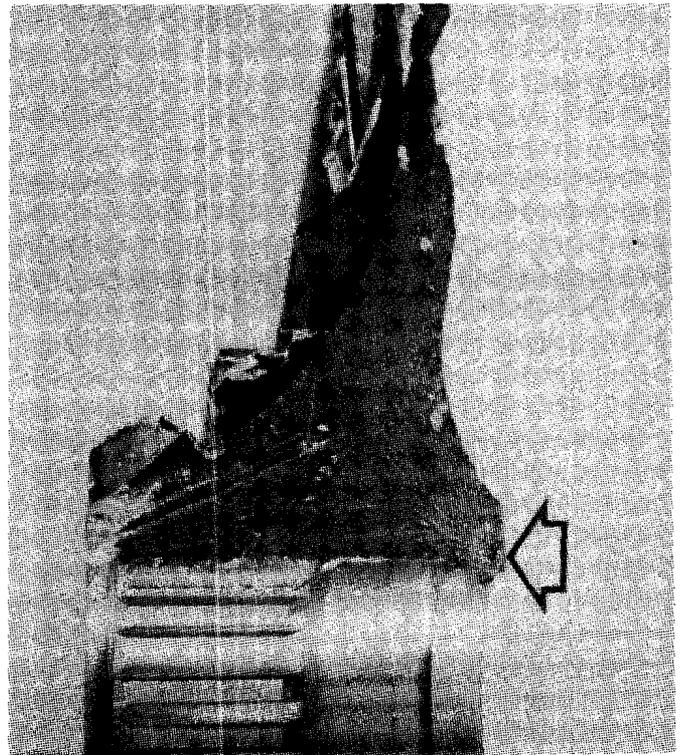
Figure 30 - Fracture after cleaning with acetone. Lighter zone at origin (arrow) appeared.

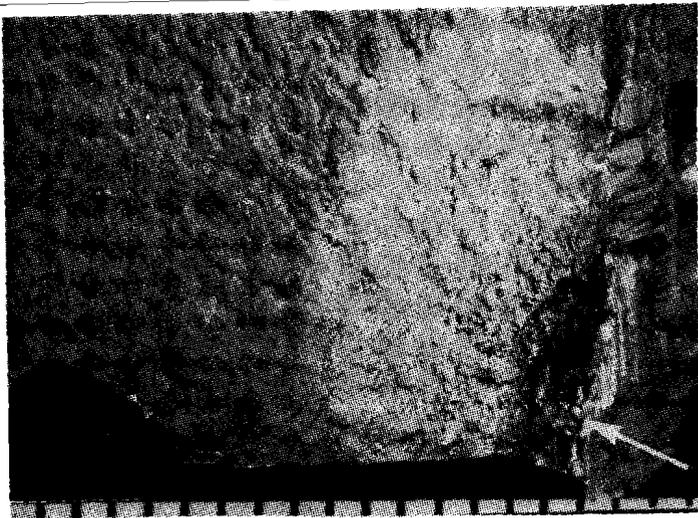
The primary fracture origin (Figure 31) and the large secondary cracks (Figure 33) were then subjected to SEM examination. Typical mixed fatigue and ductile overload zones (Figure 34) were found in the light zone of the primary origin. This explains why the stereo-macroscopic examination discerned no topographical differences between

Figure 31 - Fracture topography appears same in grey zone and lighter zone. Dark zone (arrow) shown under smeared origin.

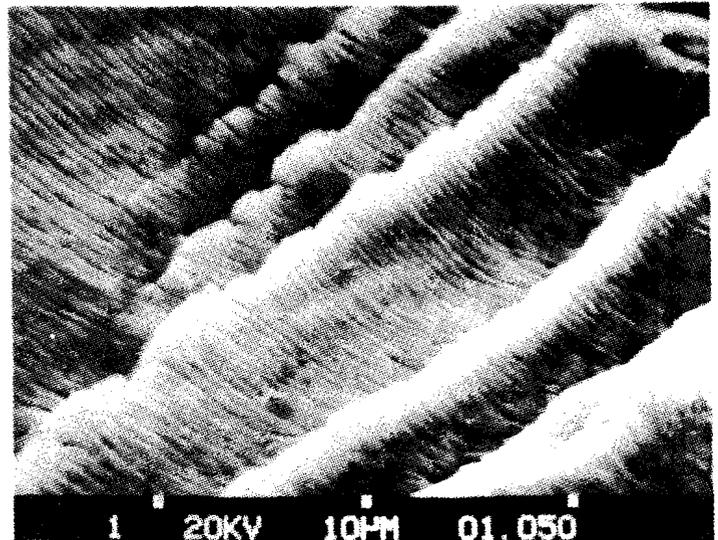
Figure 35 - SEM image typical of a fatigue area in light zone. Distinct striations are displayed. (X3000 approx.)

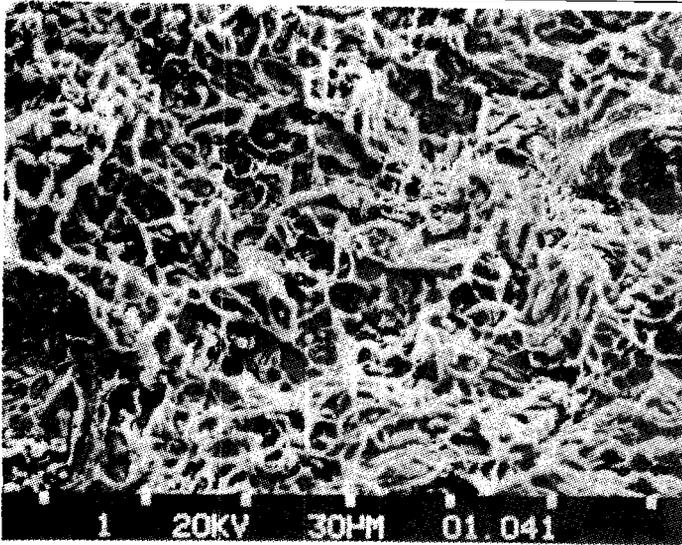
Figure 36 - SEM image of completely ductile overload in grey zone (Figure 31). (X500 approx.)

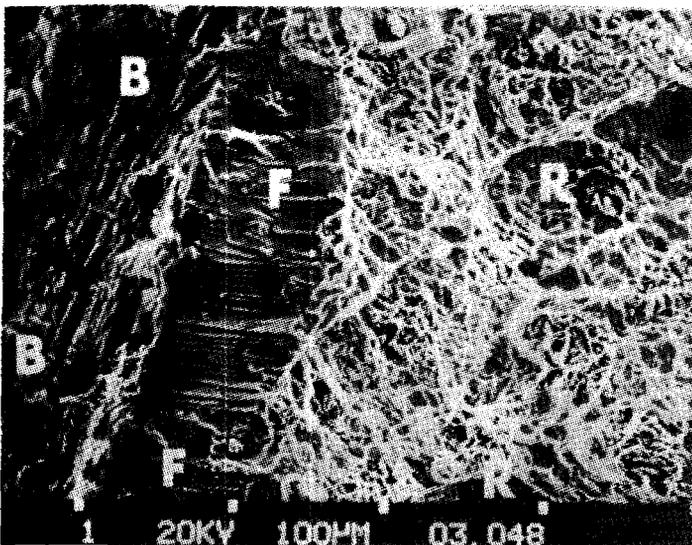
Figure 37 - SEM image clearly delineating three zones in the secondary crack. "B" is brown precrack angled at 45° to axial/radial plane, "F" is small fatigue silvery zone, and "R" is ductile overload gray zone.

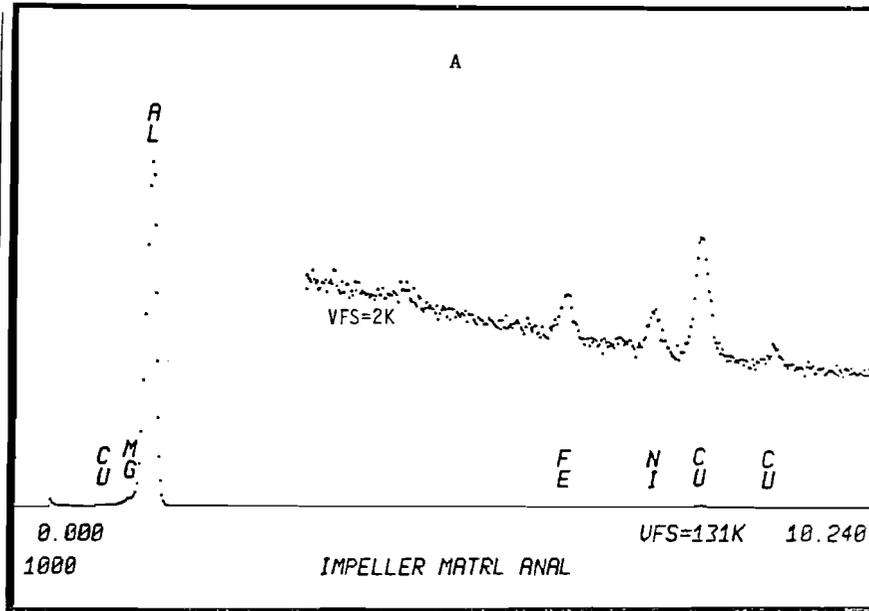
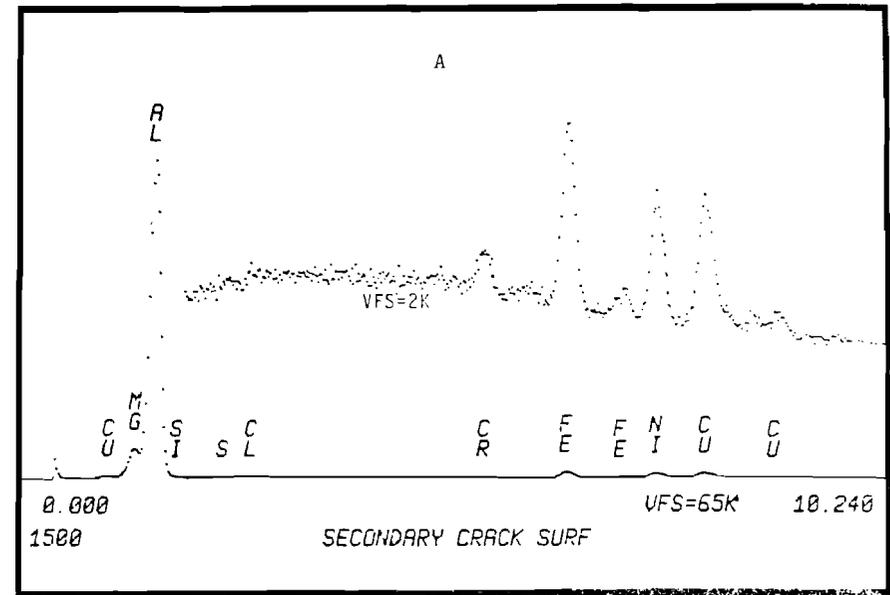
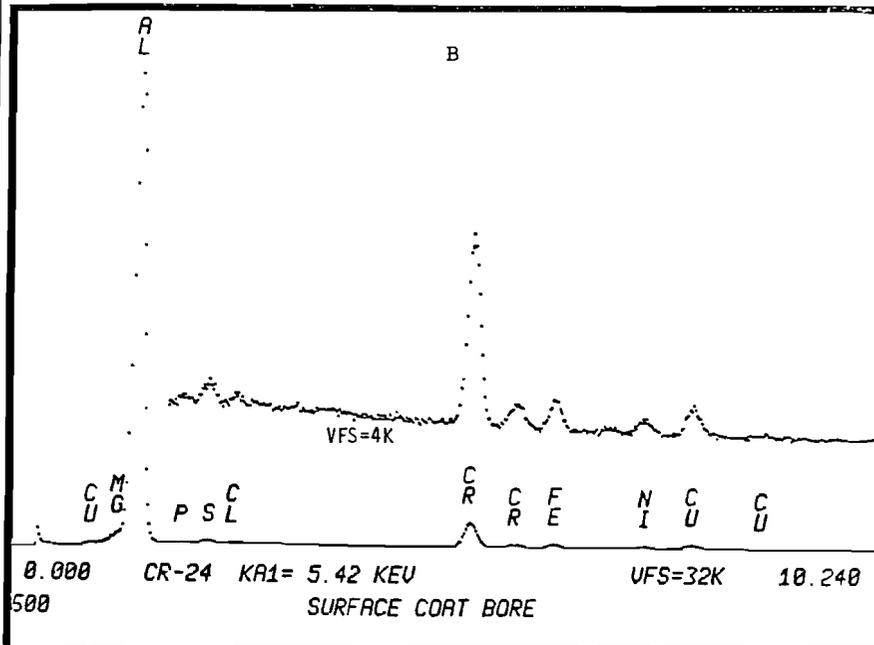
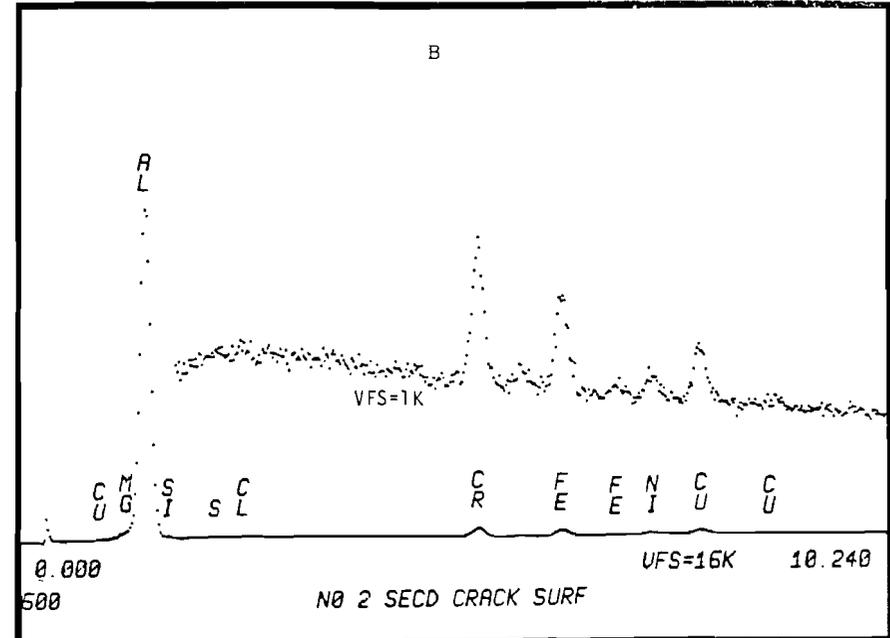
The impeller bulk material exhibited the characteristic spectrum for the specified Hiduminium RR 58 alloy (Figure 38A). It was also noted that there was no significant amount of chromium present in the basic RR 58 alloy. Analysis of the bore (Figure 38B) adjacent to the fracture surface showed a characteristic chromium peak superimposed on the RR 58 spectrum from the bulk material of the impeller. The impeller has a surface protective conversion coating applied via a proprietary "Alocrom" treatment, which explains the chromium peak. X-ray spectrometric analysis of the golden-brownish precracks (Figure 39) produced similar chromium peaks. It was concluded that the precracks were Alocromed and that variations in the height of the chromium peaks indicate greater or lesser quantities of chromium present, which in turn would represent a thinner or thicker Alocrom coating.

Figure 38 - Energy dispersive X-ray spectrometric analysis of (a) impeller base material, an aluminum alloy with no chromium; (b) bore surface with Alocrom protective treatment; displays chromium peak.

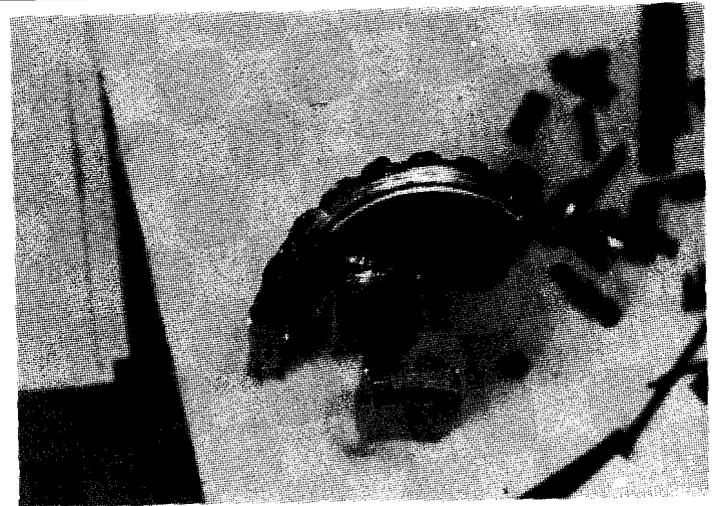
Figure 7 Fragments of Disintegrated Pinion Gear Showing Fatigue Cracks

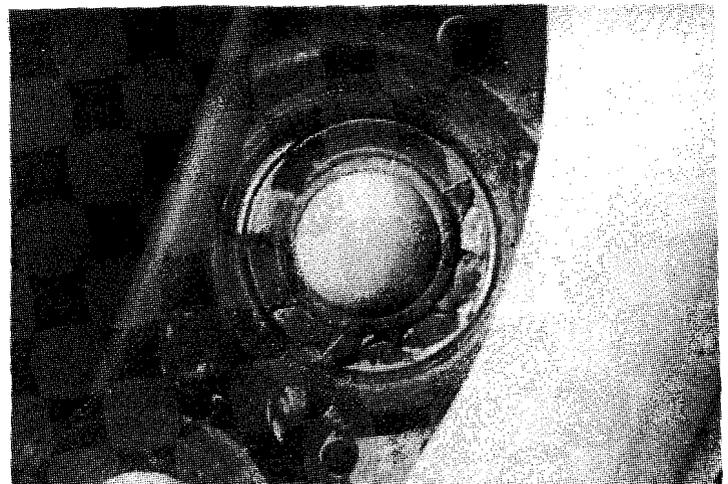
Figure 8 Reconstruction of Thrust Washer in Position on Carrier Plate

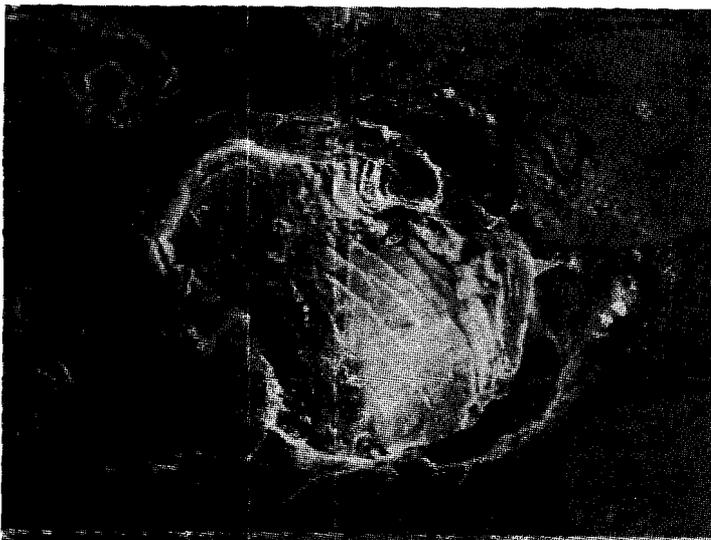
Figure 12a SEM Micrograph of "Hot Spark" Pit

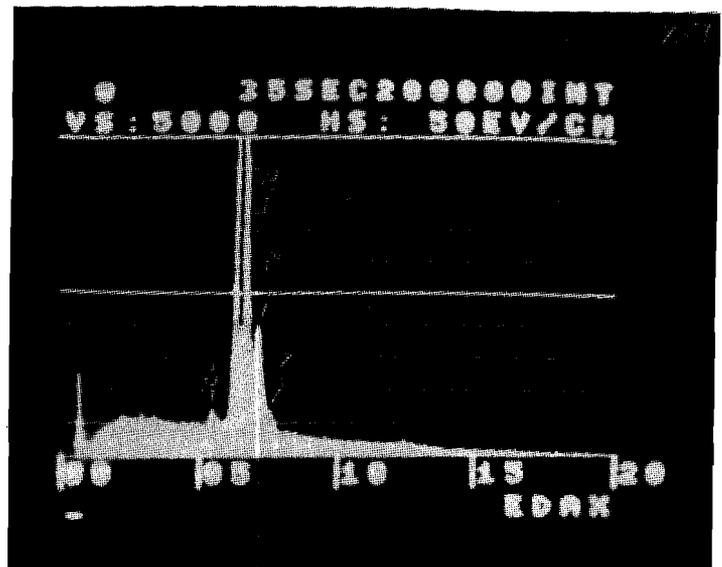
Figure 12b Energy Spectrum from within Pit of Figure 12a

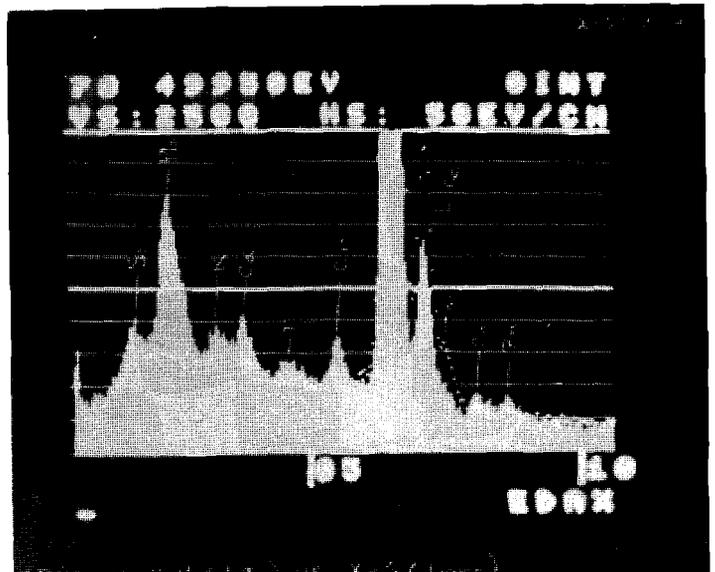
Figure 13b Energy Spectrum from within Pit and on Nearby Surface of Figure 13a.

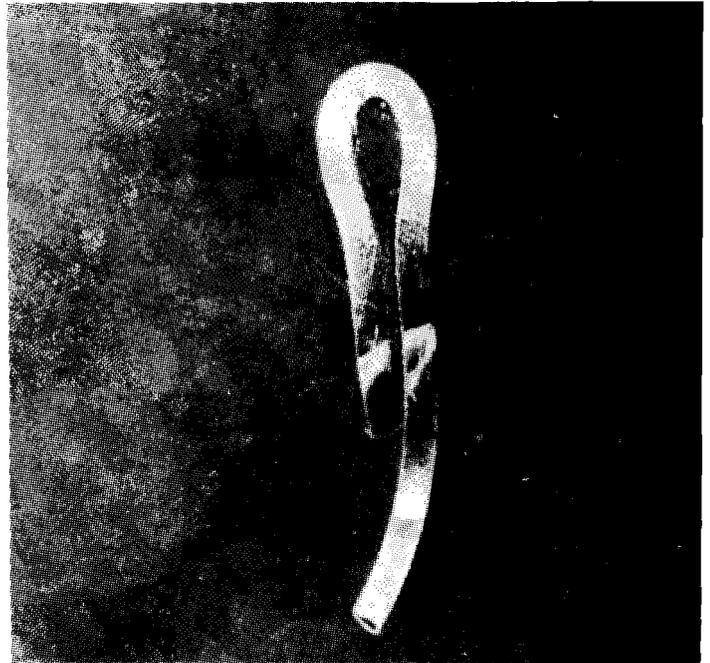
Figure 1 - Section of buckled exhaust pipe which has been mounted and polished in readiness for hardness measurements.

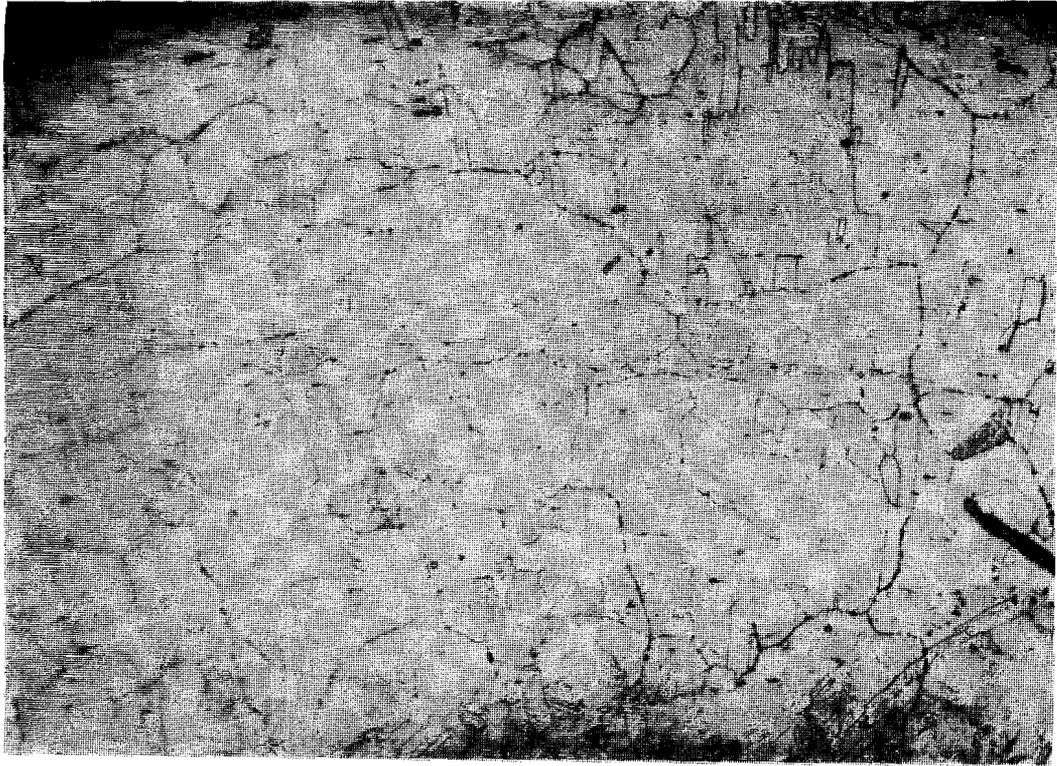
Figure 6 - A polished and etched specimen prepared from an engine known to have been operating at impact. Note the absence of slip lines. (Magn. X130)
