# Sukhoi Superjet - Airborne Image Recorder Supported Investigation

Ragnar Gudmundsson, ISASI # MO6277, Investigator-In-Charge (IIC)

## Icelandic Transportation Safety Board

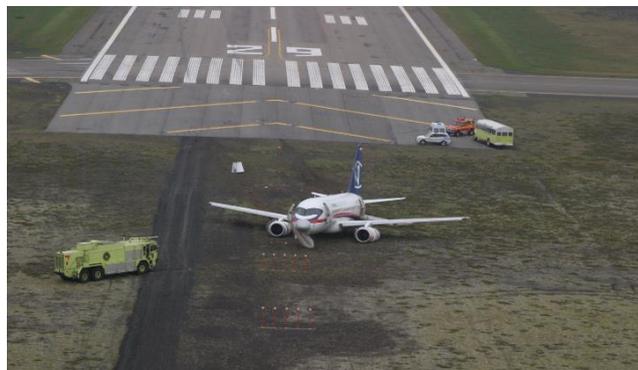
Figure 1: The Accident Site

At 05:23, shortly after the flight crew had initiated go-around for flight test #978 over RWY 11 and selected the landing gear lever to the UP position, the aircraft started to descend after having reached

a maximum radio altitude of 27 feet. This resulted in the fuselage aft lower belly and engine cowlings hitting the runway. The aircraft skidded off the end of the runway and came to rest 163 meters beyond the threshold of RWY 29 with its landing gears fully retracted.

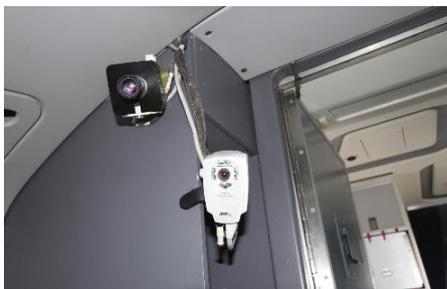
Figure 8: Cockpit RH side Video

There is no question about it, in the mind of the IIC of this investigation, the Airborne Image Recorder played a vital role in the investigation. The video image recordings it captured allowed the investigators to answer questions they would otherwise not have been able to answer in the investigation. In fact when the FDR failed to support the pilot's statement of activation of a go-around at the most critical moment of the test flight, a mere split of a second prior to the landing gears touching the runway, the Airborne Image Recorder revealed the truth of the pilot's statement. The investigation then made use of the extensive flight test data being collected as part of the flight test, as well as of the manufacturer's technical advisors. Data collected in this data bank, and not by the FDR, revealed that the go-around mode was engaged by the push of the TOGA switch,

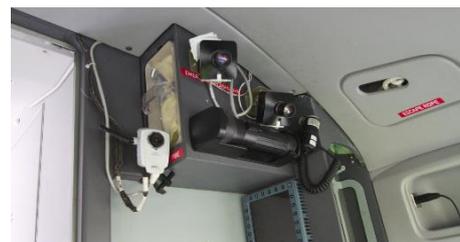
Figure 9: Cockpit LH side Video Cameras

as the Airborne Image Recorder had revealed, but the aircraft was then inhibited from go-around engagement as the weight-on-wheel signal was received within one second. As a result no go-around engagement by the push of the TOGA switch was found on the FDR.
