## **AIRCRAFT ACCIDENT INVESTIGATION IN THE JET AGE**

# AIRCRAFT ACCIDENT INVESTIGATION IN THE JET AGE

BY STEVEN R. LUND

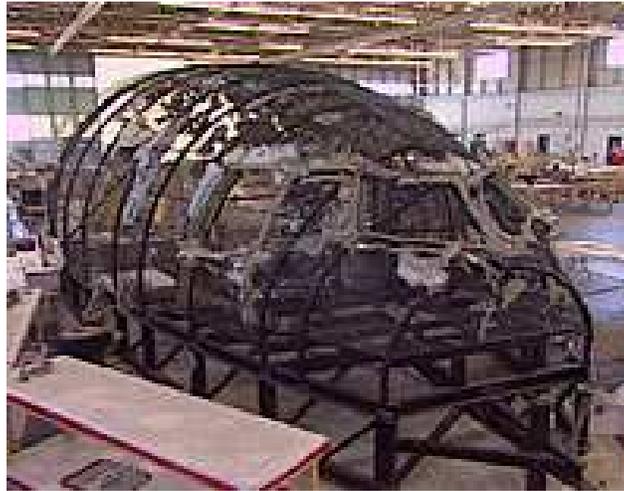
--Flight Deck reconstruction of Swissair MD-11 following its crash into the N. Atlantic; Sept 1998. [TSB Canada photo]

According to the Canadian Transportation Safety Board (TSB) official report, "At approximately 2231 Atlantic Daylight Time" the aircraft crashed into the sea near Peggy's Cove, Nova Scotia, fatally injuring all 229 occupants. About 13 minutes after the abnormal odor was detected, the aircraft's flight data recorder began to record a rapid succession of aircraft systems-related failures; presumably due to a fire attacking these systems. Both the Digital Flight Data Recorder (DFDR) and the Cockpit Voice Recorder (CVR) then stopped recording when the aircraft was at approximately 10,000 feet above the sea, about six minutes before the aircraft struck the water." Because the aircraft plunged into water, virtually eliminating any severe post-crash fire damage adding to the in-flight fire damage was minimized. Thus, giving investigators reasonable assurance that any recovered fire damaged parts occurred in flight before impact. The initial investigation revealed heat damage consistent with a fire in the ceiling area covering about one meter forward and several meters aft of the bulkhead between the flight deck and the cabin area. Physical evidence recovered from the sea floor showed numerous wires from this area exhibit charring and burnt insulation. Examples of electrical arcing damage were found. But, it was not immediately obvious whether the arcing was the ignition source for the fire or whether arcing was the secondary result of a fire that originated elsewhere and damaged the wiring insulation, which subsequently caused the arcing to occur.

- *"The type of circuit breakers (CB) used in the aircraft were similar to those in general aircraft use, and were not capable of protecting against all types of wire arcing events. The fire most likely started from a wire arcing event.*
- *A segment of in-flight entertainment network (IFEN) power supply unit cable (1-3791) exhibited a region of resolidified copper on one wire that was caused by an arcing event. This resolidified copper was determined to be located near manufacturing station 383, in the area where the fire most*

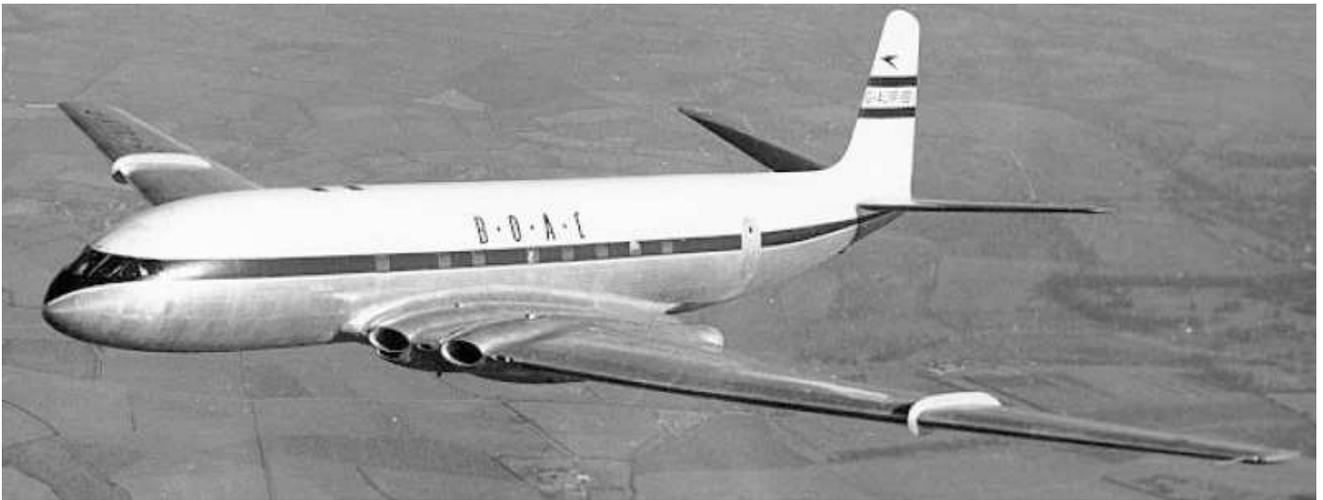
**Figure 1--Comet Mk1 G-ALYP during flight tests. It was destroyed in 1954 after crashing into the Sea near Elba Is. on a flight from Rome to London when it broke up in flight [British Airways photo].**

1. Wreckage recovery and reconstruction showing gouge marks across the upper surface of the reconstructed wing, which matched a jagged piece of fuselage structure being blown out across the upper wing surface;
2. Ground tests of fuselage pressure cycling eventually revealed the beginning of fuselage fatigue cracks emanating from stress concentrations at the sharp corners of the Comet's large rectangular windows in the fuselage.

It was unavoidably concluded in February 1955 that metal fatigue was the reason the fuselage structure failed in flight; after thousands of pressurized climbs and descents the aluminum fuselage metal around the Comet's right-angled large windows would begin to crack, which grew; eventually resulting in an weakening the fuselage to the point where the cabin pressurization loads caused an explosive structural failure.

However, it is now a requirement for airliner manufacturers to conduct ground pressure tests demonstrating fuselage structural integrity after a number of pressurization cycles equal to two complete design lifetimes of the aircraft in order to certify any new aircraft for airline use.

In addition, frequent, periodic, detailed maintenance inspections designed to detect the beginnings of fatigue cracks are required during the operational life of all airliners.

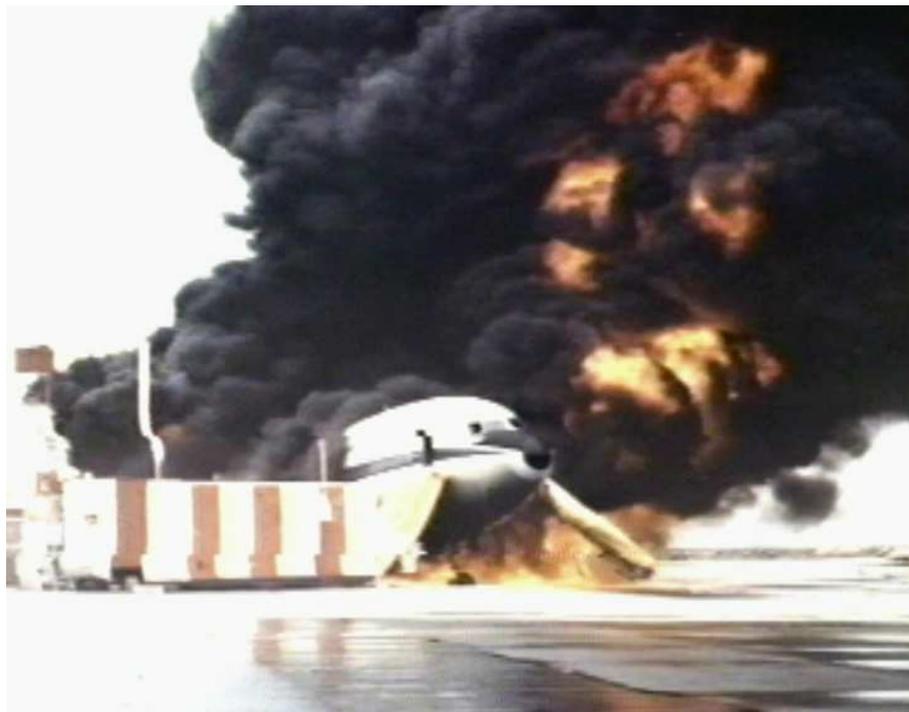
**Figure 3--**Fiery aftermath of the ONA DC-10 following an unsuccessful RTO on Nov. 12, 1975 at New York's JFK airport

The sequence of events on this RTO accident could be considered to begin when the pilots first noted something going wrong as large birds were ingested into the right wing engine, resulting in severe fan blade damage and fan rotor imbalance, with accompanying heavy airframe vibration, presumably inducing the Captain to begin to bring the heavy (555,000-lbs.) airplane to a safe stop on the wet runway. After the RTO initiation, things went from bad to very bad in a short time:

- The vibrating engine began throwing high energy parts into aircraft structure severing fuel lines to the engine and showering hot, jagged, debris toward the right main landing gear tires and brakes.
- The engine caught fire
- At least 3 of 4 tires and wheels on the right main landing gear (RMLG) began to disintegrate.
- The hydraulic lines to the RMLG brakes were severed, depleting that hydraulic system of its fluid as brakes were applied for stopping.
- Aircraft deceleration and steering control were degraded because of asymmetric braking, asymmetric engine thrust, and the loss of some wing lift spoilers, normally operated by the inoperative hydraulic system
- The aircraft veered to the right off the hard surface into soft ground.
- The RMLG collapsed
- The fire spread to engulf the entire aircraft.

1. The timely application of the proper de-icing fluids, in the icing cases.
2. More detailed attention to the condition of the tires and a better understanding of overall RTO maneuver and how the planes were certified in the RTO cases.

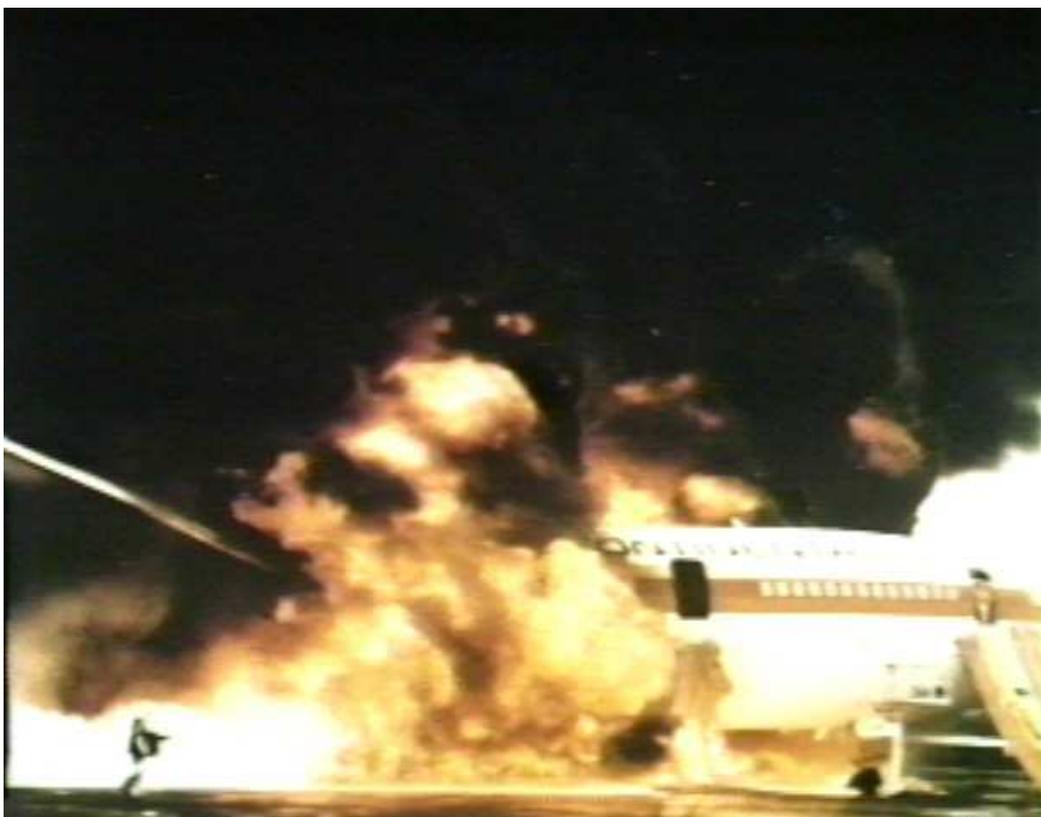
In another, very similar accident, about 3-years after the ONA RTO at JFK, another DC-10 experienced an RTO at LAX after one tire lost pressure during taxi to the takeoff runway. Even though there are 4 main landing gear wheels on both the left and right main landing gears, when one tire/wheel fails, this overloads the other on the same axle, causing it to fail in turn, which is apparently what happened during the takeoff roll while approaching the V1 speed (156kts) a loud "metallic bang" was heard, followed by a quivering. As rejected takeoff (RTO) procedures were begun, the airspeed continued to increase to 159kts. The aircraft appeared to be decelerating normally, but with 2000ft of runway remaining, the flight crew became aware that the rate of deceleration had decreased and they believed that the aircraft would not be able to stop on the runway. The aircraft was steered to the right and departed the right corner of the runway end. About 100ft beyond the runway, the left main gear broke through the non load-bearing tarmac surface and failed. A fire erupted in this area as the aircraft turned to the left, coming to rest 664ft from the runway end and 40ft right of the extended centerline in a 11deg left wing low and 1,3deg nose-up attitude.

**Figure 4--**Continental DC-10 RTO overrun accident at Los Angeles International Airport (LAX) on March 1, 1978.

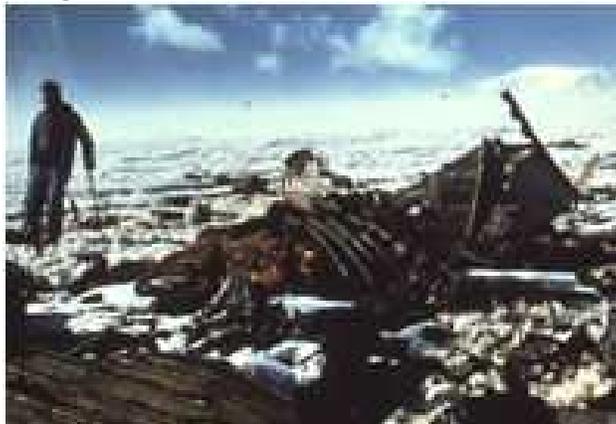
**Investigator amidst the DC-10 wreckage with Mt. Erebus in the background  
NZ Police Photo.**

The OFFICIAL CAUSE as submitted by the technical Commission of Inquiry read: "The decision of the captain to continue the flight at low level toward an area of poor surface and horizon definition when the crew was not certain of their position and the subsequent inability to detect the rising terrain which intercepted the aircraft's flight path."

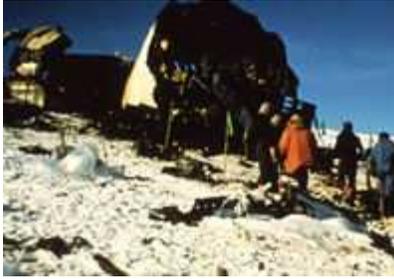
were found fastened in the wreckage and a disproportionate number of passenger remains were found some distance from the main debris path. This prompted speculation that some may have survived the impact and fire by being thrown clear when the fuselage split open at impact. However, this was not confirmed during the investigation.

**Intact DC-10 Fuselage section with NZ Police locating victims remains; marked with green flags.  
NZ Police Photo.**
