Comparisons and Lessons Learned from UA232 Sioux City and AA383 Chicago Uncontained Events

David Chapel and Daniel Kemme, GE Aviation

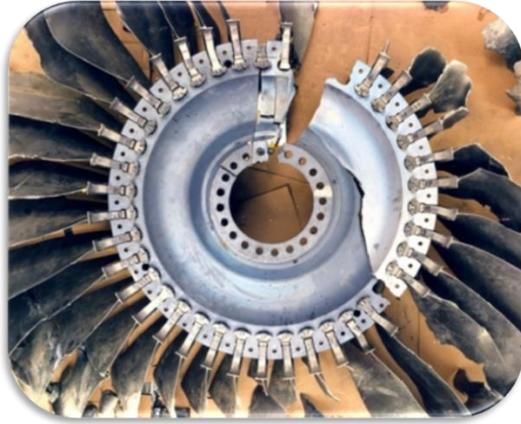
In both events, nearly all of the fractured pieces of the disks were recovered (Figure 2) and most importantly these pieces included the primary fracture surfaces. Figure 3 shows the fracture surface of each disk and Figure 4 shows the close-up of the fracture areas highlighting their respective “anomalies”.

Recovered fragments of the Stage 1 Fan Disk from UA232

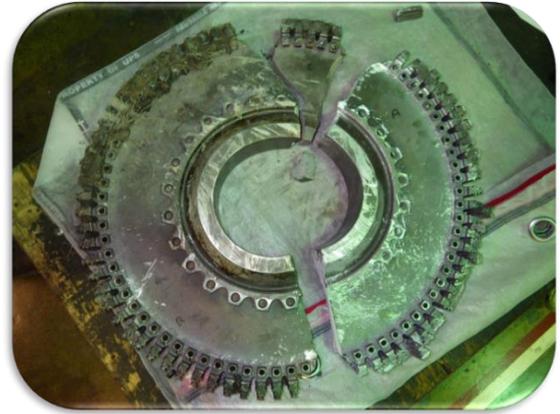
Recovered fragments of the High Pressure Turbine Stage 2 Disk from AA383

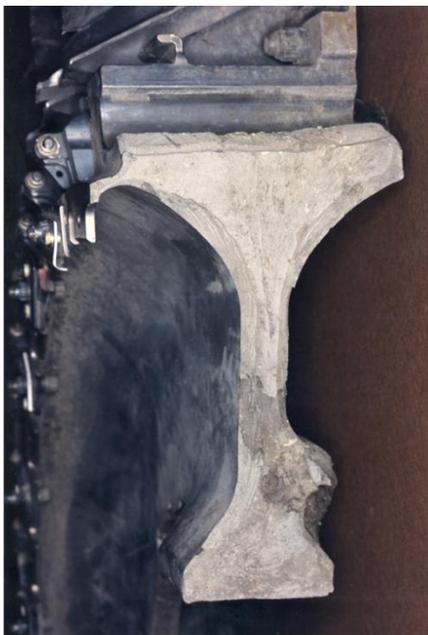
Failure Surface of the Stage 1 Fan Disk from UA232

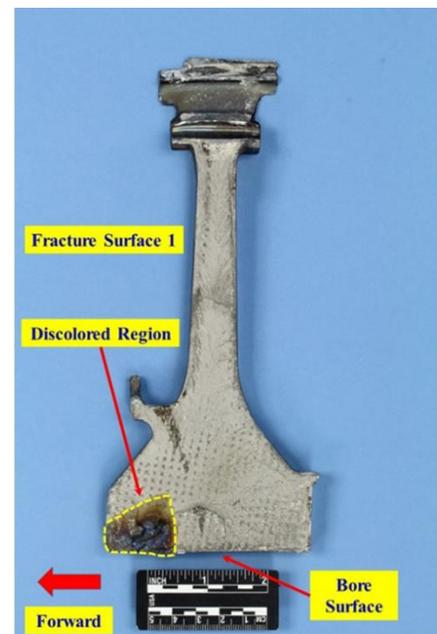
Failure Surface of the High Pressure Turbine Stage 2 Disk from AA383

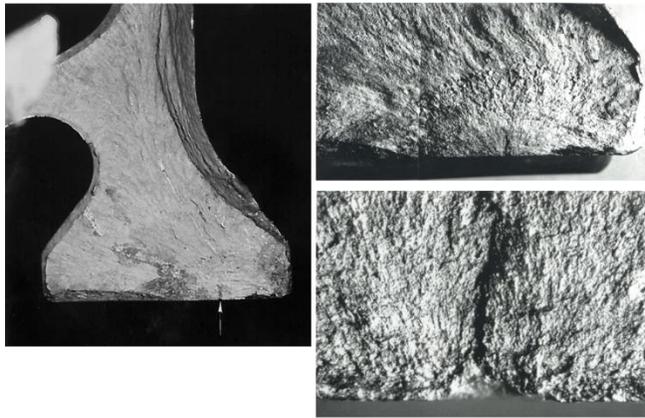
The UA232 disk developed a crack due to a melt-related hard-alpha inclusion on the bore surface. This inclusion was not detected during manufacture due to its sub-surface nature and likely uncracked and non-voided condition making detection difficult. The AA383 disk developed a crack due to an anomaly called a Discrete Dirty White Spot (DDWS). Like the UA232 disk hard alpha inclusion, this DDWS was not detected during manufacture because it was subsurface and it likely was not cracked or voided.

Anomaly area of the Stage 1 Fan Disk from UA232

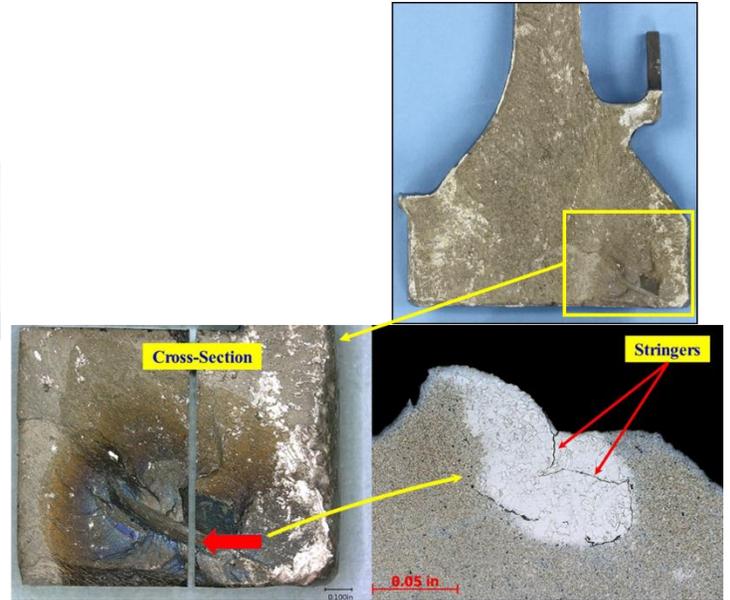
Anomaly area of the High Pressure Turbine Stage 2 Disk from AA383
