ISASI 2011 Annual Seminar, Salt Lake City, Utah,  
September 12 – 15, 2011

**Hands across the sea: Teamwork in the cause of aviation safety**

On 27 November 2008, the Airbus A320 registered D-AXLA operated by XL Airways Germany crashed into the Mediterranean during approach to Perpignan airport in the south of France. There were no survivors among the seven aviation professionals on board. Apart from a few pieces of wreckage, most of the airplane sank within minutes. The flight crew had lost control of the aircraft while demonstrating - rather than checking - the functioning of the aircraft's high angle of attack protections.

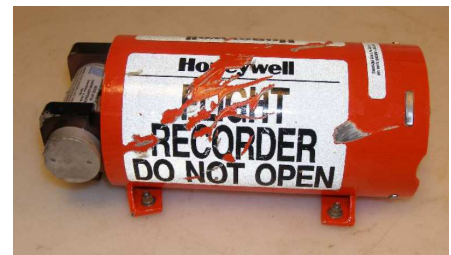
*FDR CSMU*

The Flight Recorders were found within three days of the accident and handed over to the BEA on 30 November 2008. Despite many attempts to read out both recorders using different types of independent equipment, we could not safely recover the recorded data.

The flight recorders' electronic boards remained in the custody of the judicial authorities, whose agreement was therefore necessary to perform any work on them. After much delay, they were finally examined in the manufacturer's facilities in the United States on 5 and 6 January 2009, in the context of an International Commission of Inquiry. Short-

circuits and damaged components were discovered on the boards and eliminated, allowing full data recovery from both recorders. The recordings were of good quality and the whole flight was included. Nevertheless, the fact that it had not been possible to read out the data from the two recorders added some pressure on the safety investigation team and hampered the progress of the investigation.

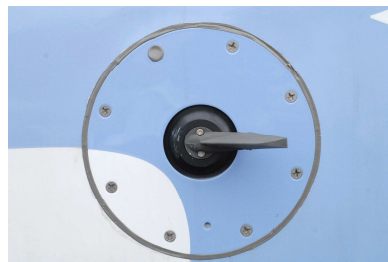
Two of the three Angle of attack sensors, located symmetrically on each side of the fuselage, stopped moving at identical values during cruise when water present inside the sensors' casing froze. It was later demonstrated that the application of a high-pressure jet of water onto an airplane without following the recommended procedure can allow penetration of a small quantity of water into an angle of attack sensor, and that this would be sufficient, when frozen, to block it.

Angle of Attack sensor on aircraft

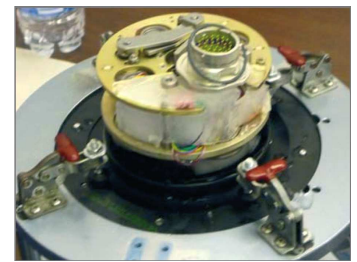
Amount of ice in the housing of the Angle of Attack sensor after the water exposure test

The inappropriate rinsing of the airplane at the end of painting operations was an active failure that revealed a latent failure in the equipment qualification process. Indeed, it was noted that for impermeability tests, undertaken for the qualification of the equipment, the installation conditions could be different from those on the airplane. Even if this difference with real operating conditions was not a contributing factor in the accident, it certainly constituted a safety loophole.
