## 75 years of scientific accident investigation support at the Bend

**L. Molent and N. Athiniotis**

Defence Science and Technology Organisation

This paper presents a brief history of 75 years of systematic scientific support to aircraft accident investigation at the now Defence Science and Technology Organisation at the Bend.

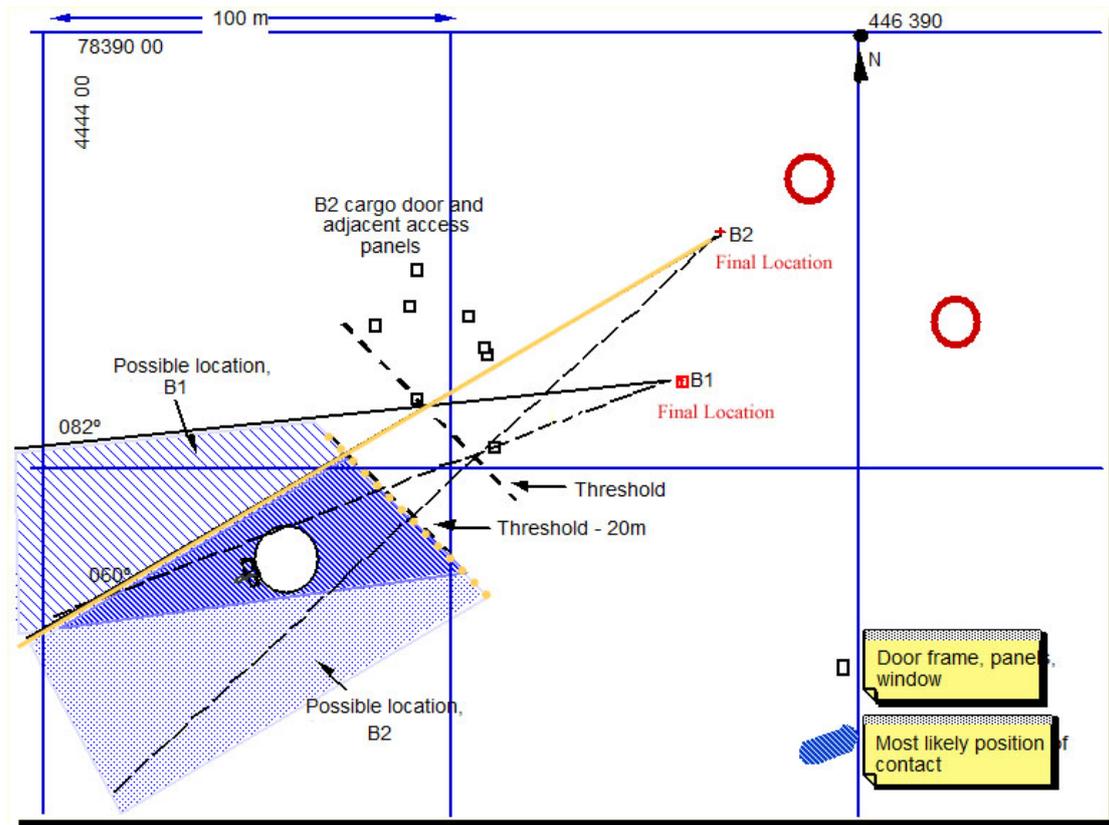
In addition to wreckage mapping, considerable efforts were devoted to aircraft reconstruction. By matching blade impact marks with the orientation of the aircraft an estimate of the impact projection of the two aircraft was made. By conducting individual trajectory analyses of each of the various component groups identified (e.g. rotor blades, light materials, major components etc) and considering their measured spread on the ground (e.g. Figure 5), the overlapping common areas was considered the most probable area of aircraft contact, see Figure 6. These two technical aspects were critical in postulating a credible scenario to explain the collision.

Figure 5: Debris trajectory analysis of cargo door parts from B1 and B2, indicating most likely location of impact.

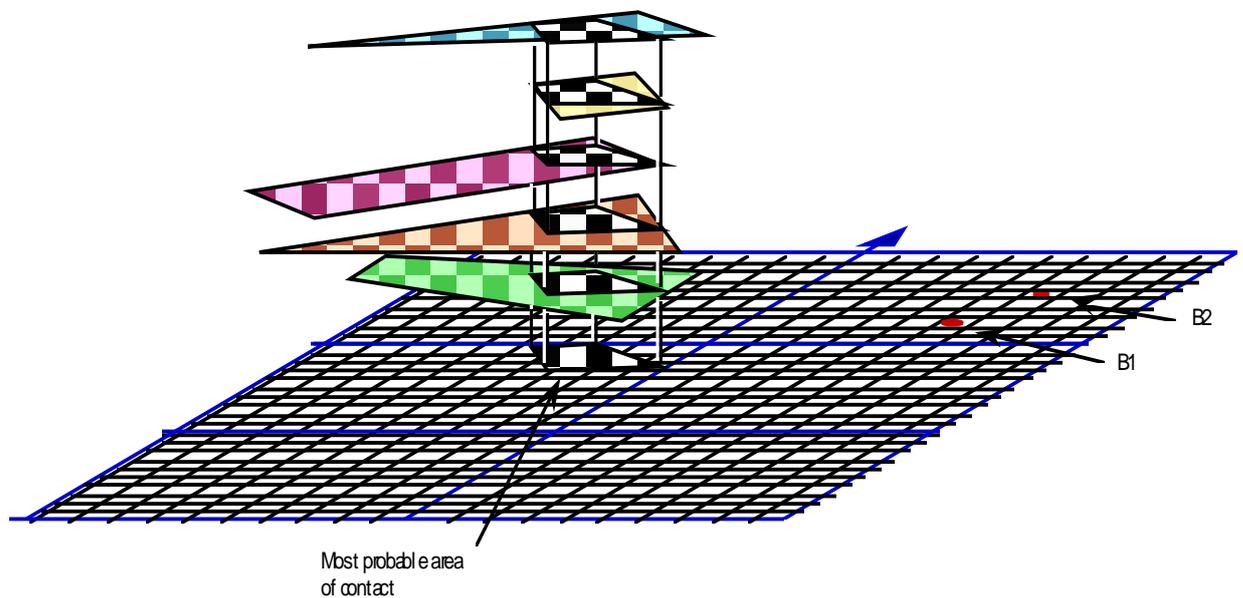
Figure 6: Most likely location of impact (grey shaded area). Each other colour represents the estimated projection of a component group (separated in height dimension for illustration purposes).

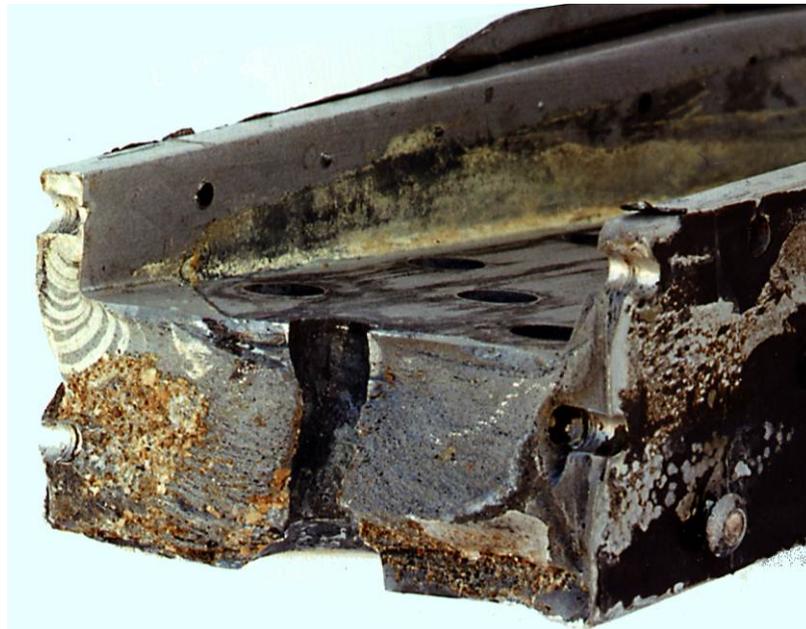
wreckage recovered from the sea disclosed that the port wing had failed when the aluminium alloy 7075-T6 lower spar boom broke as the result of a large fatigue crack [9,10]. The cracking was found to have initiated from a machining detail in the base of a flange fastener hole, Figure 7. This defect had the effect of introducing a severe notch into the fastener hole. Examination of the recovered starboard wing revealed further fastener hole cracking. All spars in the RAAF fleet had been replaced in a life extension program however a fatigue test of the new configuration had not been conducted. Examination of the Deutsch™ fastener hole from which the fatigue crack initiated revealed that the hole had been drilled though the flange to a depth where the drill tip had just penetrated the rear surface of the flange. This penetration had occurred in the central region of the hole and corresponded to the centre of the tapered end of the drill used to machine the hole. The cracking had initiated at the resultant tapered base of the hole between where the hole penetrated the back face of the flange, and the main bore of the hole. Cracking had occurred on either side of the penetration, roughly in the plane perpendicular to the length of the spar boom with the cracking on either side being slightly offset. Providence dictated that the step produced by the fastener hole drilling was aligned at the worse possible orientation, namely approximately perpendicular to the principal loading direction. The depth of the notch-step produced was estimated to be approximately 0.22 mm (i.e. a large flaw, see [11]). It was postulated that the stress concentration effect of this notch, coupled with that of the hole and low interference of the fastener, contributed to the rapid crack growth rate. Further, teardown inspection of the recovered starboard wing revealed the presence of other fatigue cracks, including at the mirror location to the port wing failure site, generally these cracks could also be attributed to poor hole machining quality. With the aid of the load history from the aircraft's Nz meter, the growth pattern on the fatigue fracture surfaces of two holes was determined via quantitative fractography. The largest of the cracks were investigated to establish their growth rates which, coupled with assistance of the non-destructive inspectors, enabled the RAAF to conduct a safety-by-inspection program which helped to recover their training capability.

**Figure 7: Fracture surface of A7-076 lower spar cap after recovery from the ocean. Note the fatigue progression marks propagating from the upper (nominally) blind fastener hole (upper left hand side).**

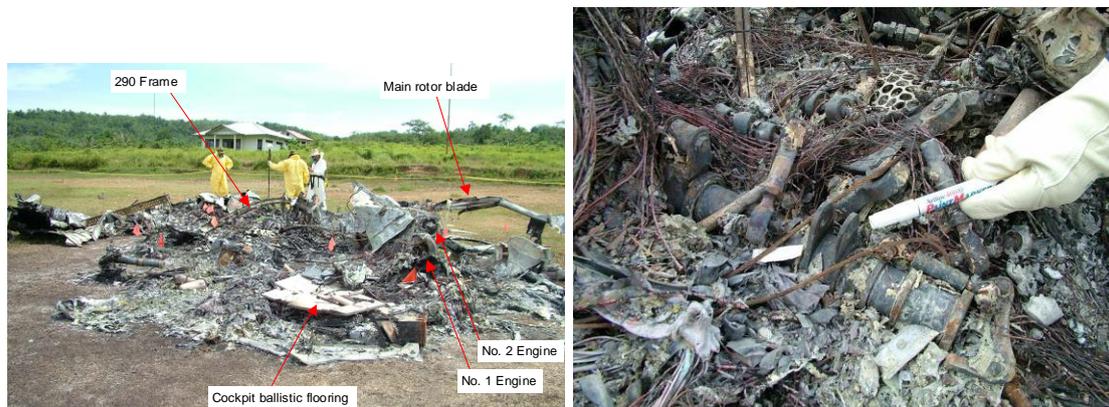
The most significant evidence found suggested that a flight control system failure occurred due to disconnection of the fore/aft bellcrank from the flight control’s Mixing Unit, Figure 8. The physical evidence indicated that an unsecured castellated nut detached from the end of a bolt holding the fore/aft bellcrank onto the Mixing Unit lugs. The bolt then slid out of the lugs, permitting the bellcrank to separate from the Mixing Unit. The Sea King flight modelling developed at DSTO indicated that the forward motion of the bellcrank and its detachment from the fore/aft lugs of the Mixing Unit would, in less than a second, cause the aircraft to pitch forward rapidly, leading to a nose-dive towards the ground. Any fore/aft inputs made by the pilot with the cyclic stick would have been ineffective because the disconnection of the fore/aft bellcrank from the Mixing Unit prevented fore/aft cyclic stick motions from being transmitted to the swashplate. There was no possibility of recover the aircraft.

Due to the difficulty in re-installing the item, the maintenance activity carried out by the early watch handed over the task to the late watch with the fore/aft bellcrank loosely secured at the pivot point, with the castellated nut not torqued and with no split-pin fitted. Whilst those undertaking the maintenance were aware of the activity, no Aircraft Maintenance Documentation existed that recorded the removal, serviceability assessment, reinstallation or final inspections of the fore/aft bellcrank. This meant that there was no documented record of a Critical Maintenance Operation maintenance task to act as a prompt for the necessary associated maintenance and inspections. It is considered that this lack of documentation and therefore prompt to inspect the critical item which may have noticed the missing split pin, that ultimately led to the unwinding of the castellated nut, extraction of the bolt and separation of the fore/aft bellcrank from the Mixing Unit pivot point.

**Figure 8. Sea King Accident Site, and disconnected fore/aft bellcrank (right)**

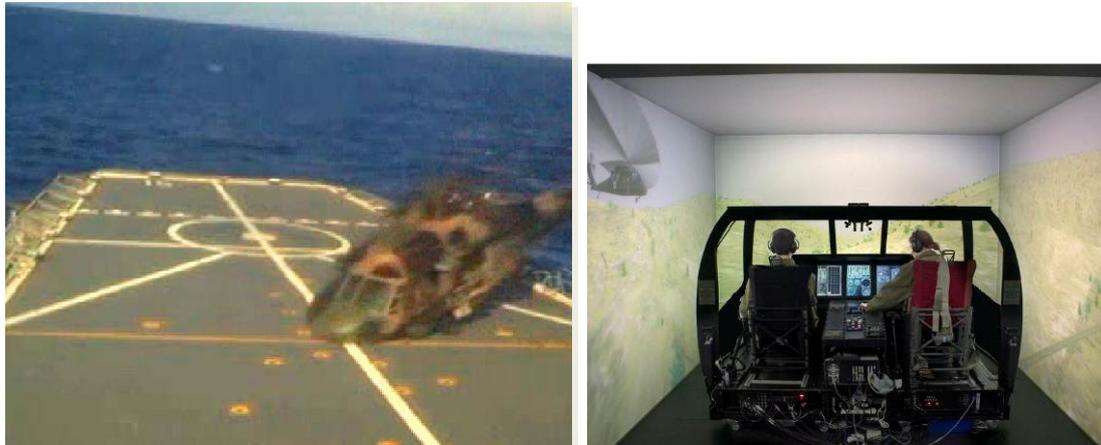
DSTO investigations commenced in parallel to the deep sea operation to recover the aircraft, deceased and the Flight Data Recorder (FDR). Using the recovered (and water damaged) video from an on-board hand-held camera along with the ship's video of the flight deck impact, DSTO photogrammetry was used to reconstruct the flight path and estimate the approach speed of the aircraft. This information was then used to develop a flight model and reconstruction of the accident, which was used in the DSTO Air Operations Simulation Centre, Figure 9, to assist pilot instructors to fly a series of manoeuvres that started with defined initial conditions and ended in a manner similar to that recorded by the video imagery of the actual accident. This allowed an understanding of the phases of the approach that led to impact with the flight deck.

DSTO forensically examined the aircraft wreckage following its recovery, however did not identify anything that may have contributed to the accident. DSTO also examined Life Support Equipment to determine the sequence of events leading to the death of the pilot. The reconstruction of the recovered FDR data matched closely to the initial DSTO flight reconstruction, and confirmed that the combination of low speed, large aircraft attitudes and high yaw rate caused a large angle of side slip and placed the aircraft in an unrecoverable state leading to the impact on the ship's flight deck and subsequent ditching.

**Figure 9. Black Hawk impact on HMAS *Kanimbla*, and DSTO Simulator with ‘roll-in’ Black Hawk cockpit**

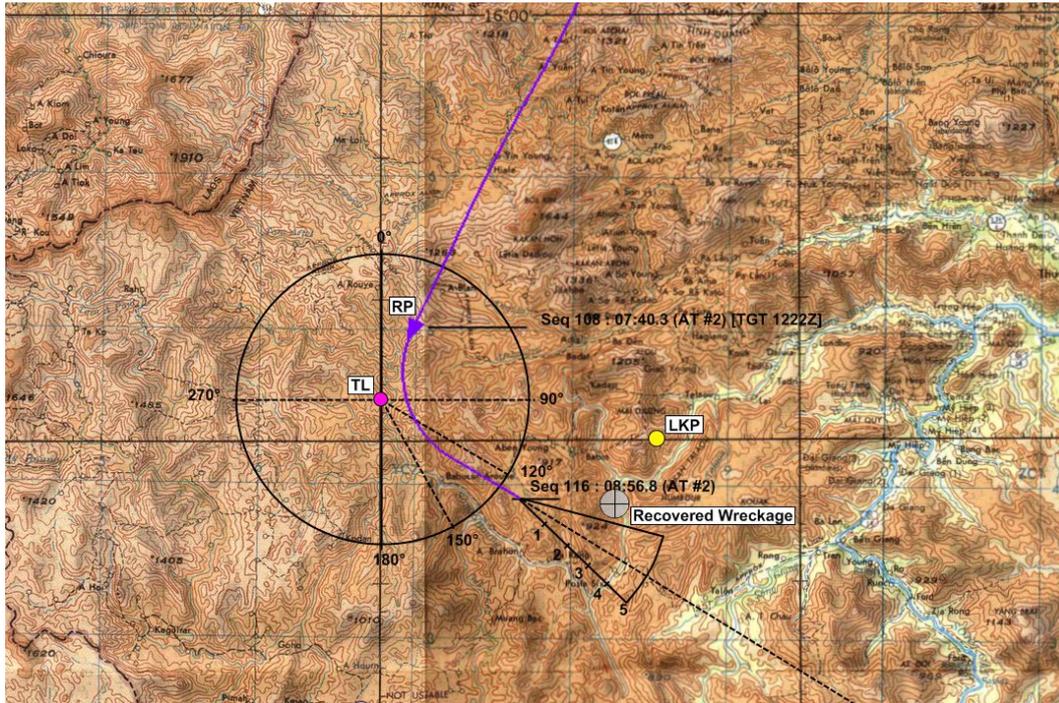
The DSTO reconstruction provided a refined area of interest for the Principal Investigator, Figure 10, which assisted in discovery of an aircraft. DSTO forensic examination of items recovered from the wreckage site confirmed that this aircraft was the missing RAAF Canberra and its crew.

Figure 10: Reconstructed flight path showing approximate location of recovered aircraft. RP =Release Point, TL=Target Location, LKP= Last Known Position based on radar 1970. DSTO predicted quadrants including possible in-flight breakup (debris field based on fragmentation size).
