## **Investigating Human Fatigue Factors – A Tale of Two Accidents**

Katherine Wilson, Ph.D.  
Human Performance and Survival Factors Division  
National Transportation Safety Board\*  
USA

#### *UPS flight 1354*

### *Sundance Helicopters sightseeing trip*

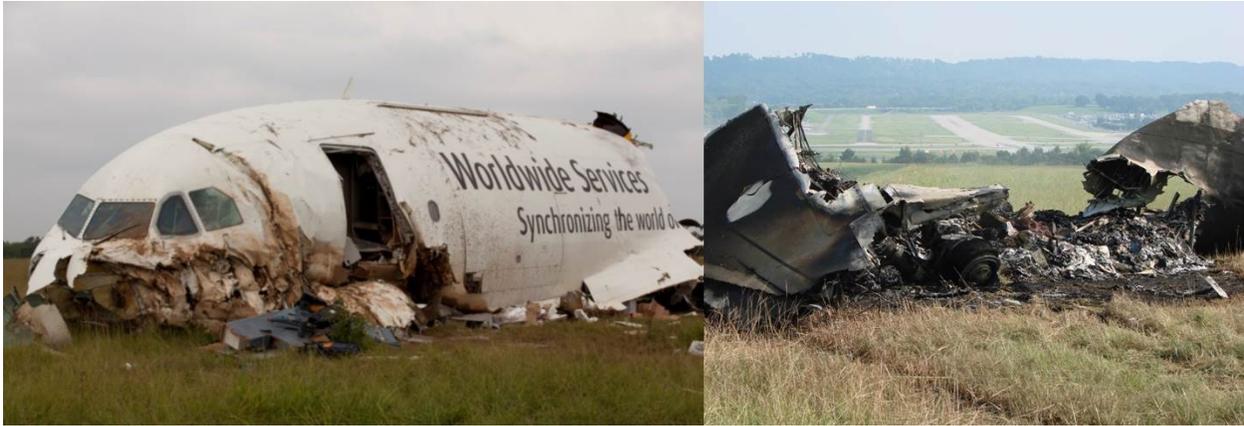
On August 14, 2013, about 0447 central daylight time (CDT), UPS flight 1354, an Airbus A300-600, crashed short of runway 18 during a localizer nonprecision approach to runway 18 at Birmingham-Shuttlesworth International Airport (BHM), Birmingham, Alabama, fatally injuring the captain and first officer (see Figure 1). At the time of the accident, dark night visual meteorological conditions prevailed at the airport, however, variable instrument meteorological conditions with a variable ceiling were present on the approach north of the runway. The flight had departed from Louisville International Airport-Standiford Field (SDF), Louisville, Kentucky, about 44 minutes before the accident.

Figure 1. UPS flight 1354 wreckage.

Postaccident examination found no evidence of any structural, engine, or system failure or anomaly occurring prior to impact, and the airplane met all FAA regulations and the manufacturer's recommended maintenance program. Therefore, the investigation focused on the flight crew. A review of company records revealed that the flight crew had adequate experience and was properly trained for the flight. While the investigation also focused on the flight crew's workload and expectation of weather conditions, the information presented in this paper will focus on flight crew fatigue.

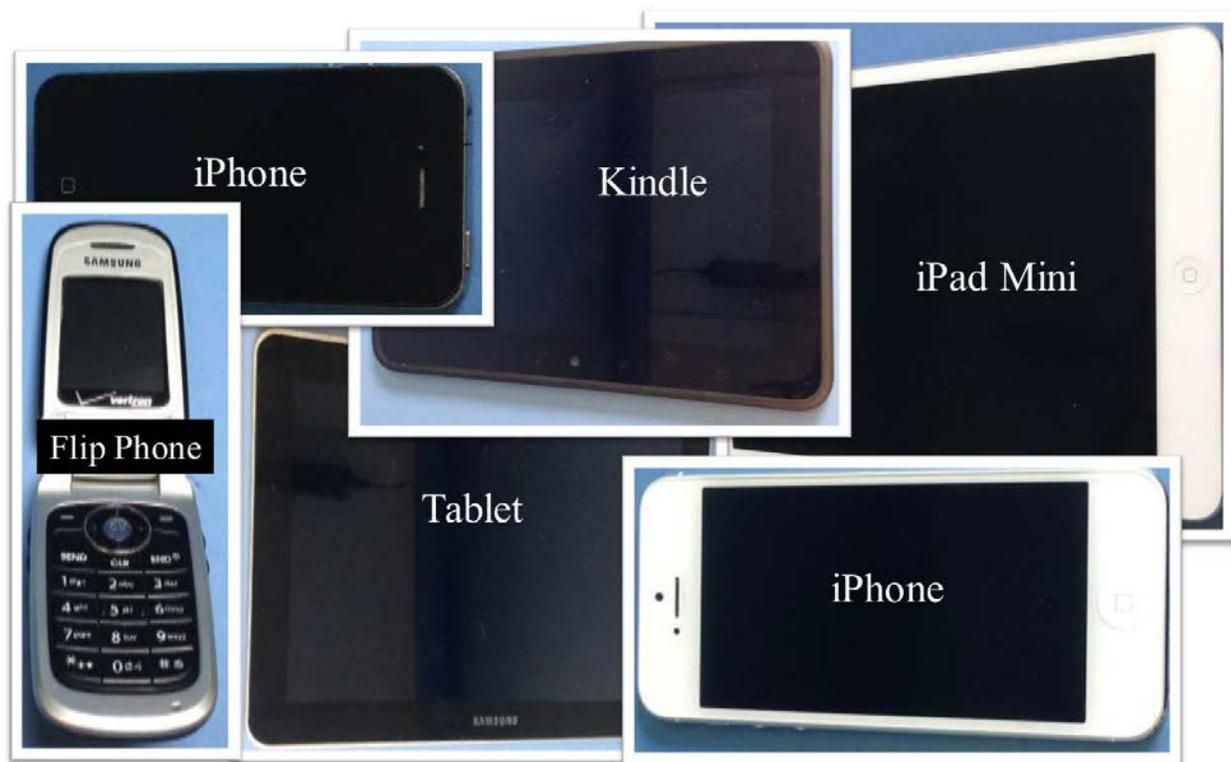
Data used to determine whether the flight crew fatigue was causal or contributing to the accident, data was gathered through interviews, company records, hotel records, cellular telephone records, and information retrieved from six personal electronic devices found in the crewmembers' personal possessions (see Figure 2).

Figure 2. Images of UPS 1354 flight crew's personal electronic devices.

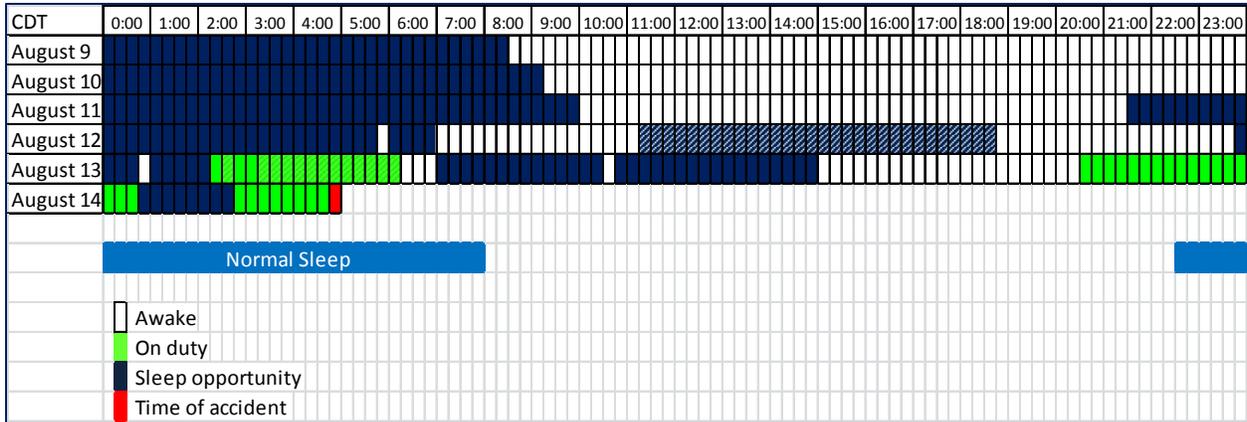
At the time of the accident, the flight crew had been on duty about 8 hours and 30 minutes. The captain had been awake about 14 hours and the first officer had been awake for over 18 hours (see Figures 4 and 5). Although the duty day was not unusually long, the first officer,

Figure 4. UPS 1354 captain's sleep/wake history.

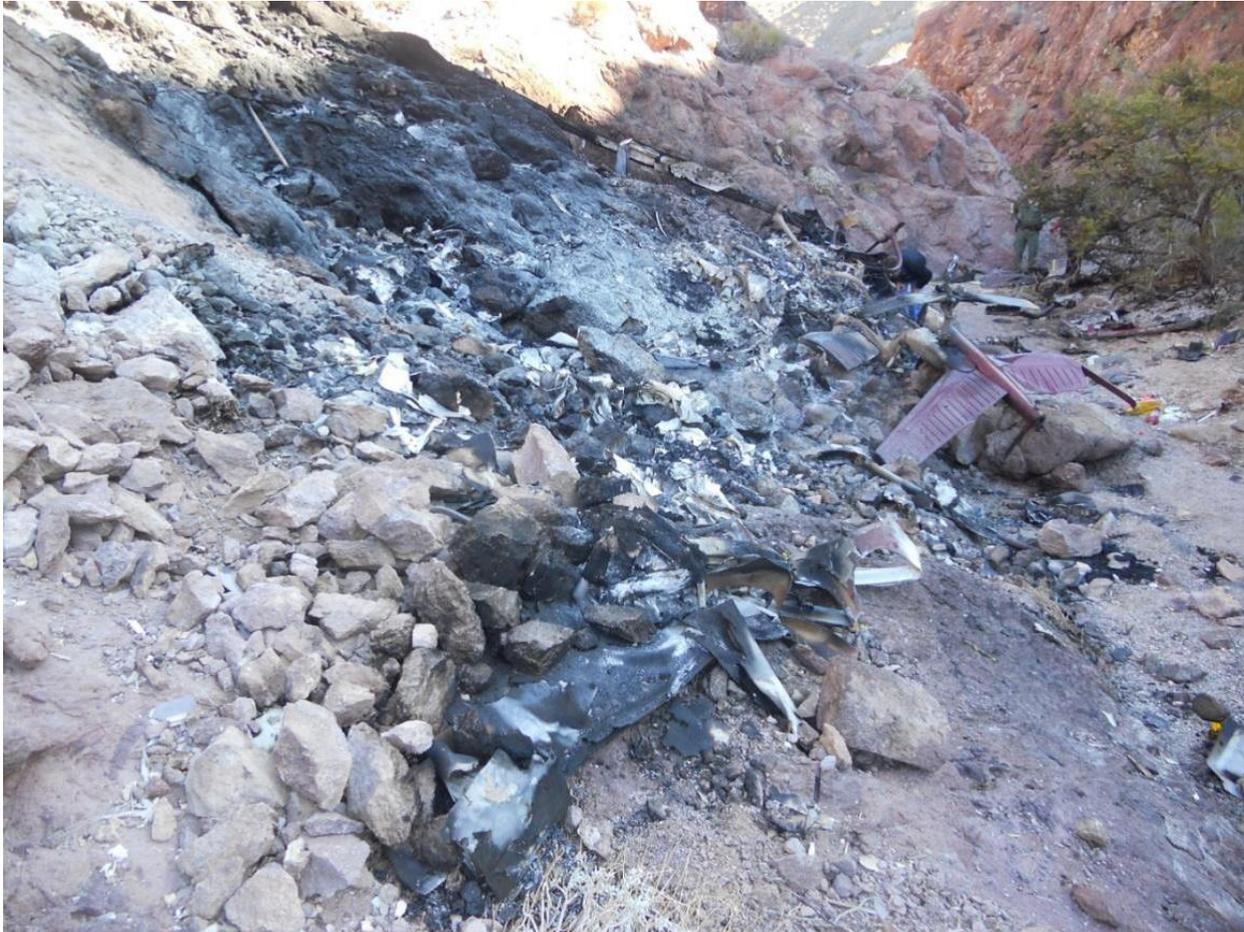
On December 7, 2011, a Sundance Helicopters sightseeing tour Eurocopter AS350-B2 helicopter crashed near Las Vegas, Nevada, about 1630 Pacific standard time, fatally injuring all aboard (see Figure 6). The helicopter was operating as a “Twilight tour” sightseeing trip. Dusk light and visual meteorological conditions prevailed at the time of the accident. The helicopter had departed from Las Vegas McCarran International Airport (LAS), Las Vegas, Nevada, about 9 minutes before the crash.

Figure 6. Main helicopter wreckage.

Examination of the wreckage found that the flight control input rod was not connected to one of the three hydraulic servos that provides input to the main rotor. Missing from the wreckage were the bolt, washer, self-locking nut and split/cotter pin that normally secures the input rod to the main rotor/aft servo. Post-crash examination of likely scenarios for why the helicopter experienced a loss of control in flight determined that the disengagement of the fore/aft servo bolt was most likely. Further testing of the most likely explanation for how the bolt disengaged during flight determined that the hardware was improperly secured during the previous day's maintenance. Specifically, the split/cotter pin was not installed or not installed correctly, allowing the self-locking nut to separate from the bolt, and then the bolt to work its way out of the joint due to normal in-flight vibratory forces. At this time, the input rod would have separated from the linkage and the helicopter became uncontrollable.

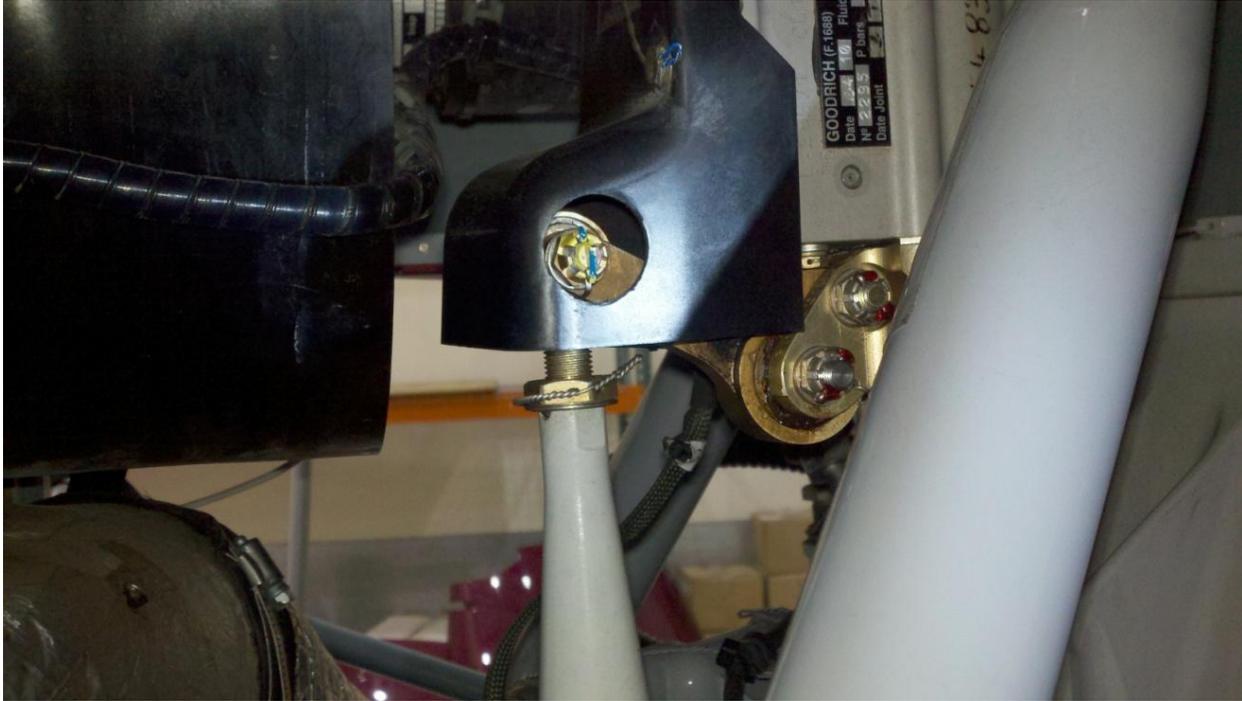
Figure 7. A properly installed nut and split/cotter pin of the fore/aft servo input rod connection.

Despite the statements made by the mechanic and inspector, as previously discussed, the evidence indicates that the split/cotter pin was not present or not installed improperly; however, neither the mechanic nor the inspector recognized this. There were no significant issues in either of their performance histories, time pressure, or environmental issues to explain the performance lapses. Although the investigation also focused on the maintenance work cards, the information presented in this example will focus on the role of fatigue on the performance of these individuals. Data sources included interviews and company records.
