Investigating the Voyager pitch down incident – a case study in civil / military co-operation.

Introduction

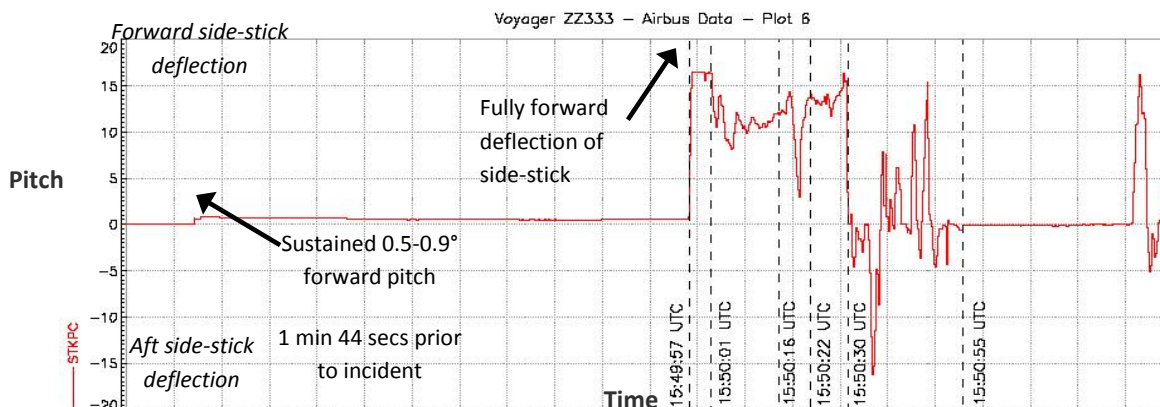
Figure 2: DDFDR trace showing pitch commands from Captain's side-stick

The breakthrough came a few days later when one of the MilAAIB investigators was listening (for the 100th time) to the CVR and detected a distinct noise on the cockpit area microphone channel, 1 min and 44 seconds before the pitch down event. This corresponded with a very small forward displacement of the Captain's side-stick that was too small to cause the auto-pilot to disengage and so did not result in any disturbance to the aircraft. The noise re-occurred just before the pitch down event and spectral analysis confirmed that the sound exactly matched the electric motor used to move the Captain's seat forward. This temporal and directional correlation between seat and side-stick movement was compelling and the investigation sought to establish how they could be connected. The small initial displacement of the side-stick and the subsequent linear ramp to full scale deflection in the fore-aft axis without any lateral input could not be recreated by human pilot input and so the Panel's focus turned to the possibility of an object connecting the seat to the side-stick. All official items and personal effects which had been on the flight deck at the time were examined, with particular interest in the Captain's camera, which had been seen in the vicinity of the Captain's side-stick shortly before the event.

Having established the potential for the camera to geometrically lock in place, the investigation sought to establish how the aircraft was recovered. When the aircraft pitched down, the Captain's instinctive reaction was to pull back on the side-stick and this can be seen clearly from the DFDR traces, albeit the side-stick remained substantially blocked in the forward position. Convinced it was an auto-pilot malfunction, the pilot repeatedly pressed the AP Disconnect button on the side-stick (although the auto-pilot had in fact already disconnected). The Co-pilot, who had hauled himself back into the cockpit, also pulled back on his side-stick and reacting to the Captain's shouts that he couldn't get the auto-pilot out, pressed his AP Disconnect button repeatedly. The button has a dual function, and when the auto-pilot is disconnected, as it was in this case, the button switches the priority stick input to the Flight Control System (FCS) between the LHS Captain's side-stick and the RHS Co-pilot side-stick. Had control been formally handed to the Co-pilot, the Captain's inputs would have been locked out and the problem neutralised. But, in the confusion of the event, on a darkened flight deck, in a negative 'g' bunt, the crew became fixated on trying to get the auto-pilot out and control priority kept switching back to the fully deflected left stick.

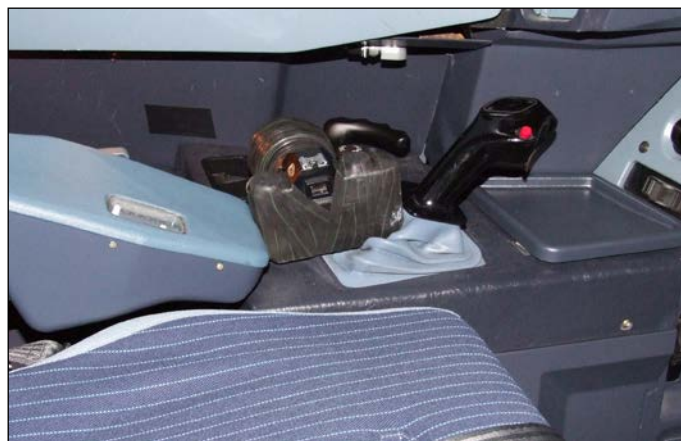
Using the Voyager simulator, the team placed a copy of the camera between the armrest, which had been adjusted to the Captain's preferred setting, and the side-stick. When the seat was motored forward, the camera pushed the side-stick fully forward and became geometrically locked in place (Figure 3). The hand control base-plate was perfectly aligned with the position of the dent in the Captain's camera. The reconstruction took only a few seconds to set up and could be repeated time and again.

Figure 3: Re-construction of camera behind Captain's side-stick

Once all other possibilities had been eliminated, the Panel concluded that the cause of the pitch down event was an inadvertent physical input to the Captain's side-stick, by means of a physical obstruction (a camera) that jammed between the left armrest and the side-stick unit when the Captain's seat was moved forward.

- Implement a comprehensive strategy to effect a positive change in the safety culture with respect to loose articles on the flight deck.
- Take steps to minimise what is carried on the flight deck and maximise the use of designated stowage areas.
- Review the rules governing minimum crew numbers at their station.
- Take measures to further strengthen the reporting culture.
- Ensure that the critical importance of a clear handover of control in side-stick equipped aircraft is emphasised throughout training.
- Examine ways of managing low in-flight pilot workload.
- If possible, implement measures that could help prevent the placing of loose articles in close proximity to the side-stick.

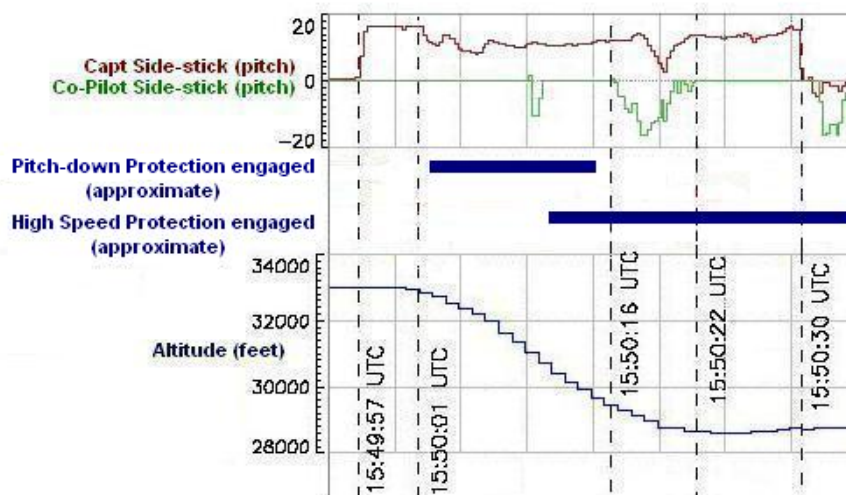
Fortunately, the A330 fly-by-wire FCS incorporates overpeed and pitch down self-protection features to prevent exceedance of flight envelope limitations. 3 seconds after the initiation of the pitch down, the FCS acted to limit the pitch attitude to 15 degrees nose down, and 10 seconds later the high speed protection feature activated to reduce the engine thrust to idle and pitch the aircraft up at approximately 1.75 'g' (Figure 4). The aircraft flew itself out of the dive.

Figure 4: Activation of pitch and high speed protection features
