Reverse-Engineering the Causal Links Reveals Safety Analysis Issues

Paper

by **Sébastien David** and **David Romat**

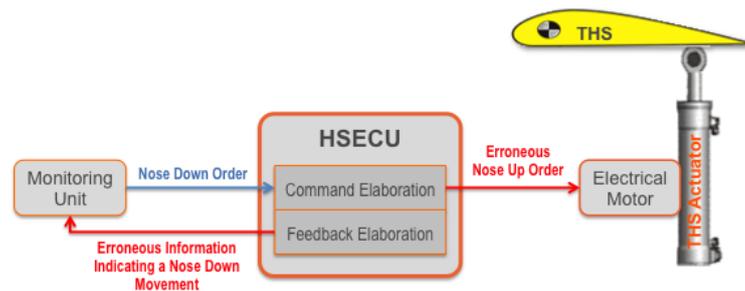
The investigation revealed that a soldering defect on one pin of an onboard unit component was the triggering event of the THS runaway. This soldering defect stems from a manufacturing defect that was not detected during the manufacturing process. It was caused by insufficient heat during the soldering process because the plated through-hole had not been properly insulated from the rest of the circuit board. Part of the soldering heat was therefore absorbed, preventing the creation of a proper solder.

The equipment involved was the Horizontal Stabilizer Electronic Control Unit (HSECU), which drives the main electrical motors of the THS actuator. Its design and manufacture were subcontracted by Dassault-Aviation to Rockwell-Collins. The micro-cracks on an induction coil solder caused the HSECU to generate incorrect nose-up commands to the motor controlling the horizontal stabilizer and to transmit nose-down values to monitoring systems indicating a change in the opposite direction to that in which the motor was actually moving.

Consequently, the nose-down orders computed by the flight control computers were consistent with the feedback elaborated by the HSECU. Hence the monitoring function, which by design relied only on HSECU information to detect an HSECU-induced THS runaway, did not trip.

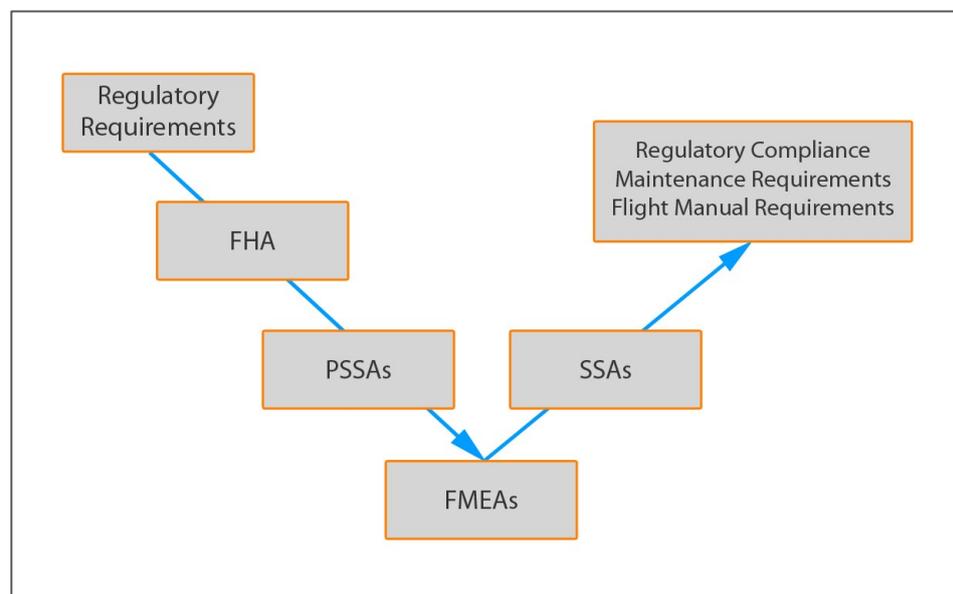
The analysis is the result of a highly complex safety assessment process and comprises many different types of analysis, including:

- FHA (Functional Hazard Assessment): These are preliminary engineering assessments that are frequently updated as the aircraft and system designs evolve. They list the main functions of the primary flight control system and identify failure conditions associated with each of these functions. The severity of each failure condition is also evaluated in FHAs, as well as the corresponding safety objective in terms of probability.

- PSSA (Preliminary System Safety Assessment): For each failure condition identified in the FHAs, the safety objective is cascaded down to the equipment level, on the same principle as fault trees.

- FMEA (Failure Modes and Effect Analysis): At equipment level, a structured and inductive analysis is performed to evaluate for each individual component the effects of its failure modes on the system. The FMEA is used to feed the PSSA to get the final System Safety Analysis (SSA).

- SSA (System Safety Assessment): SSAs take into account the results of FMEAs and other safety assessments and contain the definitive list of system failure conditions and associated probabilities. The purpose of SSAs is therefore to check compliance with safety requirements.
