# **5mm Crack Leading to an Engine Fire – Lessons Learnt**

**Author: David Lim – Principal Investigator, Transport Safety Investigation Bureau**

On 27 June 2016, a Boeing 777-300ER aircraft departed Singapore for Milan. About two hours into the flight, the right engine indication showed a low oil quantity.

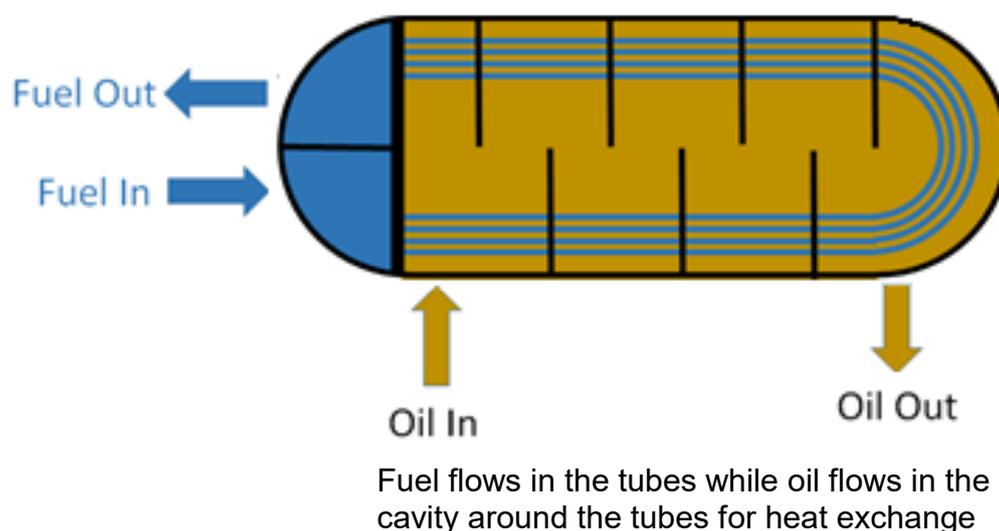
suspected and when the flight crew should perform the FUEL LEAK checklist. One such scenario is when the TOTALIZER fuel quantity is less than the CALCULATED<sup>5</sup> fuel quantity.

Figure 1: Schematic diagram of MFOHE

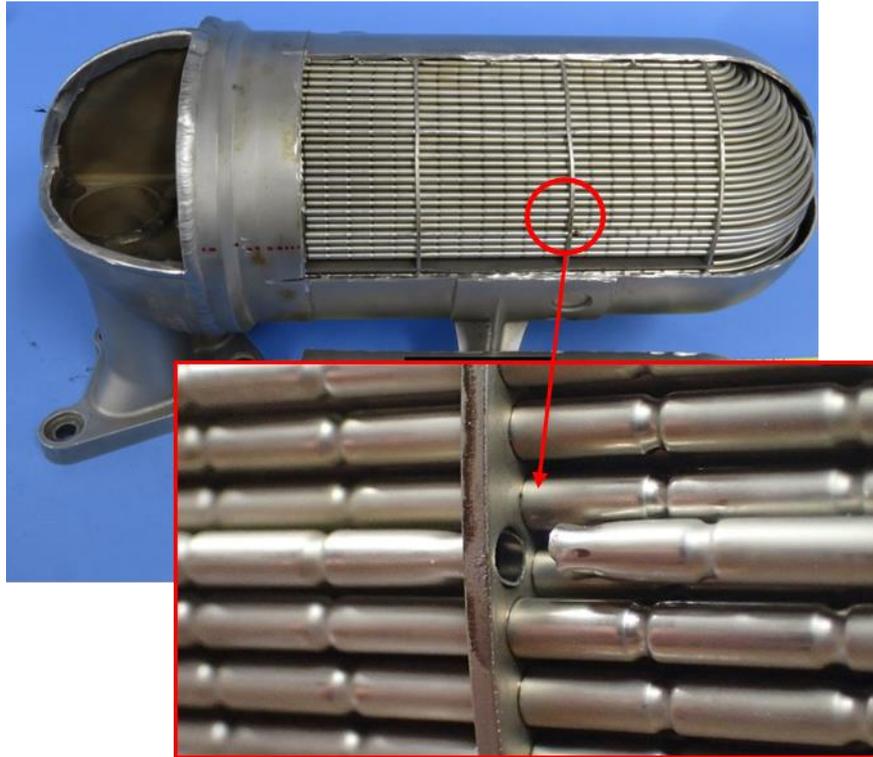
36 A portion of the MFOHE casing was removed. One of the fuel flow tubes was found cracked and displaced (**Figure 2**).

Figure 2: View of cracked tube in MFOHE

37 The cracking of a tube in the MFOHE allowed fuel in the fuel flow path of the MFOHE to flow into the oil flow path in the MFOHE. The investigation has not revealed other sources of fuel leak.

38 During all phases of the engine fuel pump operation, fuel is delivered at pressures between 400 and 1600 psi. In comparison, the pressure within the engine oil system is about 100 psi. As such, when the fuel carrying tube in the MFOHE cracked, the higher pressure fuel entered the engine oil distribution system.

68 As required by SB 79-0034, the MFOHEs were to be sent back to the MFOHE manufacturer to check for leakages. Should a leakage be detected, the openings at the entrance and exit of the leaking tube would be welded close to prevent fuel from flowing into it. Crimped tubes that had a history of cracking will also be welded close, regardless of whether the MFOHE was found leaking.

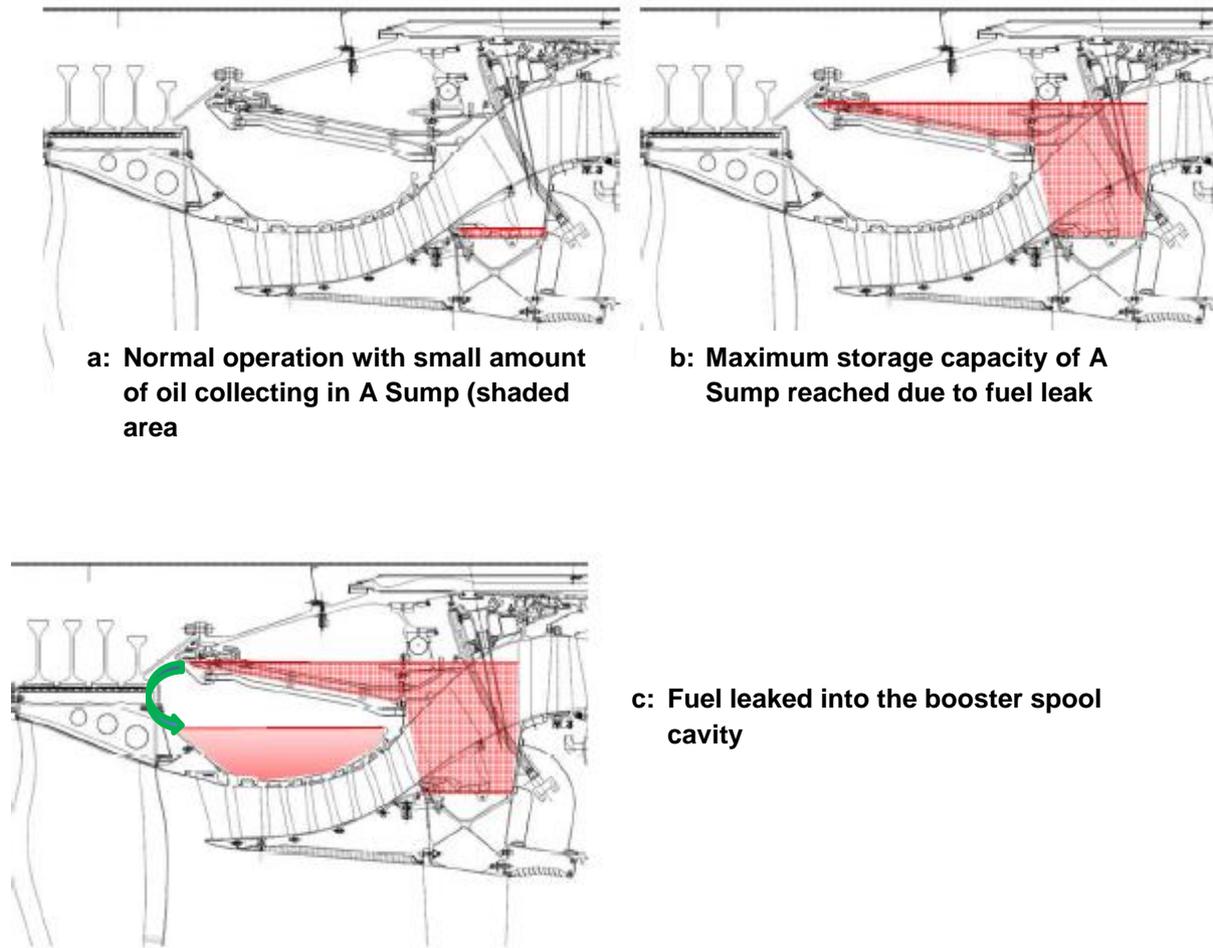
39 During the normal operation of the engine oil system, a small amount of oil will collect in the A Sump<sup>11</sup>. However, when fuel leaked into the oil system, it filled the A Sump until its maximum storage capacity. The additional quantity of leaked fuel overflowed into the booster spool cavity and started to collect there (**Figure 3**).

Figure 3: Process of fuel filling the A sump and booster spool cavity

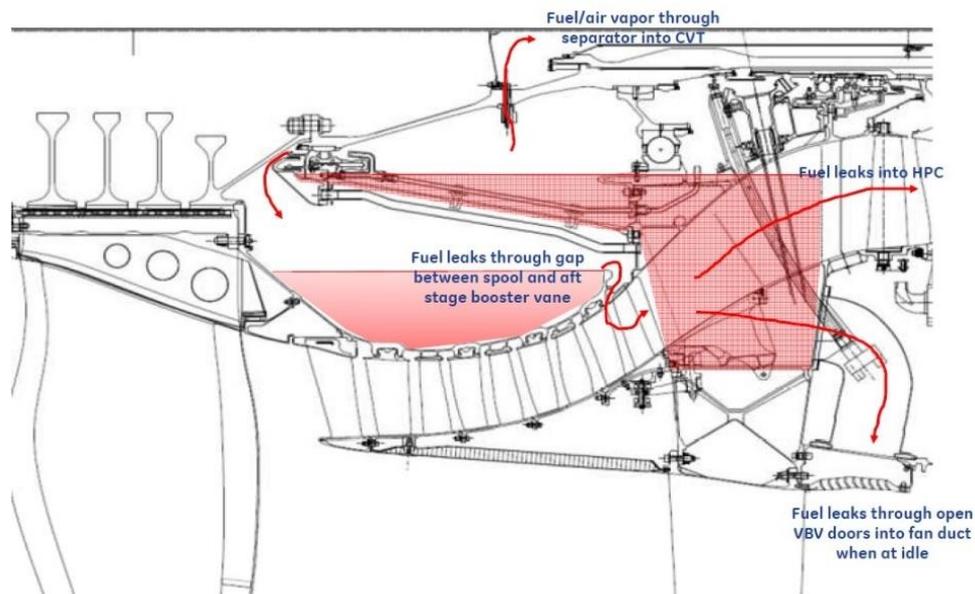
40 Once the booster spool cavity was filled up to the aft lip, the excess fuel leaked through a gap between the spool and aft stage booster vane into these areas (**Figure 4**):

- High Pressure Compressor (HPC) through the core airflow
- Fan duct when the Variable Bleed Valve (VBV) doors are open at engine idle power

Figure 4: Leak path for fuel

47 As the aircraft arrived to land, fuel was still leaking from the engine through various leakage areas (**Figure 4**). When the thrust reversers were deployed, the velocity of airflow over the core exhaust nozzle was significantly reduced. The area aft of the turkey feather seal, which is a protrusion on the core exhaust nozzle, would have experienced the most significant disruption of airflow. In addition, the accumulated fuel in the fan duct was also distributed over a wide area of the lower surface of the wing.

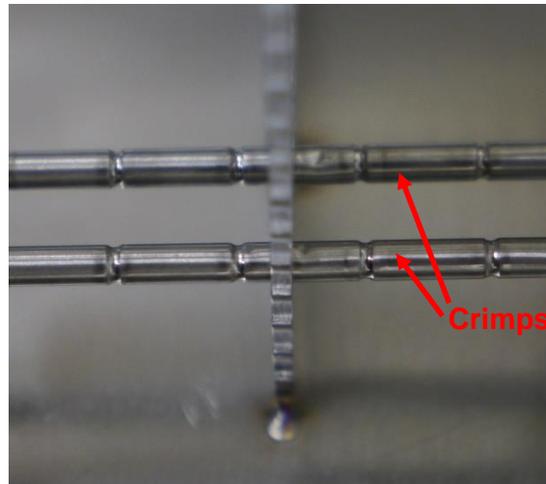
52 The manufacturing process involves crimping, a process where a force is applied to achieve a slight deformation of a material. The purpose of the crimping is to deform the cross-sectional shape of the tubes so that the tubes cannot slide freely through the round holes of the support plates. This prevents the support plates from moving during assembly (Figure 5).

Figure 5: Crimps on tubes

58 The cause of the crack in the August 2014 event was determined by the engine and MFOHE manufacturers to be the variation in the crimp on the tube that resulted in contact between the support plate and crimped tube. The contact resulted in stress concentration that could have led to crack initiation.

55 In April 2014, the engine and MFOHE manufacturers conducted a review of the manufacturing operations. Improvements to the manufacturing process were made in May 2014. The improvements included using a standardised crimping tool to eliminate the variation in the crimps due to the use of hand tools. In addition, the crimped fuel tubes that have a history of cracking will be welded close at assembly.
