# The EC 225 LP accident near Turøy in Norway

## The Second Loss of a Helicopter Main Rotor - Need for a Change in Certification and Continued Airworthiness of Large Rotorcraft?

By Kåre Halvorsen and Tor Nørstegård (AAIB)

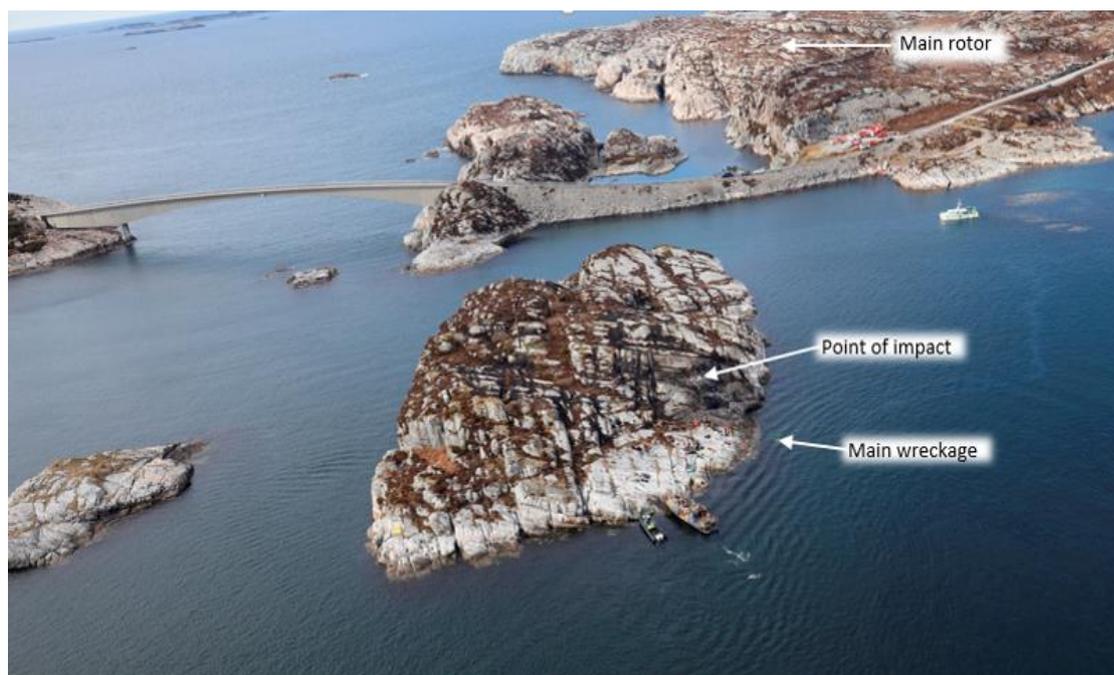
Wreckage parts were spread over a large area both at land and in the sea. The Main Rotor landed on an island about 550 meters north of the crash site (See Figure 1). The impact forces destroyed the helicopter, before most of the wreckage continued into the sea. Fuel from the helicopter ignited and caused a fire onshore.

Figure 1: The accident site.

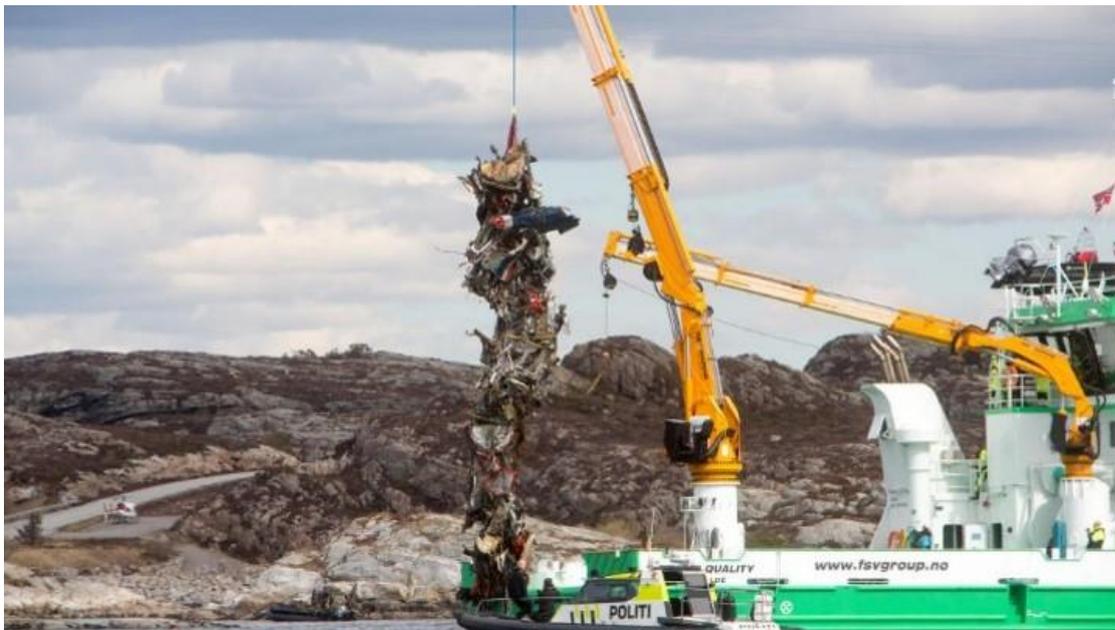
Figure 2: Main wreckage being lifted from the sea.

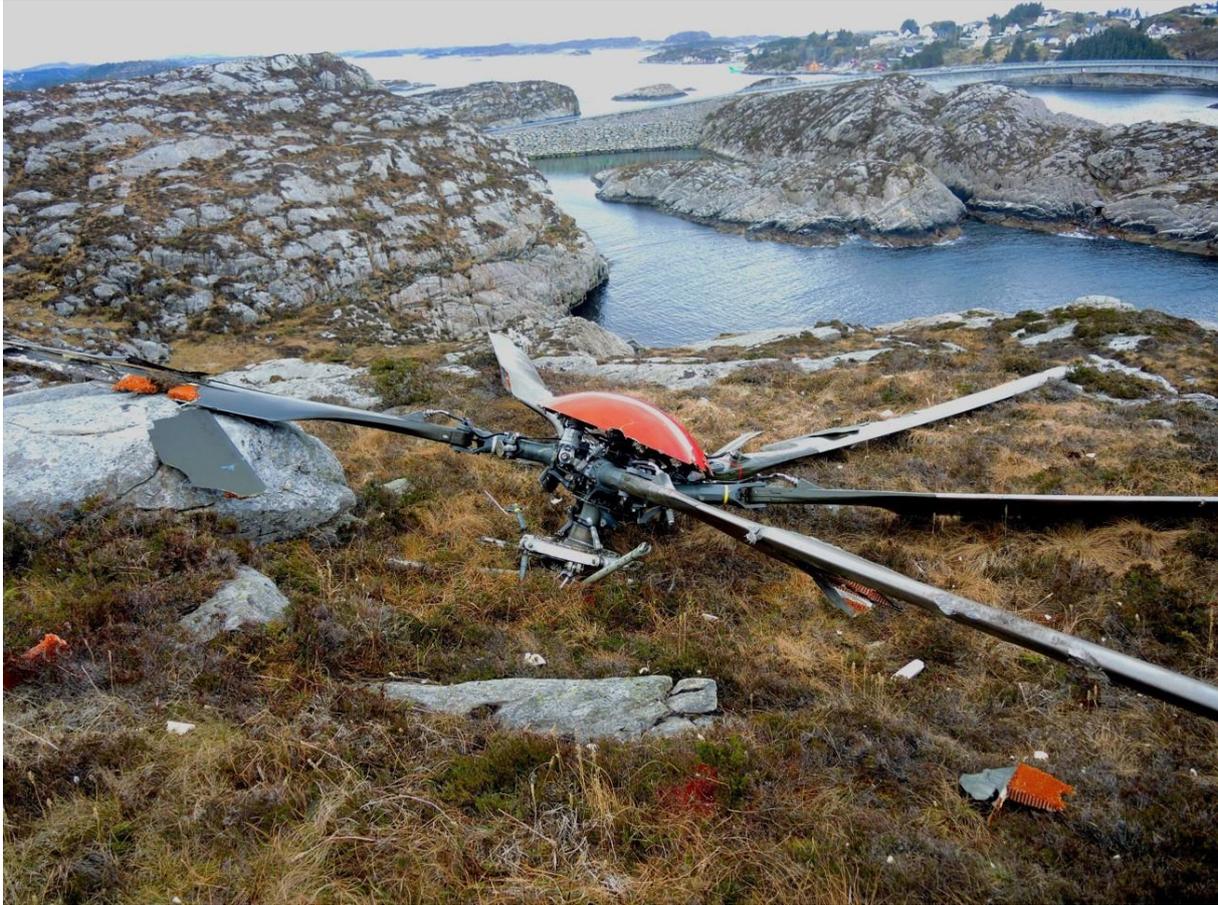
Figure 3: The main rotor gear.

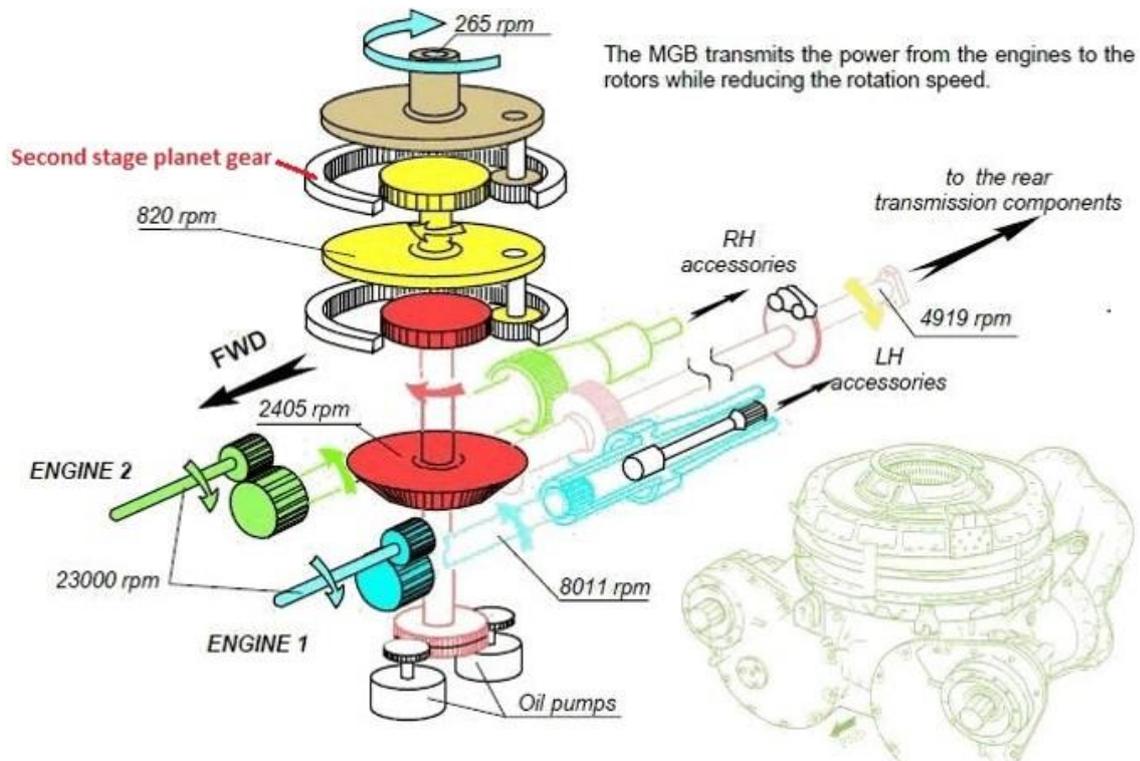
Two recovered segments of the fractured second stage planet gear, that make up approximately half of a gear, got special attention (See Figure 4).

Figure 4: The rotor gear assembly showing the second stage planet gear.

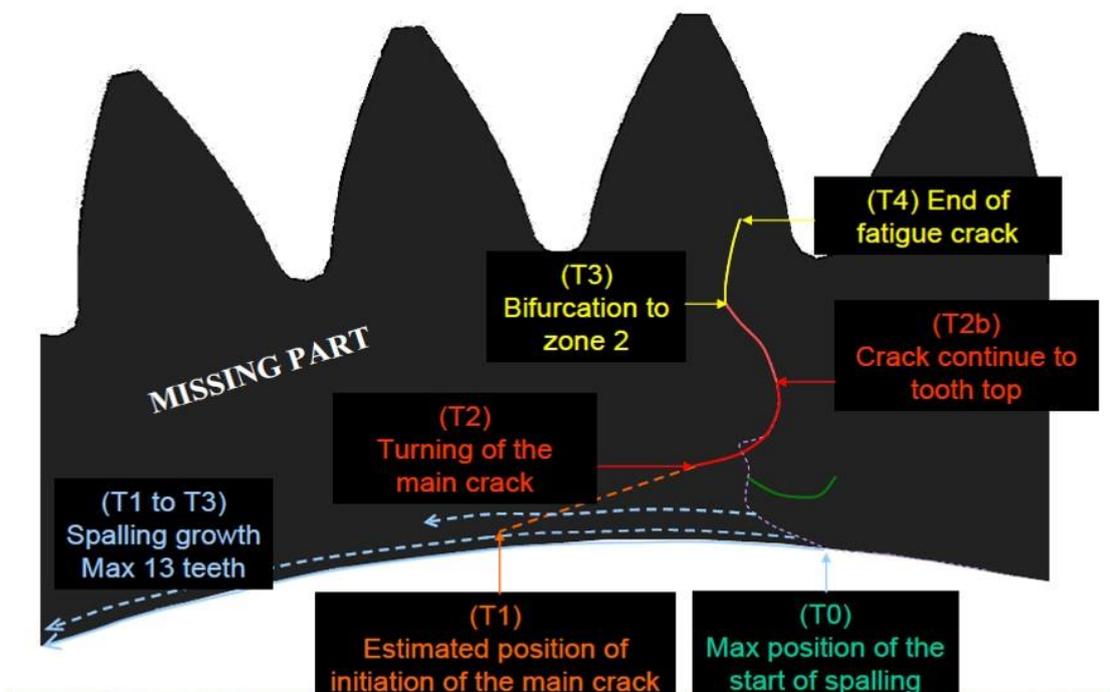
Detailed metallurgical examinations carried out at QinetiQ, Farnborough in UK, confirmed that the gear had fractured due to fatigue. The different examinations revealed the sequence of break-up of the gearbox (See Figure 5).

Figure 5: An estimate of the fracture sequence.

The fractured gear clashed teeth with other gears and caused an abrupt seizure and rupture of the gearbox, which lost its structural integrity.

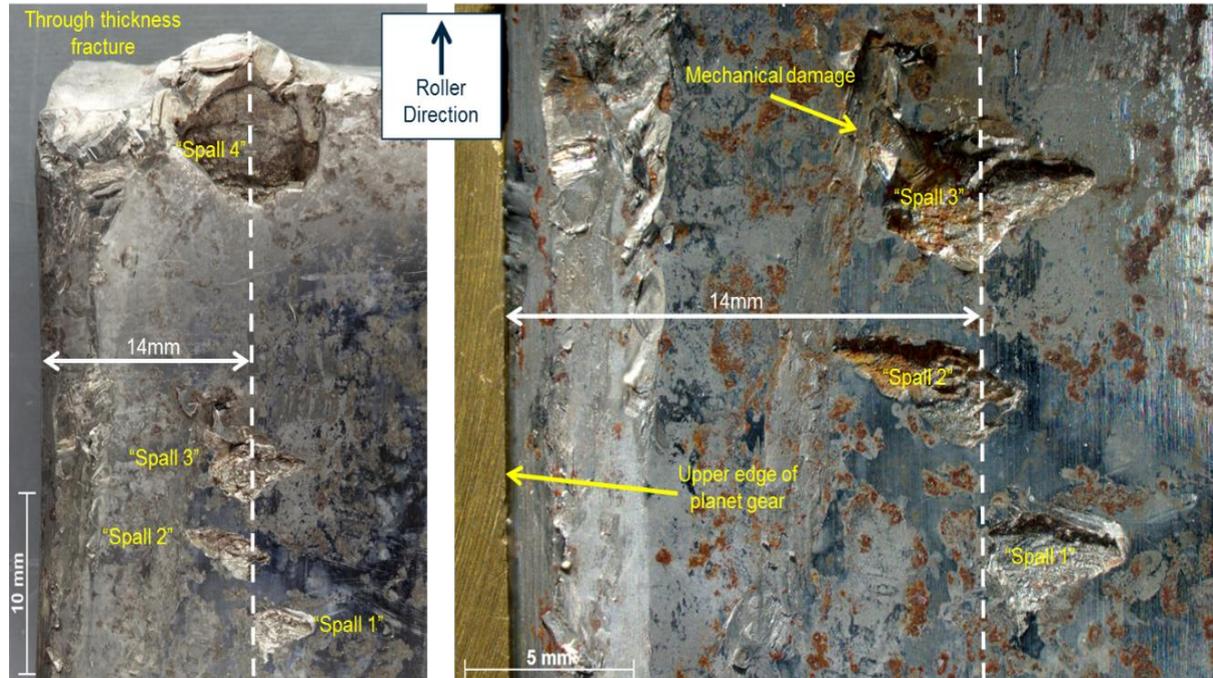
The fatigue fracture initiated from a surface micro-pit in the upper outer race of the bearing (inside the second stage planet gear), propagating subsurface while producing a limited quantity of particles from spalling, before turning towards the gear teeth and fracturing the rim of the gear. Four spalls were observed centred along the line with maximum contact pressure (See Figure 6).

Figure 6: Investigators found spalling inside the second stage planet gear.

It is probable that the failure was initiated by debris caught within the bearing and scratching one or more rollers. This probably caused a band of local work hardening and associated micro-pitting at the outer race. The AIBN concludes that the fatigue fracture were neither a consequence of a mechanical failure or misalignment of another component, nor due to material unconformity. More research is needed in order to understand the fatigue behaviour for the material. It has not been possible to determine a conclusive crack propagation rate, but it must have developed within a maximum of 260 flight hours since the gearbox was inspected and repaired at Airbus Helicopters. The repair was done following a road transport incident.
