**German Military Aviation  
Authority**

**Aircraft Accident Investigation Report Summary**

**Global 5000**

**Berlin-Schönefeld, 16 April 2019**

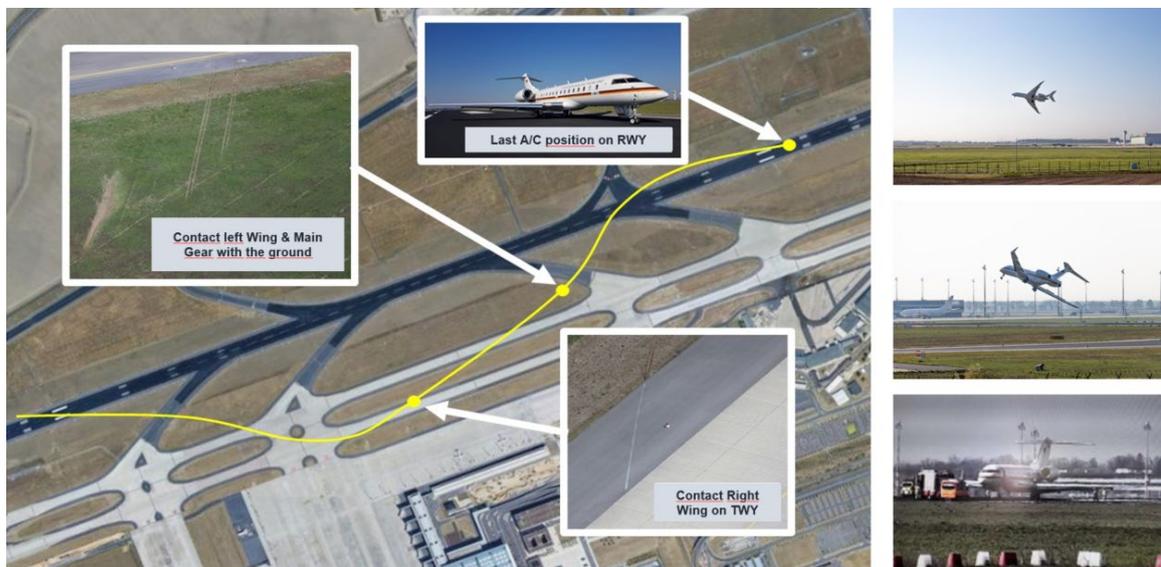
The accident aircraft, a BOMBARDIER Global 5000 BD-700-1A11 belonging to the Flugbereitschaft BMVg (FIBschft BMVg) was being ferried from Berlin-Schönefeld back to Köln-Bonn after routine maintenance was performed by the aircraft system-managing company. Shortly after takeoff, the crew experienced problems with the flight controls, and decided to abort the flight and return to Berlin-Schönefeld. In the flight back towards an approach to landing, during a normal turn, the aircraft departed controlled flight and was subsequently recovered by the crew. After recovering the aircraft, the crew continued the approach, and during the final phase of the landing, experienced severe control difficulties leading to ground contact of both wings, before the aircraft settled on the main gear. The crew was uninjured and only minor damages occurred to the airfield and signage. The aircraft was severely damaged

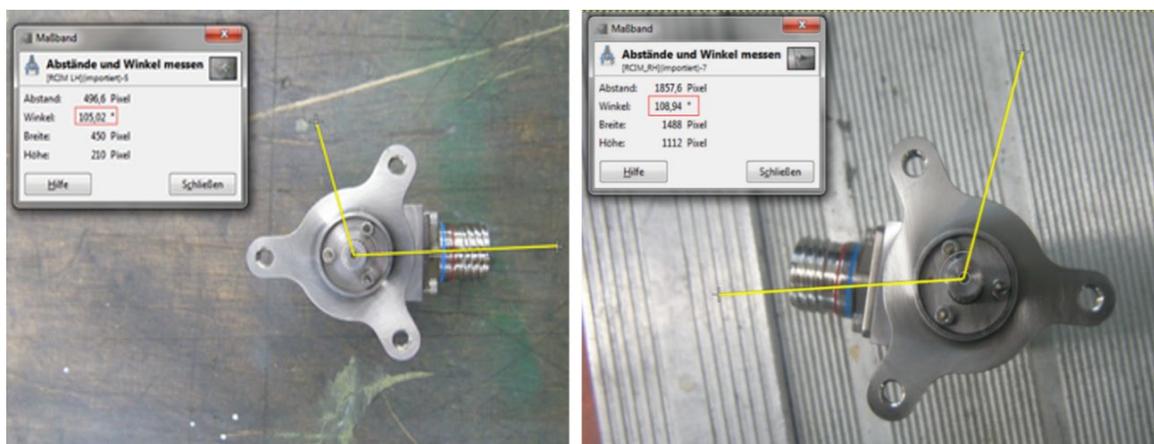
The technical error that occurred during the installation and adjustment procedure of the RCIMs represents the event triggering the accident. The system design further enabled this failure, which allowed the RCIMs to be installed and adjusted in such a manner that the MFS functioned opposite of the corresponding input, and generated no error messages on the EICAS or the PMAT. Since the maintenance crew relied solely upon the EICAS warnings and the results given by the PMAT, the error remained undetected in the tests following the installation.
