# The unpredictable safety impact of COVID19

## Toni Flint

This paper describes three cases, investigated by the AAIB in the UK, where the COVID19 pandemic combined with other factors to degrade safety in an unpredictable way.

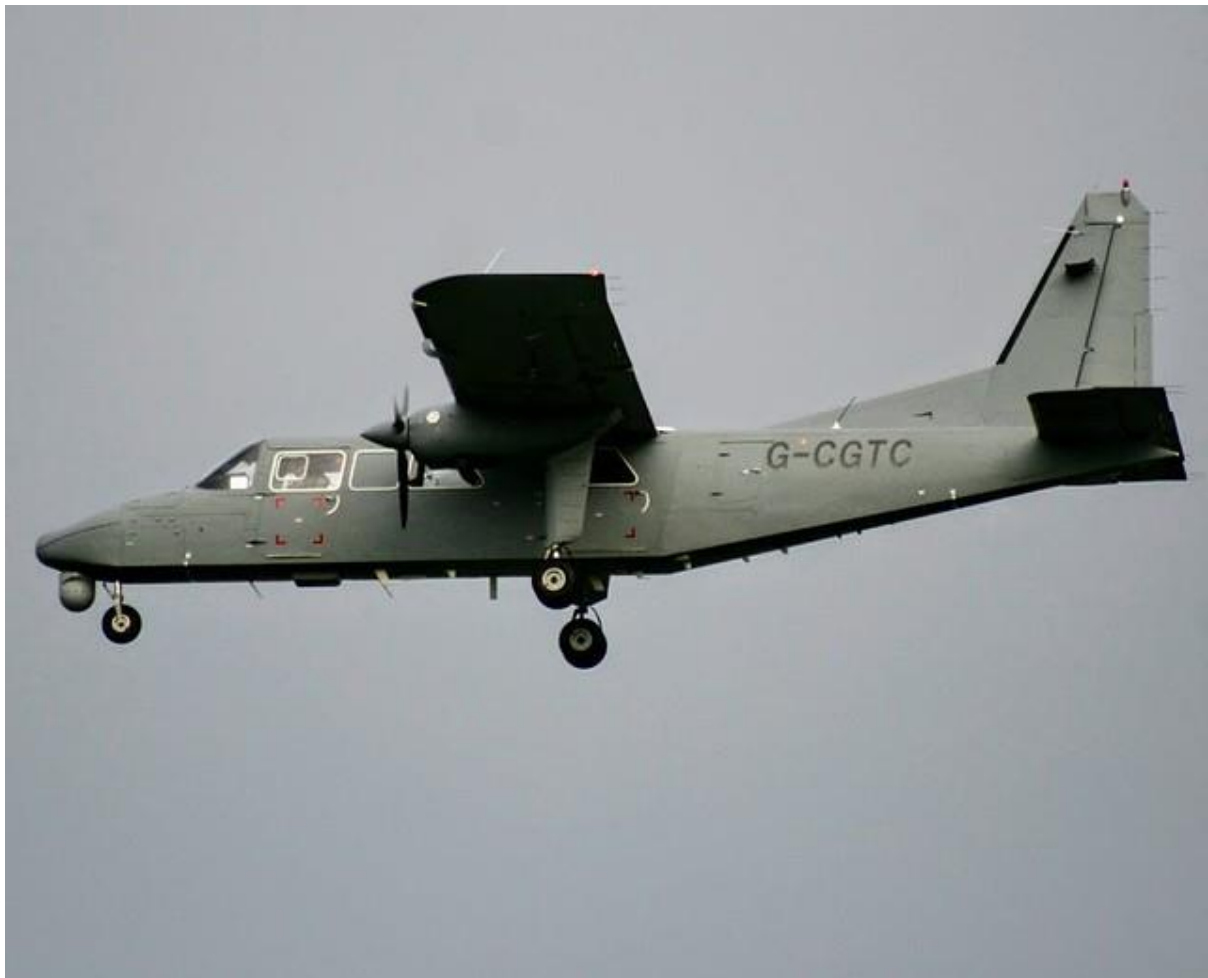
### **G-CGTC, 12 November 2020, Britten Normal Islander, double engine flame out near City of Derry Airport in Northern Ireland (1)**

On 12 November 2020 at 2054, G-CGTC suffered flame out of both engines at around 7000 ft close to City of Derry Airport in Northern Ireland. The pilot was initially startled but with the assistance of one of the passengers, recovered and was able to start his engine failure drills. Descending at a peak rate of approximately 3,300 ft/min, he tried to reach the nearby airport. Fortunately, at an altitude of 2,100 ft amsl, one of the engines was restarted 74 seconds after it had failed. Around 7 minutes later at 800 ft amsl, the second engine was also restarted. The pilot felt uncertain about the reliability of the engines, so decided to continue with landing at the closed and unlit City of Derry Airport. The runway was barely visible in reflected cultural lighting, but the aircraft was landed successfully with no damage or injuries.

been flying at around 7000 ft with an outside air temperature of 0°C for about 10 minutes. The conditions would have made the aircraft susceptible to airframe and engine intake icing. Analysis of the flight data showed decreasing fuel flow in both engines eventually reducing to zero before the engines flamed out. The aircraft was equipped for flight in known icing conditions with a powerplant anti-ice system and a pneumatic de-icing system for the wing and tail leading edges. Having ruled out malfunctions and fuel causes, the investigation found it was likely that the pilot did not turn on the engine anti-icing system before entering engine icing conditions.

The operator took safety action to improve training by introducing a winter programme, briefing and checklist use for flight in icing conditions. They also increased communications to pilots relating to mental wellbeing and provided access to a specific aviation-focused peer support programme.

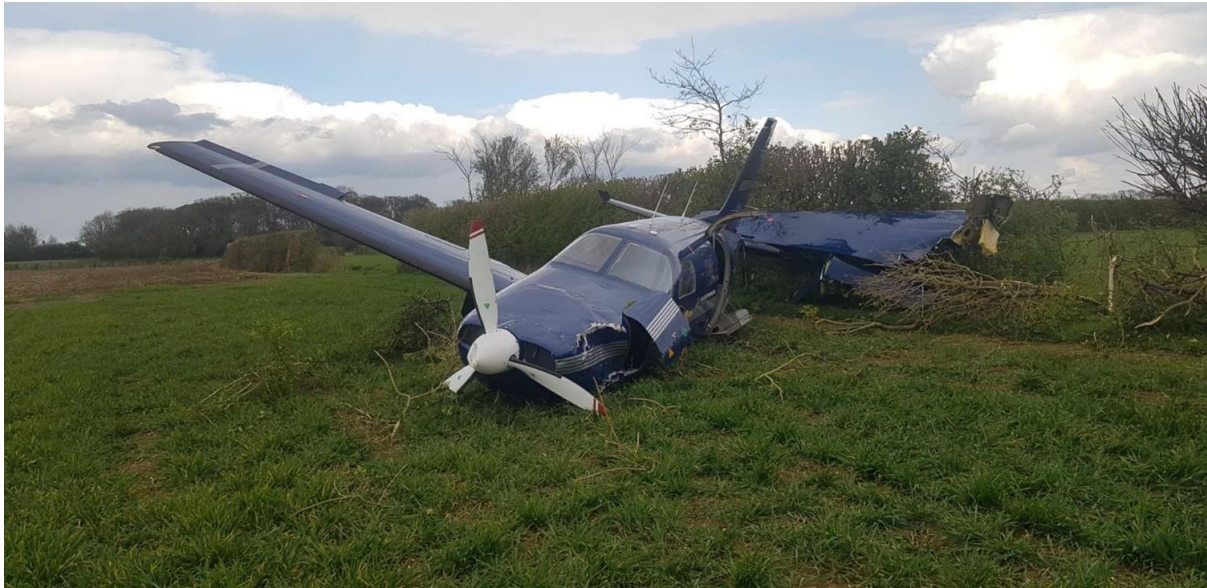
### **G-HYZA, 29 April 2021, Malibu Mirage with an experimental modification, power loss and forced landing, near Cranfield Airport in England (3)**

On 29 April 2021, G-HYZA was on a test flight with a pilot and an observer on board. The objective of the flight was to demonstrate flight on the fuel cell alone for three or more circuits of Cranfield airport. The takeoff was conducted using both power sources. When the pilot selected the HV battery off to continue on the fuel cell alone, all power to the motors was lost. The aircraft was at the runway threshold at approximately 940 ft agl when this occurred, the pilot and observer tried to restore the power supply but were unsuccessful and by the time they realised they must commit to a forced landing they were at 320 ft agl and had travelled the length of the runway. The aircraft landed in a field and was significantly damaged when it struck a hedge and came to rest in a ditch. The pilot and observer were not injured.

The investigation explored the technical, operational and organisational causes of the accident, of which there were many. One aspect was ad hoc decision making by the flight crew who had decided to change the test parameters and the location of the switch between power sources without discussion with the competent person. It transpired that the competent person was quite distant from the project with limited involvement on a day-to-day basis. One reason for this was that, while the experimental project team continued to work physically together, the competent person was still working at home due to the COVID19 pandemic. Total power loss was foreseen as a possibility for this experimental aircraft and perhaps the accident would still have occurred even with closer oversight from the competent person. However, working at home was a factor that affected the competent person's ability to fulfil his important safety responsibilities because he had to try and do so using only remote communication. The operator took safety action to improve their approach to flight testing and to strengthen and formalise their safety management system. The AAIB made five safety recommendations to the UK CAA around the scope and content of E Conditions.

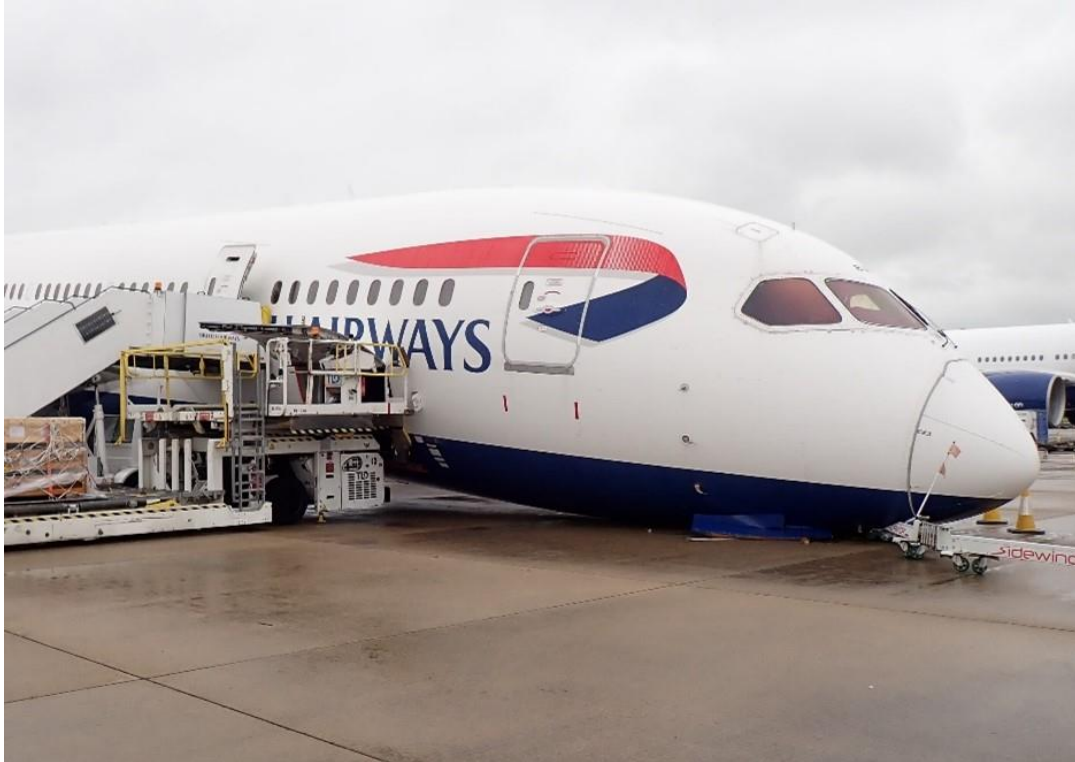
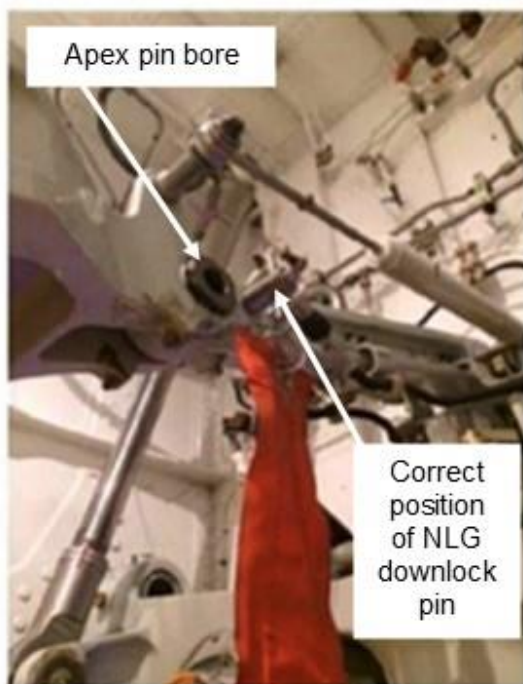
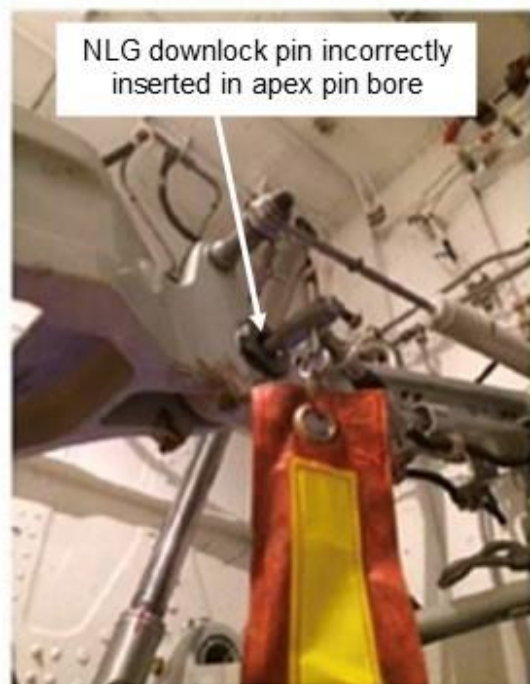
### **G-ZBJB, 18 June 2021, Boeing 787-8, Inadvertent retraction of the nose landing gear, Heathrow airport in England (2)**

G-ZBJB is a Boeing 787 operated by a major commercial air transport operator in the UK. In the early morning on 18 June 2021, it was being prepared for a cargo flight by a team of maintenance engineers and the flight crew. The engineers were engaged in maintenance activity to clear three status messages associated with a defect for a nose landing gear door-closed solenoid valve. It required the cockpit landing gear lever to be cycled. The lead engineer instructed two of the mechanics to fit the landing gear locking pins that would prevent the landing gear retracting during this process. The pin for the nose landing gear was fitted into the wrong hole so that when the

landing gear lever was operated, it did not lock the nose landing gear. The nose landing gear retracted causing the nose of the aircraft to collapse to the ground. A loader was injured when struck by a descending cargo door and there was millions of pounds worth of damage to the aircraft. The front left passenger door was ripped off by the passenger stairway as the aircraft collapsed and there was the potential for serious or fatal injury had people been boarding or under the aircraft at the time.

The AAIB published a special bulletin within a month to highlight the potential for incorrect fitment of the pin. A detailed investigation followed that considered the performance of the maintenance team, the post-accident emergency response, and organisational factors within the maintenance organisation. The design of the nose landing gear on the Boeing 787 created a high probability for error because there were two similarly sized holes close together. Fitment of the pin in the wrong one felt, looked, and sounded similar to fitment in the correct one. The manufacturer and the regulator had been aware of this hazard since early 2018 because of other events. A service bulletin and airworthiness directive had been issued for a modification that would blank the incorrect hole. The airworthiness directive had a three-year compliance period until 16 January 2023. The operator intended make the required modifications but, as was permitted by the long compliance period, had chosen to postpone it because of the operational and financial pressures created by the COVID19 pandemic.

The operator has now made the modification to all their 787 fleet. AAIB made two recommendations to the manufacturer and regulator to review the processes used to determine compliance periods for service bulletins and airworthiness directives.
