**Training to manage partial power events in single engine GA aeroplanes**  
**Graeme Gow and Alison Campbell**  
**United Kingdom Air Accidents Investigation Branch**

### **AAIB Case Study G-CJZU**

### **AAIB Case Study G-BBSA**

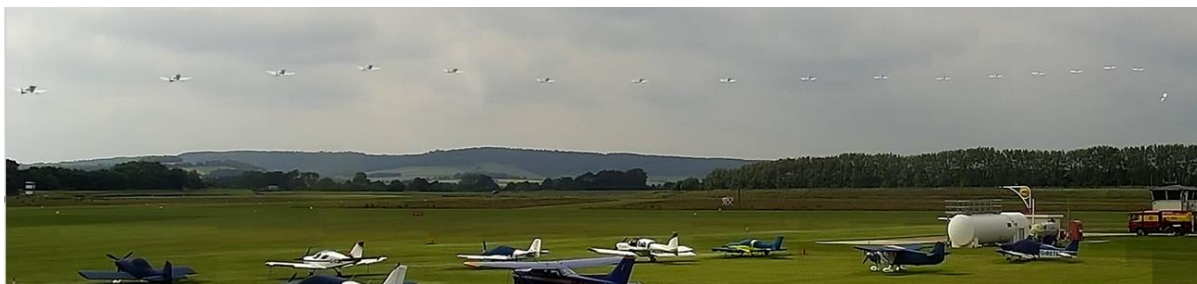
**Figure 1**

G-CJZU was a Rogers Sky Prince, effectively a Jodel D150 made from plans translated from the original French by Frank Rogers in Australia. The aircraft suffered a partial power loss a few seconds after take off from Goodwood Airfield in June 2021. Analysis of the CCTV at the airfield initially showed the aircraft away from the runway normally before it could be seen to level off or descend slightly. On reaching a height of approximately 150 ft the aircraft then began to climb very slowly. After a further 26 seconds, having reached a maximum height of approximately 300 ft, the aircraft was seen to enter a turn to the left which then increased rapidly in angle with the nose dropping. A safe flying speed had not been maintained, and the aircraft departed from controlled flight at a height from which it was not possible to recover. The aircraft descended steeply and struck the ground nose first. The accident was not survivable and both aircraft occupants were fatally injured.

Composite image from CCTV showing G-CJZU flightpath (two-second spacing between aircraft)

Examination of the engine could not find any faults that could have caused or contributed to the loss of power. The aircraft had sufficient fuel for the flight. Insufficient supply of fuel to the engine from the tanks could have caused the power reduction but the damage to the aircraft meant that it was not possible to establish the condition of the fuel system or level of fuel supply. It is also possible that a fault in the ignition system could have contributed to the power reduction, but the damage from the post impact fire meant that the integrity of the electrical system could not be fully assessed. Weather conditions were also conducive to carburettor ice forming on the taxi out to the runway. It is possible that carburettor ice formation caused the engine to lose power after take off.

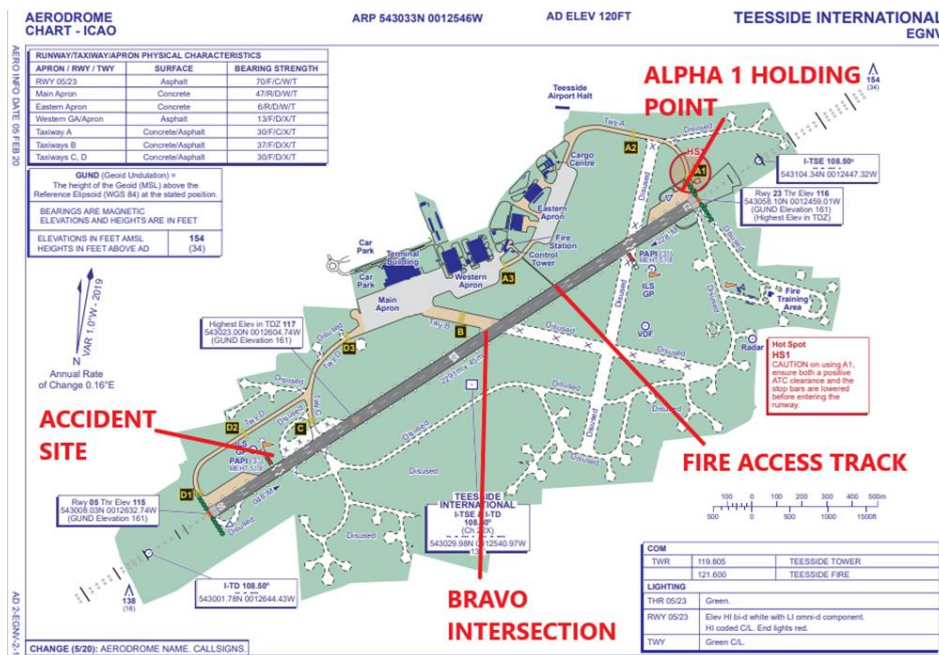
**Figure 2**  
 Teesside Airport

Approximately 14 seconds after becoming airborne, there was a significant change in the engine note. At this point the aircraft was passing intersection Bravo (Figure 2) at a height of approximately 120 ft agl. ATC noticed its track was drifting to the right of the centreline of Runway 23 but otherwise considered that the departure looked normal.

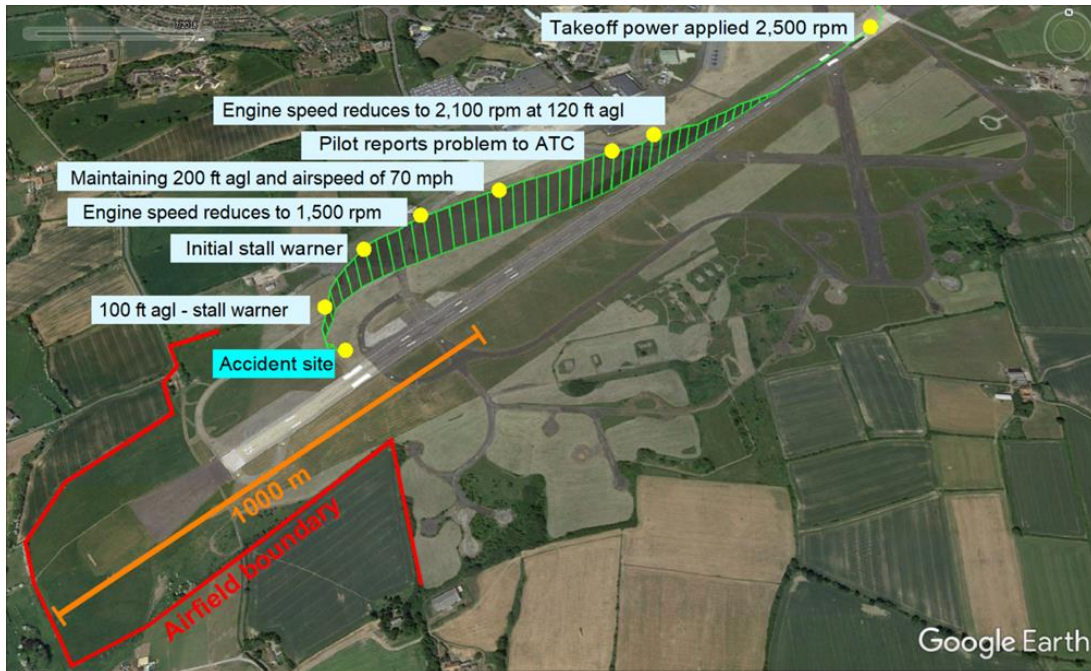
**Figure 3**  
Composite of G-BBSA flight data.

The data retrieved from the aircraft was used to make a composite picture of the short flight and overlaid onto a Google Earth Image of the airport (Figure 3).

Contrary to the pilot's recollections the aircraft never passed the airfield boundary and up until the turn during which control was lost there still remained a distance of 1000 m to the airfield boundary. While at this point a landing ahead would have been off the runway it would likely have produced a better outcome for those on board.
