TransAir Flight 810
Boeing 737-200 Water Recovery

Clinton R. Crookshanks
Aerospace Engineer (Structures)
National Transportation Safety Board
ISASI Member 69258782

ISASI 2023 Seminar Nashville

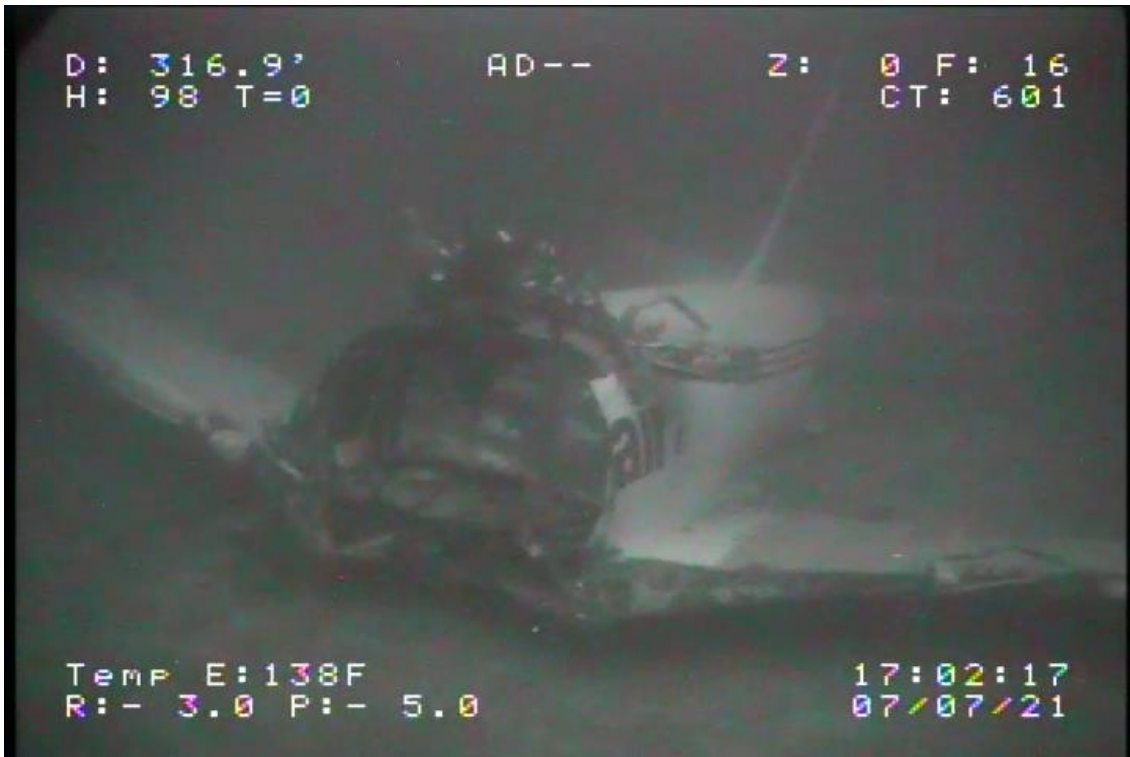
Figure 10. Aft fuselage, wings, and tail.

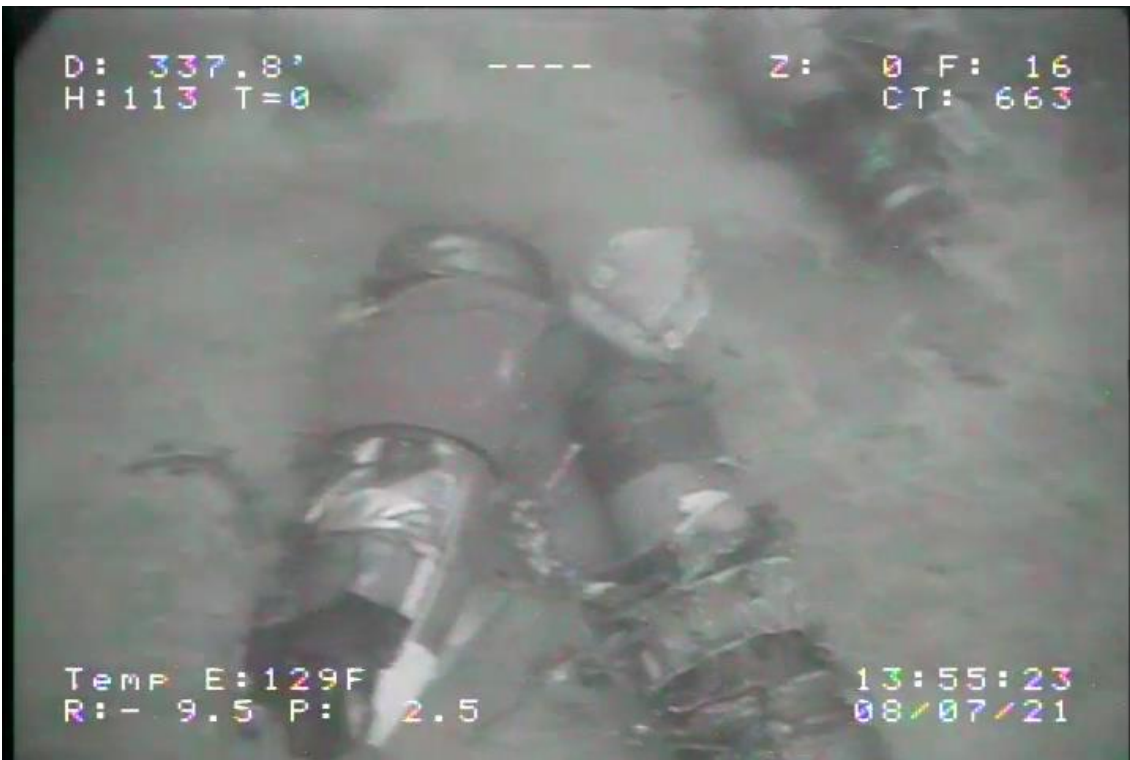
Initially it was thought that only one engine had been located, so about a half a day was spent surveying the debris field looking for the second engine. The powerplants investigative group examined the ROV video survey at the completion of the day's operation and concluded that both engine cores were located within about 3 ft of each other on the seafloor and adjacent to one thrust reverser. The #2 engine inlet case had separated from the engine and was located in the debris field.

Figure 11. Engine cores and one thrust reverser.

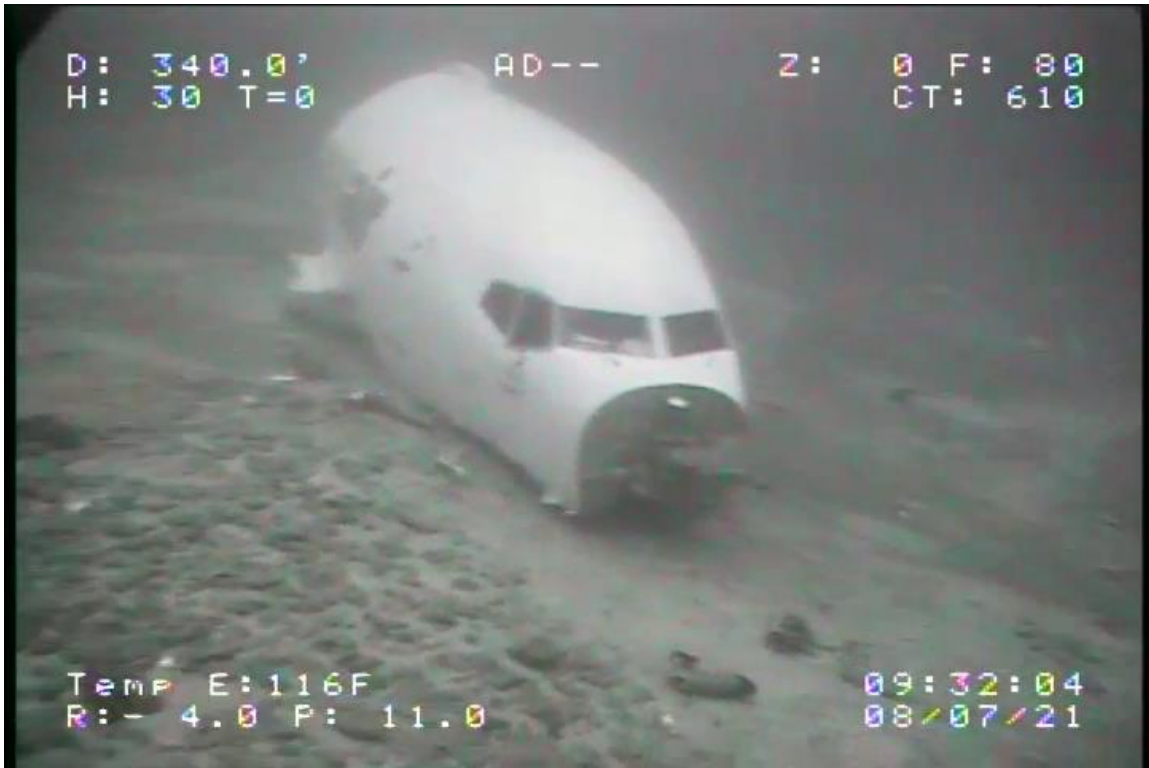
The forward fuselage was partially intact from the forward pressure bulkhead to about BS 540. Significant damage to the lower portion was evident, but the extent could not be determined. The radome was separated. The main deck cargo door was closed, the cockpit emergency windows were open, and the left entry door was ajar with the handle in the stowed position. No cargo was present in the forward fuselage. The nose landing gear remained attached to the wheel well structure and was in the up and locked position but the whole assembly was separated from the forward fuselage.

Figure 12. Forward fuselage.

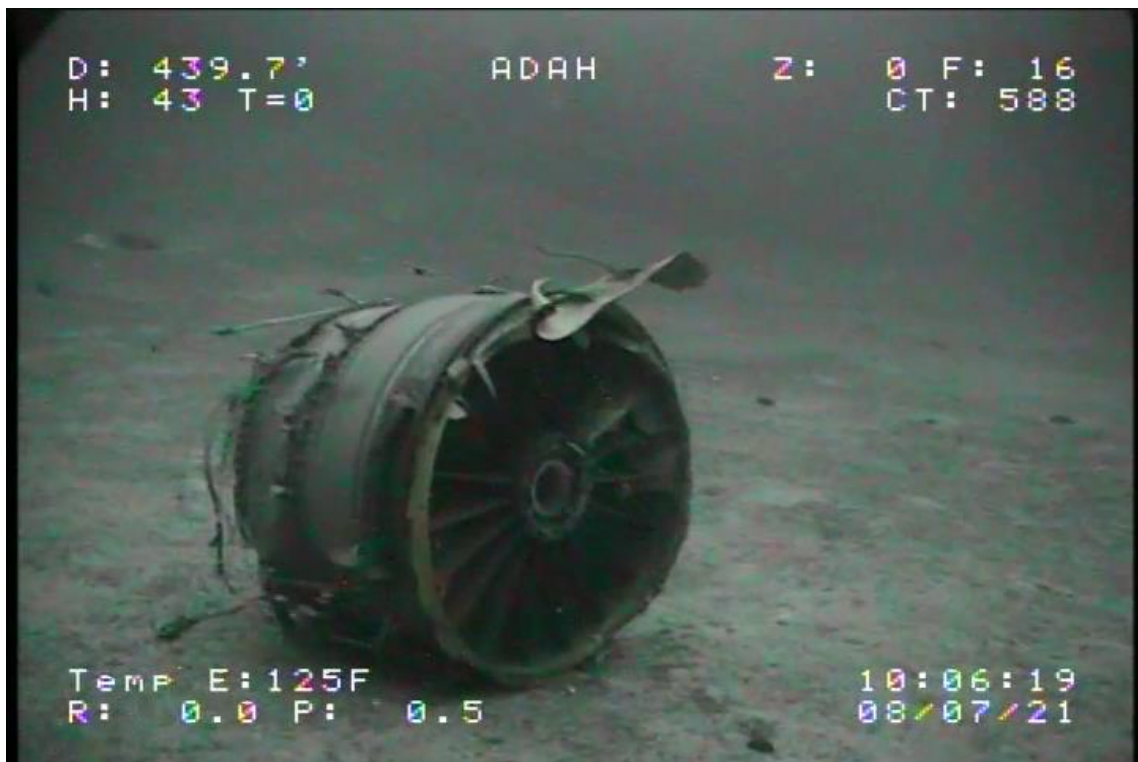
Figure 13. Engine #2 inlet case.

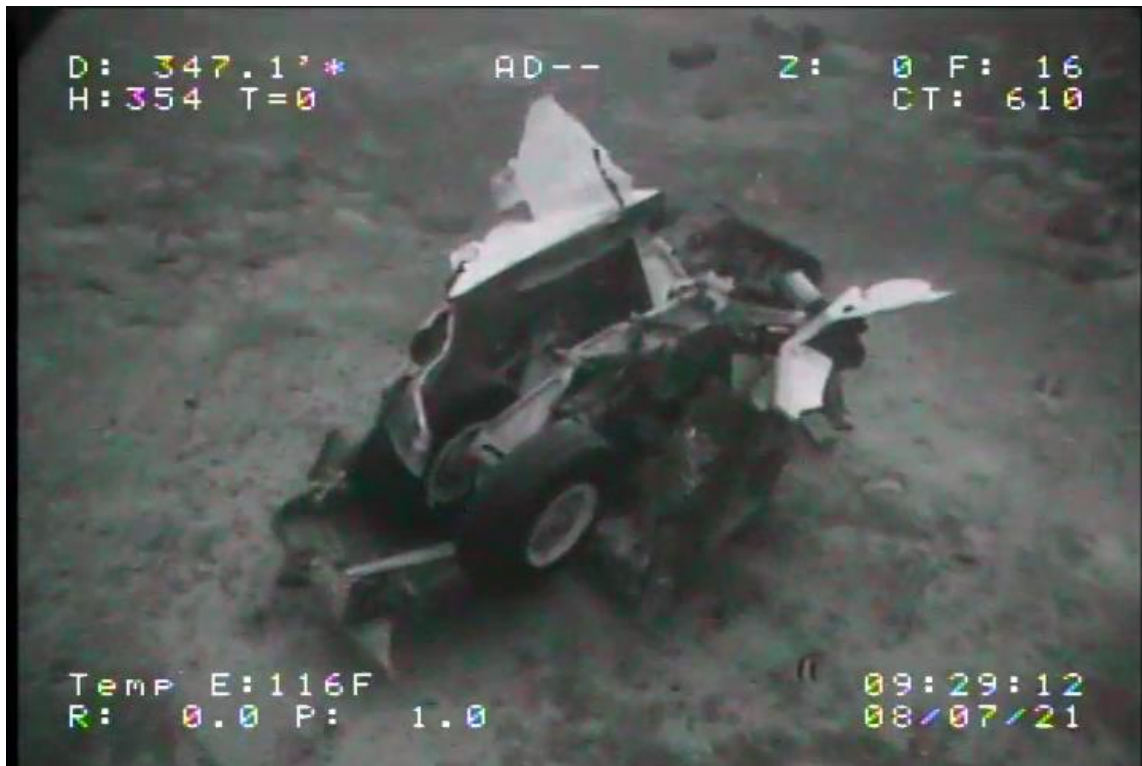
Figure 14. Nose landing gear.

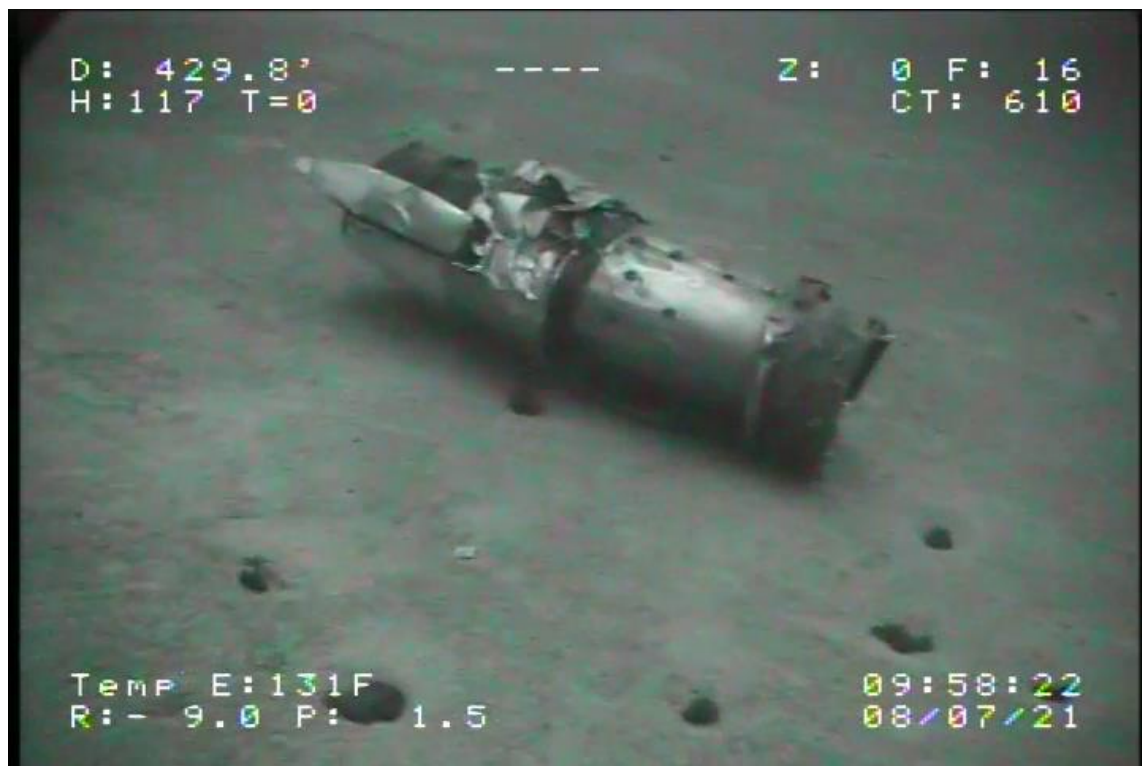
Figure 15. Thrust reverser.

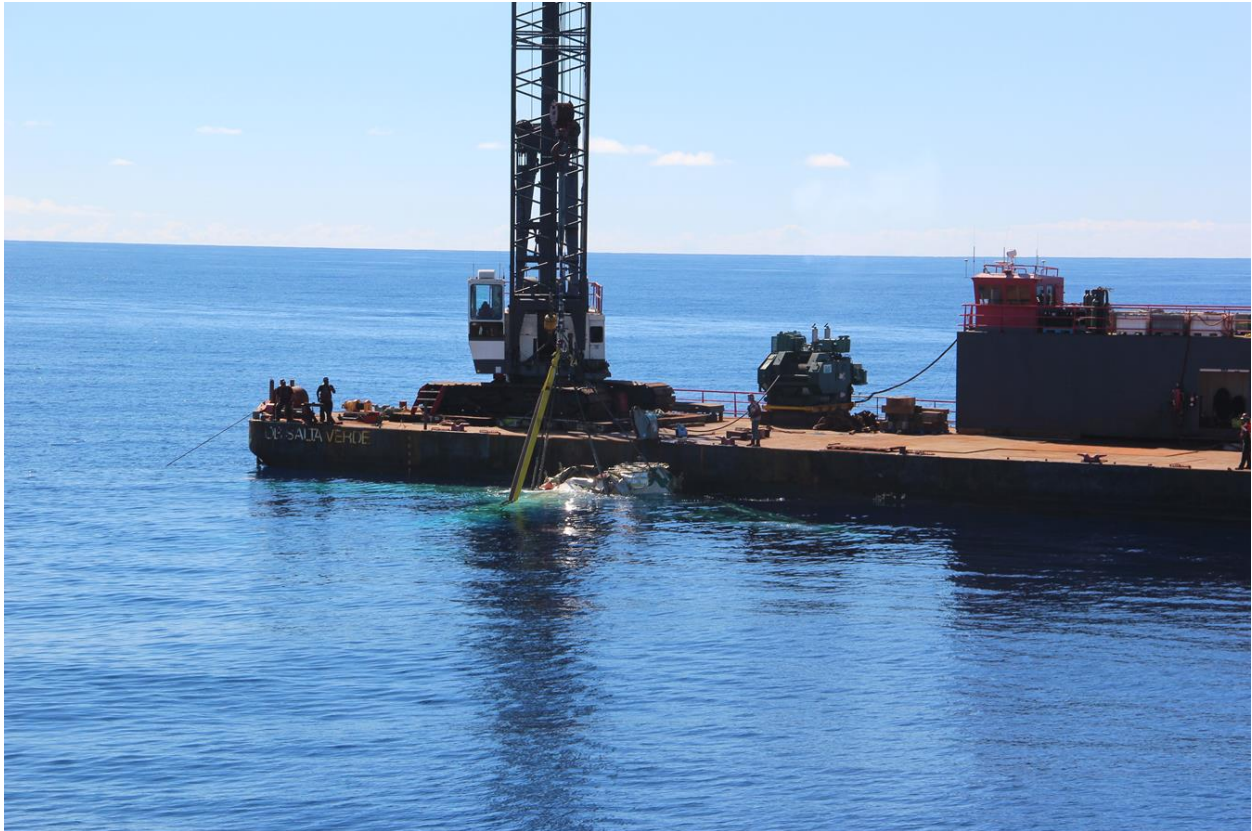
interface (Figure 22). The crane would lift until the load meter showed about 95 kips before stopping to let water drain to about 75 kips and then repeated. Once the forward end of the section and the wing leading edge were above the barge height, the section was moved onto the barge for support while water drained. The aft fuselage lift was completed about 1030 (Figure 23). The maximum load recorded on the crane was about 130 kips during a heave while the airplane was still transitioning through the interface. The maximum load recorded when the airplane was fully out of the water was about 110 kips. The *OSRV Century* was on site during the entire lift and no evidence of a fuel or oil sheen on the water was observed.

Figure 22. Aft fuselage section at water surface.

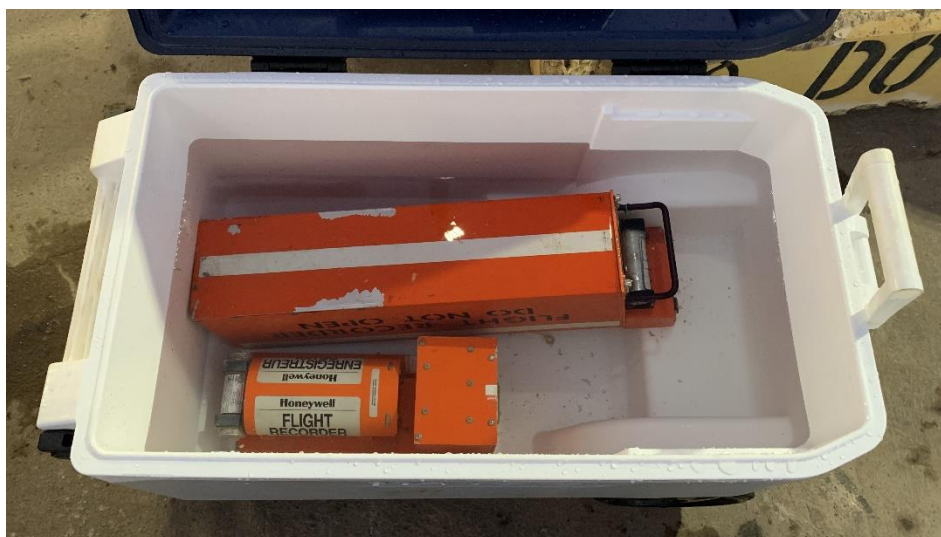
NTSB investigators were able to access the flight recorders once the *DB Salta Verde* was tied up at the harbor. The flight data recorder (FDR) located in the aft galley ceiling was accessed through the right aft entry door. The FDR remained installed in the rack and was

undamaged. The cockpit voice recorder (CVR) located in the lower cargo compartment could not be accessed through the aft cargo door due to the fuselage damage. Investigators cut a hole through the right lower fuselage skin to access the CVR. The CVR remained installed in the rack, although the rack was partially separated from the fuselage. The CVR was undamaged. The FDR and CVR were placed in a cooler of distilled water for shipment to the NTSB laboratory in Washington, DC (Figure 24). The cooler with both recorders and water was too heavy for shipment, so a second cooler was purchased, and the recorders were separated with each cooler filled with distilled water.

Figure 24. Flight recorders from accident airplane.
