Accident Investigation - Sydney Seaplanes DHC-2 collision with water accident

Author: Duncan BOSWORTH, Investigator Australian Transport Safety Bureau

On the afternoon of 31 December 2017, the pilot and five passengers of a de Havilland Canada DHC-2 Beaver floatplane, registered VH-NOO, boarded the aircraft for a return charter flight from Cottage Point to Rose Bay, New South Wales. Shortly after take-off, the aircraft conducted a 270° right turn in Cowan Water and then entered Jerusalem Bay, below the height of the terrain (Figure 1). The aircraft stopped climbing, continued along the bay and then made a very steep right turn. The aircraft's nose then dropped and the aircraft collided with the water. All on board were fatally injured and the aircraft destroyed.

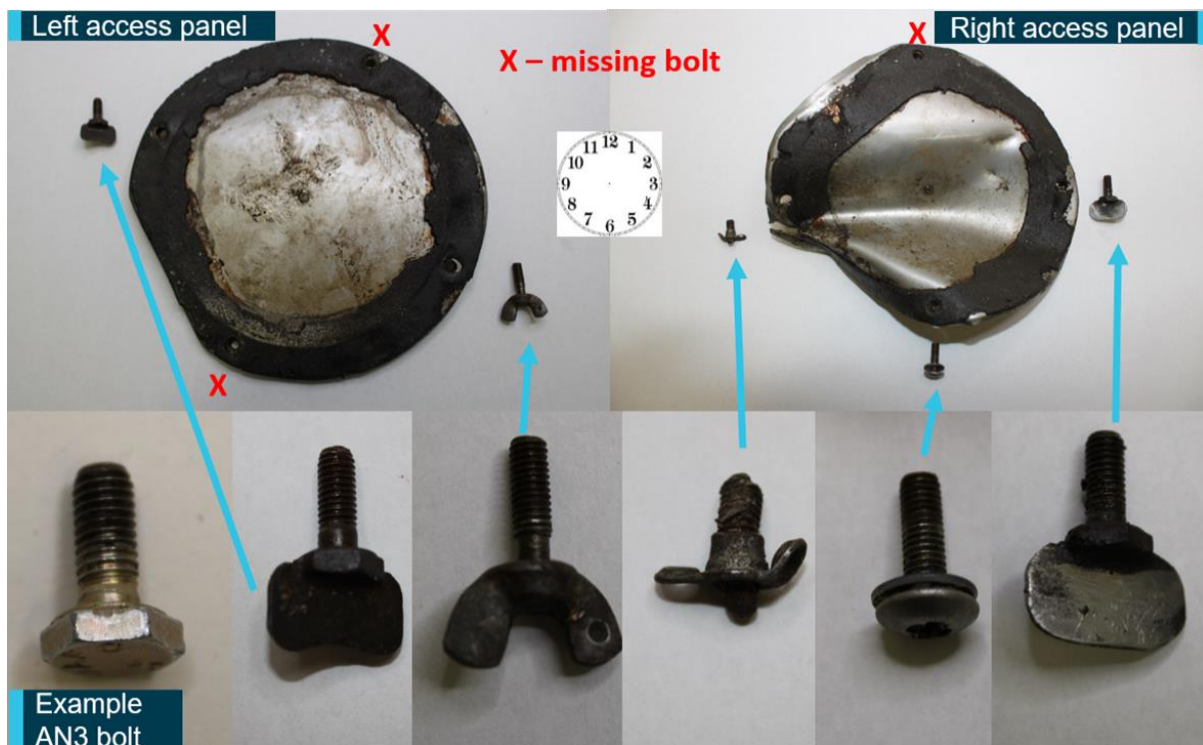
Figure 2: Magneto access panels, attaching hardware and gaskets

Toxicology results identified that the pilot and passengers had higher than normal levels of carboxyhaemoglobin in their blood. This was almost certainly due to elevated levels of carbon monoxide (CO) in the aircraft cabin. The ATSB's wreckage examination established that several pre-existing cracks in the exhaust collector ring, very likely released exhaust gas into the engine/accessory bay, which then very likely entered the cabin through holes in the main firewall where three bolts were missing from the magneto access panels. In addition, the examination also found that the in situ bolts used by the operator's external maintenance provider to secure the panels were worn, and were a combination of modified AN3-3A bolts and non-specific bolts (Figure 2).

Related to the consideration of CO exposure, the operator has implemented a range of measures and amended the DHC-2 system of maintenance, including: fitting active electronic CO detectors to their aircraft; monthly CO detector serviceability check; directing its new maintenance provider that following maintenance activities on the engine exhaust system or use of the main firewall access panels, the test for the presence of CO must be conducted.
