Miracle at Beja

Abstract

On 11 November 2018, Air Astana Flight KC1388, an Embraer E190-100LR, registration P4-KCJ, departed from Alverca do Ribatejo, Portugal (near Lisbon), following scheduled heavy maintenance at a Maintenance Repair Organization (MRO). Shortly after take-off in adverse weather, the pilots had extreme difficulty in controlling the aircraft. At several times, with the aircraft climbing and descending at unusual attitudes, the recovery attempts created structural loads greater than 150 percent of the E190's limit loads. The aircraft had departed with reverse rigging of its ailerons. This paper highlights the human factors and system deficiencies that led to the reverse rigging. It also explores how such a situation went undetected for many days by many maintenance professionals, and ultimately by the pilots as they prepared for departure. The paper also discusses the many lessons learned about accepting an aircraft after heavy maintenance at an MRO. The many positive safety factors demonstrated by the pilots, the air traffic controllers, and the Portuguese Air Force, which resulted in safe landing at Beja after a long and dramatic flight, are also studied.

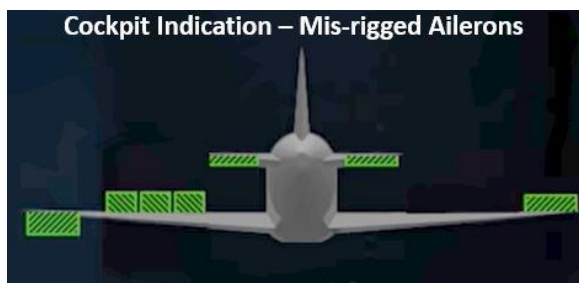
Figure 1 Cockpit Indications - Roll Control Movement

During troubleshooting by the flight crew, as the aircraft was gyrating violently, the pilots determined that the ailerons were moving in the reverse direction. The wrong movement of the ailerons was confirmed with the cockpit indication. The Air Astana technicians who were passengers assisted the flight crew during the troubleshooting.

The Air Astana checklist has been revised for both pilots to check the correctness of ailerons, rudder, elevator and multifunction spoiler surfaces deflection in respect of the flight control column movement utilizing the flight controls synoptic page.

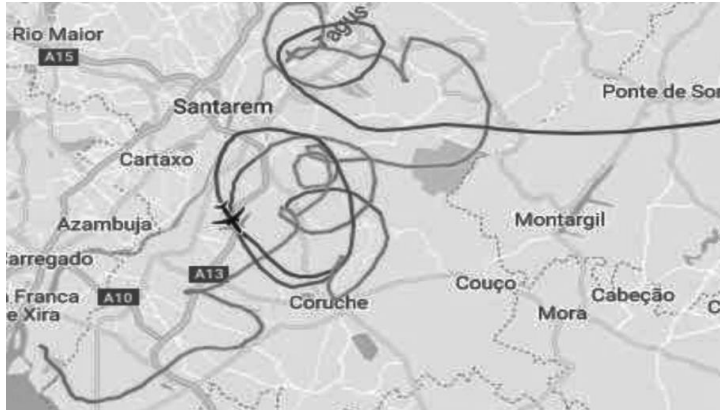
Figure 2 The Flight Path of KC1388

After gaining some aircraft control and when flying to east, while being effectively assisted by air traffic control, the crew found better

weather conditions that allowed visual cues providing better and more precise action of the aircraft's flight controls.

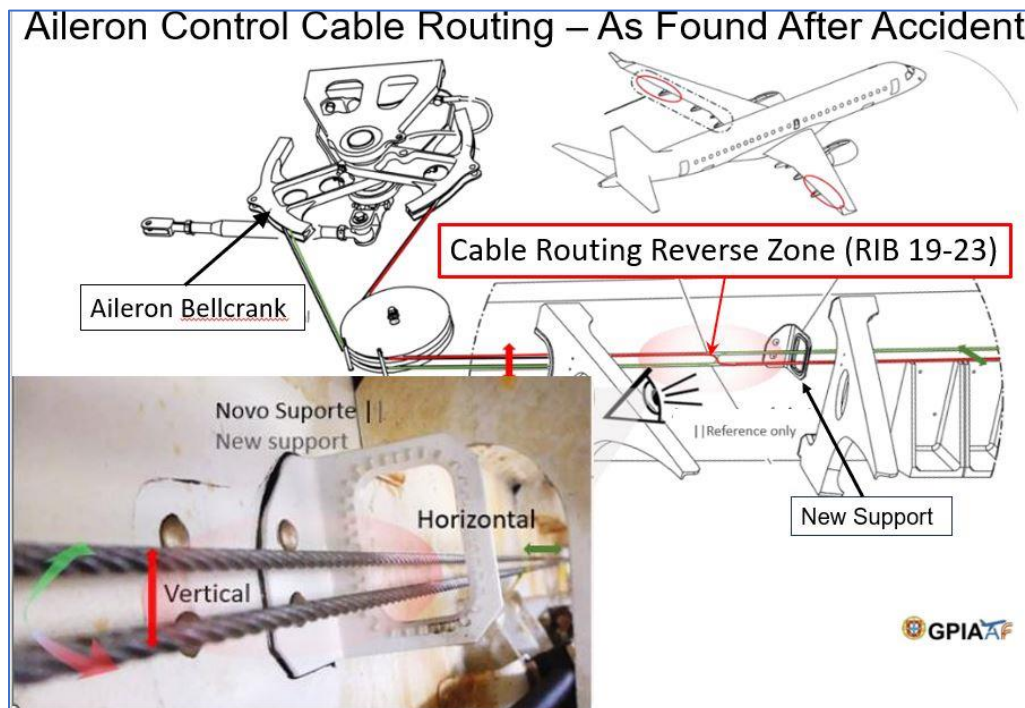
Figure 3 Aileron Control Cable Routing

In addition to a C2-Check, OGMA also carried out the work related to the accomplishment of several Service Bulletins (SB). One of the SBs, SB190-57-0038R2, changed the type of routing of the ailerons' control cables, with the replacement of pulleys and respective structural supports by a non-contact support, aiming to reduce the control cable friction on that area. The structural work, with the removal and crimping of the supports in the rear wing spar in the fuel tank area, also required the complete disconnection of the control cables.

Then, SB190-27-0037R1 was accomplished, which consisted of replacing the installed stainless-steel control cables by carbon steel cables. The investigation revealed maintenance errors and inconsistencies during this work. The C-Check work interrupted the installation procedures for the aileron control cables on several occasions. Some procedures had to be put on hold and some checks were not completed including the ailerons correct movement physical check as per the Aircraft Maintenance Manual (AMM).

In addition, the investigation noted that the aircraft manufacturer did not provide proper and clear maintenance instructions for the aileron control system installation and operational checks. Some of the diagrams were unclear and apparently the OGMA Technicians had difficulty interpreting the instructions. As a result, the newly installed aileron cables crossed each other near rib 19-23 (see figure 3).

“Embraer made important changes to the approved instructions and procedures, such as changing aileron control cables replacement task adding clearer instructions and using figure colouring on SB 190-57-0038 aileron control cables – fairleads and grommet replacement related instruction, the SB for cable material replacement and also on the operational task to check the ailerons position.”

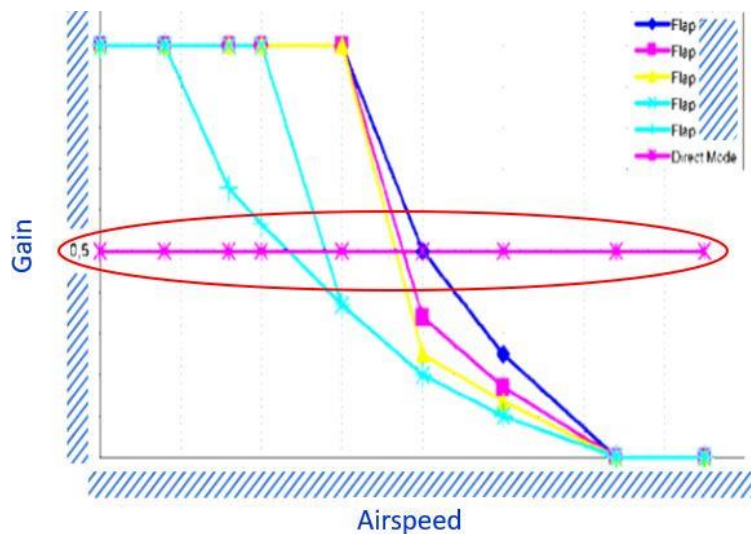
Figure 4 Performance of the FCS Roll Augmentation Modes

The pilot’s decision to use “Direct” FCS Mode made the reverse roll performance more predictable and removed the variable of control gain, from their flight control problems (see Figure 4)
