Saab 2000 Runway Excursion in Dutch Harbor, Alaska

Sathya Silva, PhD
Senior Investigator-in-Charge
U.S. National Transportation Safety Board (NTSB)

On October 17, 2019, a Saab SA-2000 airplane, operated by Peninsula Aviation Services Inc. d.b.a. PenAir flight 3296, overran the end of runway 13 at Unalaska Airport (DUT), Unalaska, Alaska. The flight crew executed a go-around during the first approach to runway 13; the airplane then entered the traffic pattern for a second landing attempt on the same runway. Shortly before landing, the flight crew learned that the wind at midfield was from 300° at 24 knots, indicating that a significant tailwind would be present during the landing. The captain reported after the accident that the initial braking action after touchdown was normal but that, as the airplane traveled down the runway, the airplane had “zero braking” despite the application of maximum brakes. The airplane subsequently overran the end of the runway and the adjacent 300-ft runway safety area (RSA), which was designed to reduce airplane damage during an overrun and came to rest beyond the airport property. The airplane was substantially damaged during the runway overrun; as

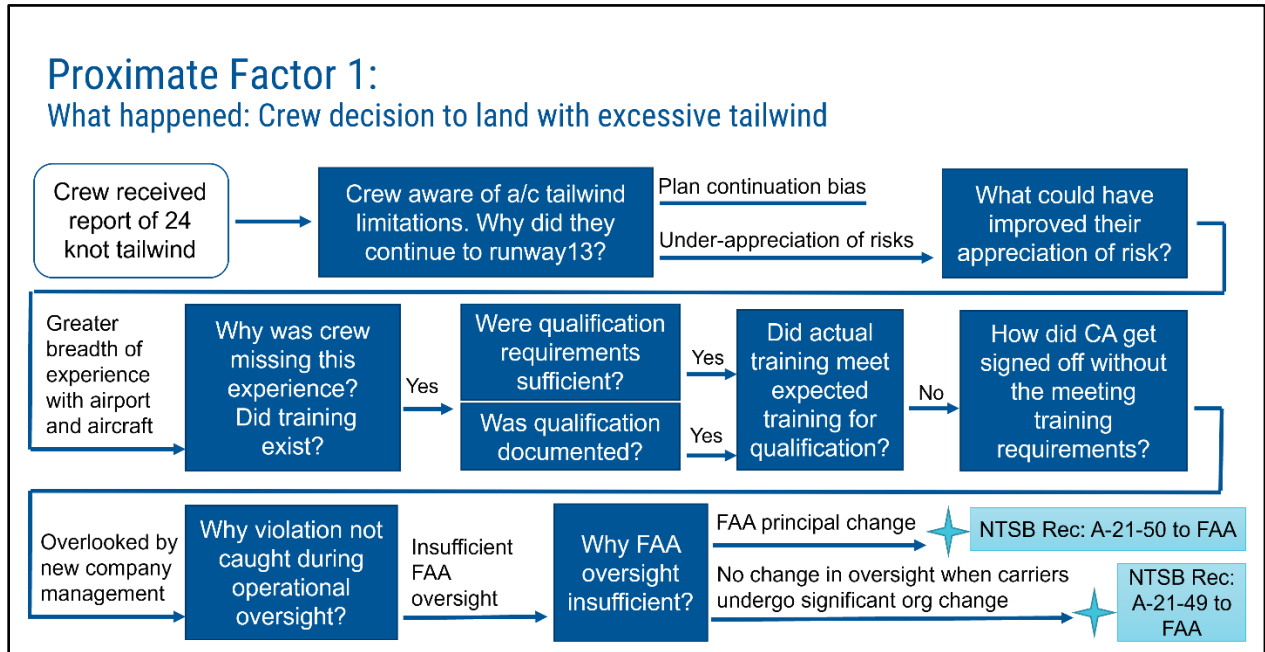
Provided one “what went wrong?” answer had been determined here to be an inappropriate crew decision, Figure 1 details a subset of investigative questions leading to the root causes or “why”

Figure 1. Flowchart illustrating investigative path to understand why the crew landed with an excessive tailwind and develop safety recommendations.

Ultimately, the proximate factor of the crew decision-making error resulted in the NTSB issuing two recommendations addressing root factors to the FAA to (1) emphasize with CMTs importance of detecting and mitigating the safety risks that can result when certificate holders experience significant organizational change and (2) revise guidance to include a formalized transition procedure for CMT personnel responsible for overseeing a certificate holder that is undergoing significant organizational change to ensure that incoming CMT personnel are fully aware of potential safety risks [4].

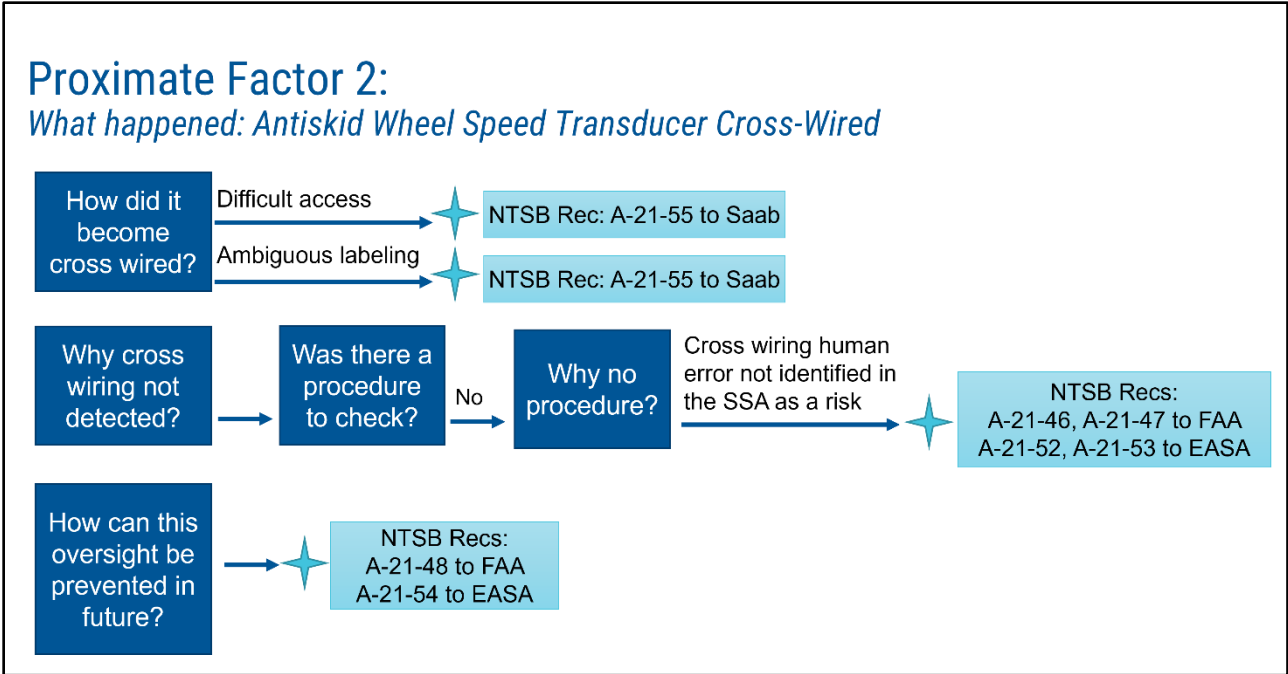
For this proximate factor, the "what went wrong?" answer was determined to be the cross-wiring of the L MLG antiskid wheel speed transducers. Figure 2 details a subset of investigative questions leading to the root causes of how this error occurred and could be prevented in the future.

Figure 2. Investigative path illustrating how safety recommendations were developed to mitigate the risk of MLG cross-wiring in the future.

A recommendation was issued to the FAA and EASA to identify system safety assessments for landing gear systems on currently certificated (and future certificated) transport-category airplanes to determine whether the assessments evaluated and mitigated human error that could lead to cross-wiring of antiskid brake system components, including the wheel speed transducers, and then require transport-category airplane manufacturers without such assessments to perform them and then implement mitigations [4].

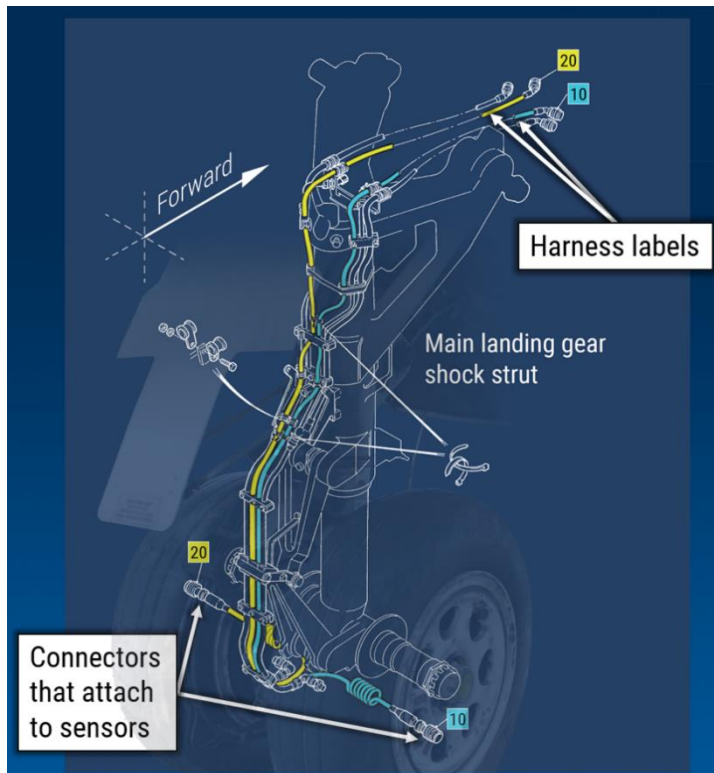
Post-accident examination of the airplane's antiskid brake system found that the wire harnesses for the left (L) main landing gear (MLG) wheel speed transducers were incorrectly routed; the harness that should have been routed to the left inboard wheel was instead routed to the L outboard wheel (and vice versa). As a result of the incorrect (crossed) wiring, the antiskid system performance was substantially compromised. The incorrect wheel speed transducer wiring most likely occurred during the overhaul of the L MLG at the landing gear manufacturer's facility in January 2017, more than 2.5 years before the accident.

Upon discovering the wires were crossed, the investigation strove to understand how this error occurred. Figure 3 illustrates that the top end connectors of the wire harness had labels and individual mating keys for the left (yellow line in figure 3) and right (teal line in figure 3) wheels; however, the area is difficult to access in the wheel well and labels would not have been easily readable. The bottom end connectors were more easily accessed; however, both connectors were identical with the same part numbers and mating keys. Therefore, the human factors involved with connecting these harnesses were not optimal for ensuring the correct wiring

Figure 3 Main landing gear depiction with antiskid wheel speed transducer wiring harness (yellow indicates the wiring for the left wheel and teal indicates the wiring for the right wheel). Source: APPH. Adapted from [1].

between L and R wheels of a MLG. As a result, the NTSB issued a recommendation to Saab to redesign the antiskid wire harness to prevent human error that could result in cross-wiring [4].

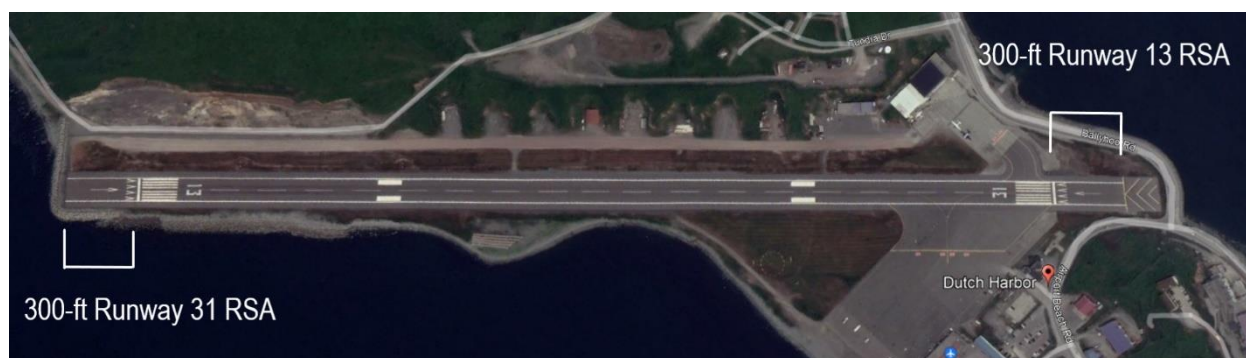
The fatal injury in this accident was caused when a propeller projectile entered the cabin once it separated from the engine after impacting a boulder at the end of the runway. RSAs were developed to protect an aircraft from terrestrial hazards in the case of runway excursions. Post-accident analysis revealed that the airplane would have been able to stop within a runway safety area that was suitable for the operation; however, the actual RSA at DUT for each runway was 700 feet shorter than what would have been suitable for an aircraft with the approach speed and size of the Saab 2000.

Figure 4. Graphic depicting the runway safety areas at DUT at the time of the accident.

For this proximate factor, the “what went wrong” answer was determined to be that the RSA at DUT was of insufficient length to protect for a runway overrun of the Saab 2000. Figure 5 details a subset of investigative questions leading to the root causes of how PenAir received approval to fly this aircraft into DUT on a consistent schedule despite this discrepancy.

Upon evaluation of the FAA’s process for approval, it was discovered that the guidance used in this assessment did not include evaluating the RSA dimensions appropriateness for the size/speed of the aircraft operating into the airport. Therefore, the NTSB recommended to the FAA to include the runway design code for runways of intended use among the criteria assessed when authorizing a scheduled air carrier to operate its airplanes on a regular basis at an airport certificated under Title 14 *Code of Federal Regulations* Part 139 [4].

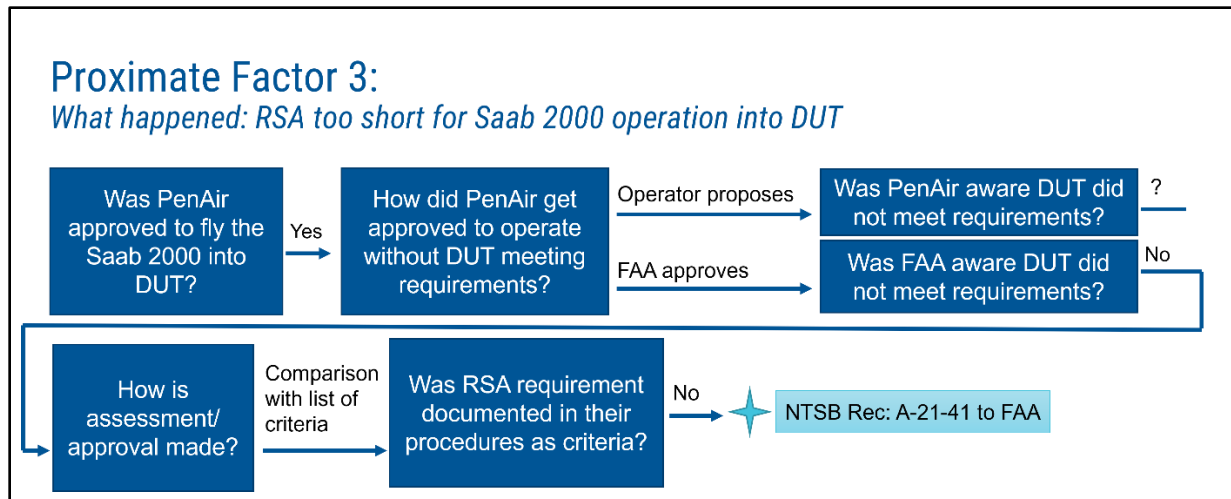
Figure 5. Flowchart illustrating investigative path to understand how the Saab 2000 was approved to operate into DUT despite the insufficient runway safety area for the aircraft size/speed and develop safety recommendations.
