MOUNTAIN HELICOPTER ACCIDENT

(AW139 JA139F, main rotors severed tail drive shaft) [1]

Aircraft Accident Investigator

Japan Transport Safety Board, Japan

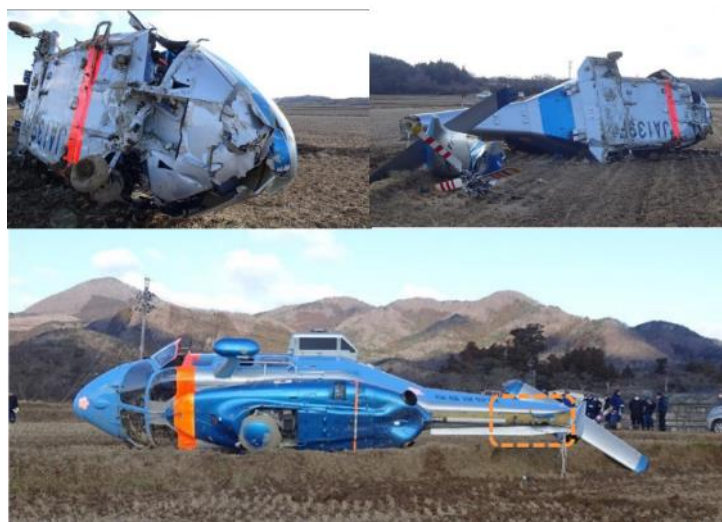
On Saturday, February 1, 2020, when an Agusta, AW139, JA139F, operated by the Fukushima Prefectural Police Aviation Unit, took off from the prefectural police heliport at 07:09 to transport organs for transplantation. Passing over Koriyama City to check the weather in advance and heading to the Aizu Central Hospital heliport in Aizu-Wakamatsu City, Fukushima Prefecture. (See Figure 1 and 2) The captain, about 3,000 ft southeast of Lake Inawashiro, confirmed that the wind was blowing from the northwest at about 50 kt, and after consulting with the co-pilot, decided to fly at a higher altitude on the return flight than on the outbound flight. The helicopter then landed at the Aizu Central Hospital heliport at 07:40. After the organs for transplantation and two passengers were seated, the helicopter took off from the Aizu Central Hospital heliport at 08:00 and headed for Fukushima Airport, the destination of the transfer. After climbing to an altitude of 5,700 ft over Lake Inawashiro, the helicopter gradually began to descend. During the descent, the captain recognized that the ground speed had increased from 193 kt to 200 kt due to the tailwind. After passing over the Ou Mountains, at 08:08, at an altitude of about 4,300 ft above Mihoda-machi, Koriyama City, Fukushima Prefecture, the helicopter's indicating airspeed (IAS) rapidly increased to 188 kt, causing the helicopter started rolling to the right. During the right rolling, the main rotor blades severed the tail drive shaft, making it difficult to control. The captain attempted a forced landing in a paddy field in the town, but the helicopter made a hard landing while rotating to the right and rolled over to the right. After the rollover, all crew members escaped through the captain's seat window. There were seven people on board the helicopter, including the captain, the co-pilot, two mechanics, and three passengers, of whom four were seriously injured and three minor injured. The helicopter was destroyed, but no outbreak fire. (See Figure 3)

Figure 3 Rollover of the Accident Helicopter

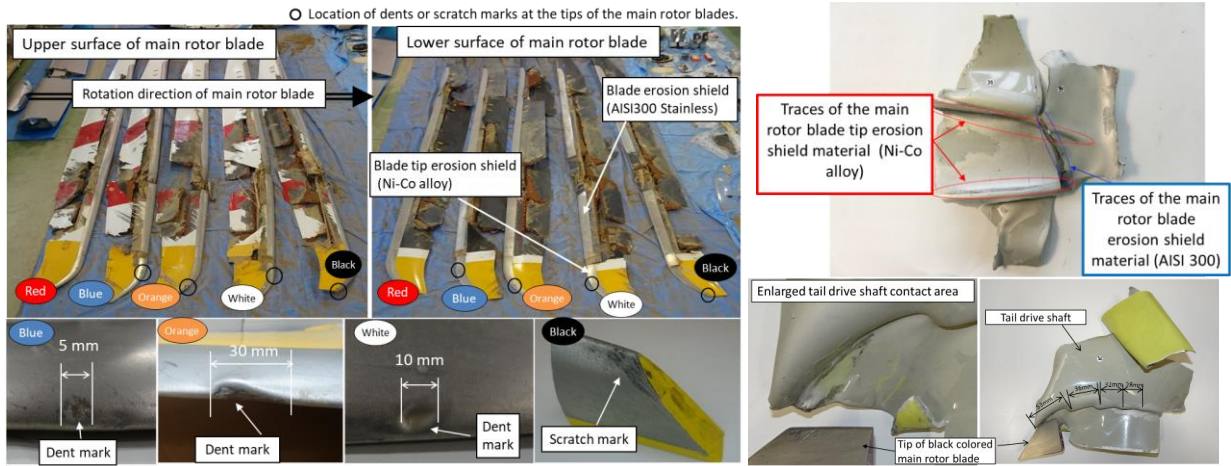
Figure 4 Wreckage of main rotor blades and tail drive shaft

From the condition of the wreckage of tail drive shaft and main rotor blade, it was clear that the tail drive shaft had been the cut by the main rotor blade. (See Figure 4) To identify the part of the main rotor blade that had encounter it, the ANSV, Leonardo Co. and JTSB investigated the material composition and deformation of the contact surface. The two pieces of the tail drive shaft with matching cut surfaces had dents with shapes that matched the shapes of the main rotor blade tip erosion shields, and on the outside, they showed signs of friction of compatible materials.

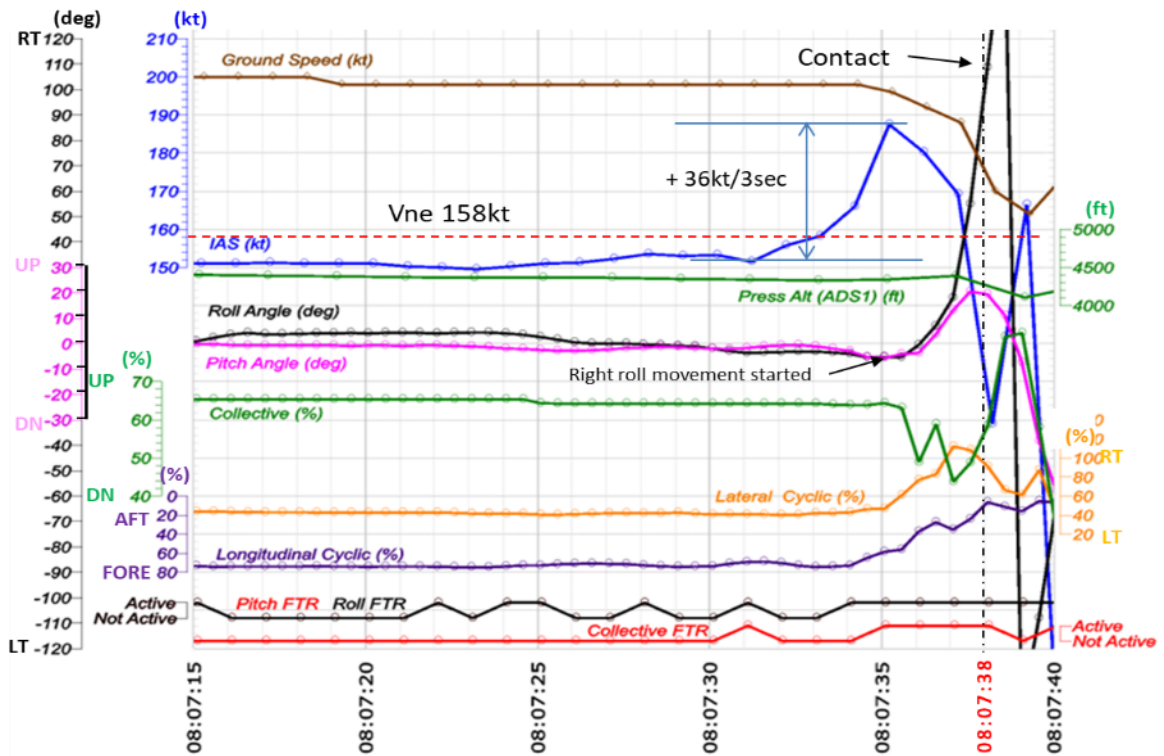
Figure 5 The record of MPFR when the IAS increased rapidly

Next, the time when the main rotor blade contacted the tail rotor blade during a right rolling identified using the Multi -Purpose Flight Recorder (MPFR) contact sound data. The helicopter was in a pitch attitude of +19°, right bank of 108°, with a right roll rate of 100°/sec, and the captain was being operated the collective upward from a vertical acceleration of -1.4G. As a result, it was highly probable that the main rotor blade was subjected to an excessive load, and the main rotor blade flapped toward the fuselage, and contacted the tail drive shaft. (See Figure 5 and 6)

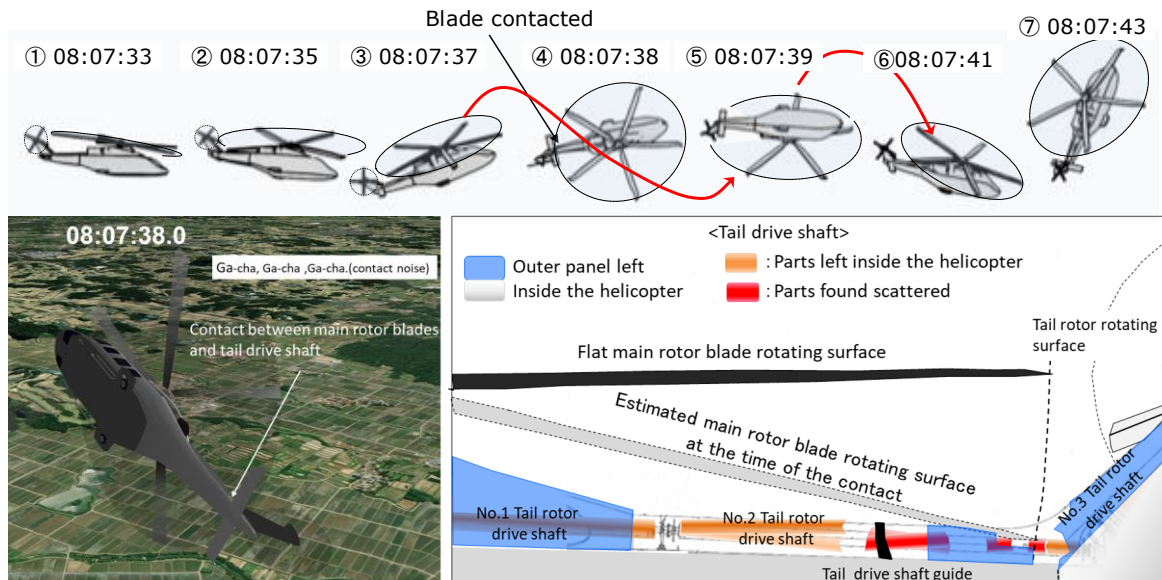
Figure 6 Changes in helicopter attitude and blades when the tail drive shaft was severed by the main rotor blades

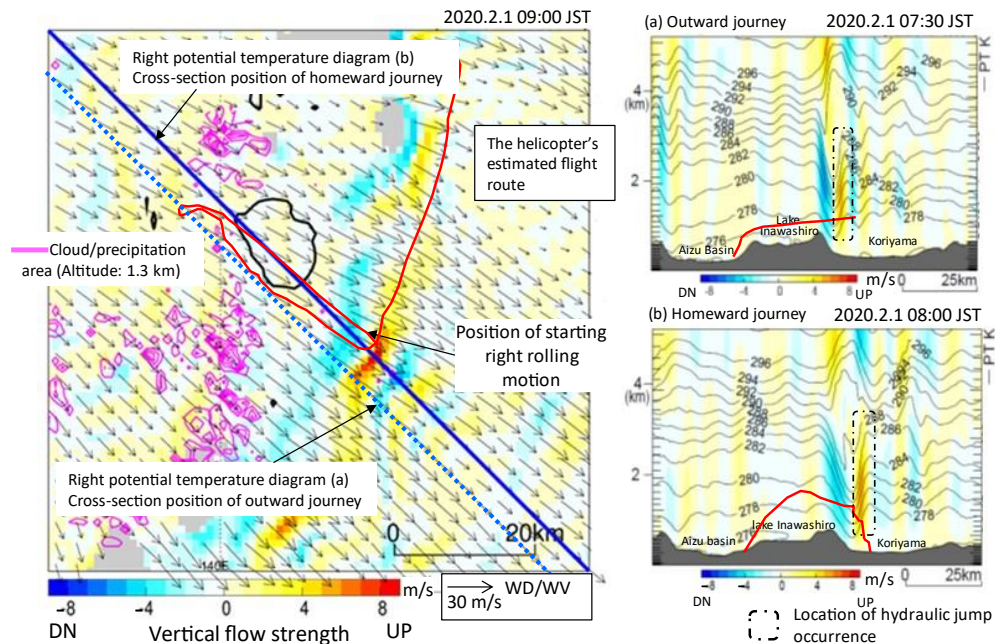
Based on the results of the weather simulation analysis, it is probable that in the skies above Aizu-Wakamatsu to Koriyama, general winds of 20 m/s (40 kt) to 30 m/s (60 kt) were blowing from the northwest, and that a vertical current running in a southwest to northeast direction was occurring in the skies above the lee side of the Ou Mountains.(See Figure 7)

Figure 7 Horizontal distribution of vertical and horizontal flow s at an altitude of 1.3 km (Left) and Cross section of potential temperature and vertical flow according to the blue dotted line / the blue solid line in the left (Right (a) / (b))

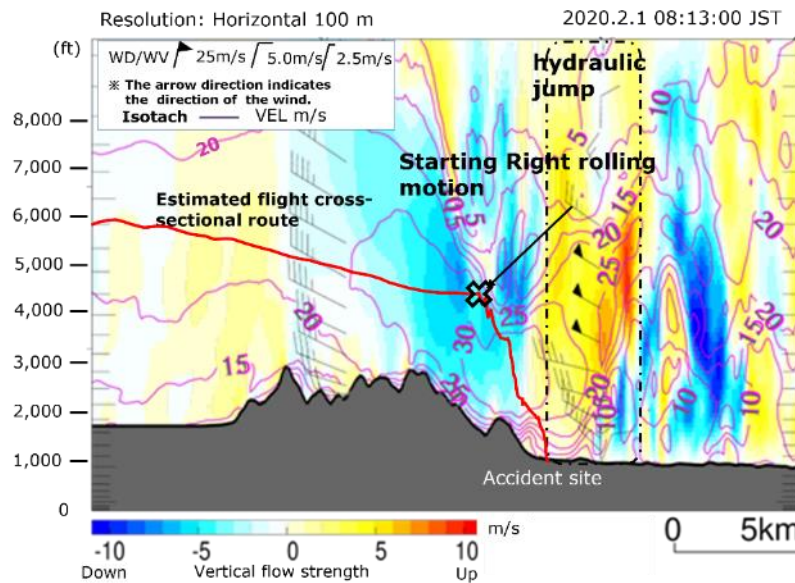
It is probable that the helicopter encountered an area where air currents changed drastically and locally in a short period of time, and because the horizontal wind speed at the altitude where the helicopter was flying had dropped sharply from 25 m/s (50 kt) or more to less than 15 m/s (30 kt), it is probable that in this area, the helicopter experienced a rapidly increase in IAS, which had a strong effect on flight control.(See Figure 8 and 9)

Figure 8 Vertical cross section of horizontal wind velocity and vertical flow

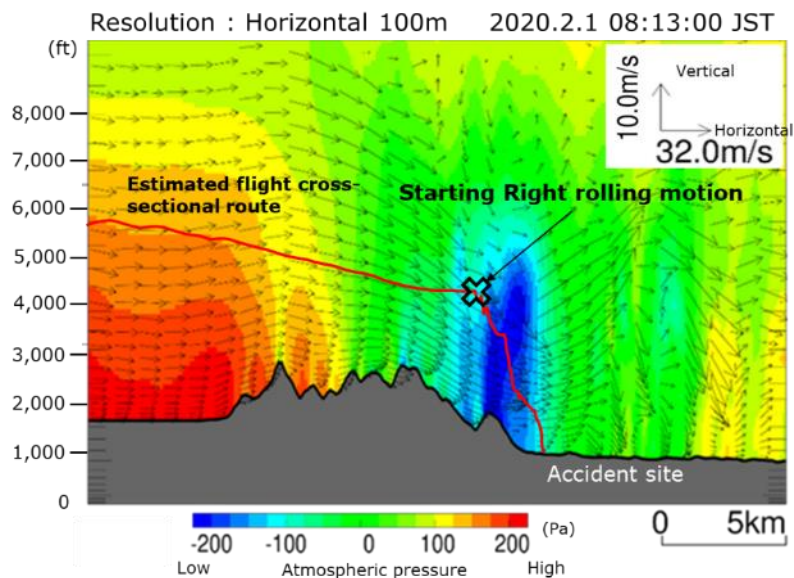
Figure 9 Distribution map of wind and Atmospheric pressure deviation along the cross section
