Aborted landing after thrust reverser selection

Kristian Ulstrup Sivertsen (MO7715), Safety Investigator, AIB Denmark

Introduction

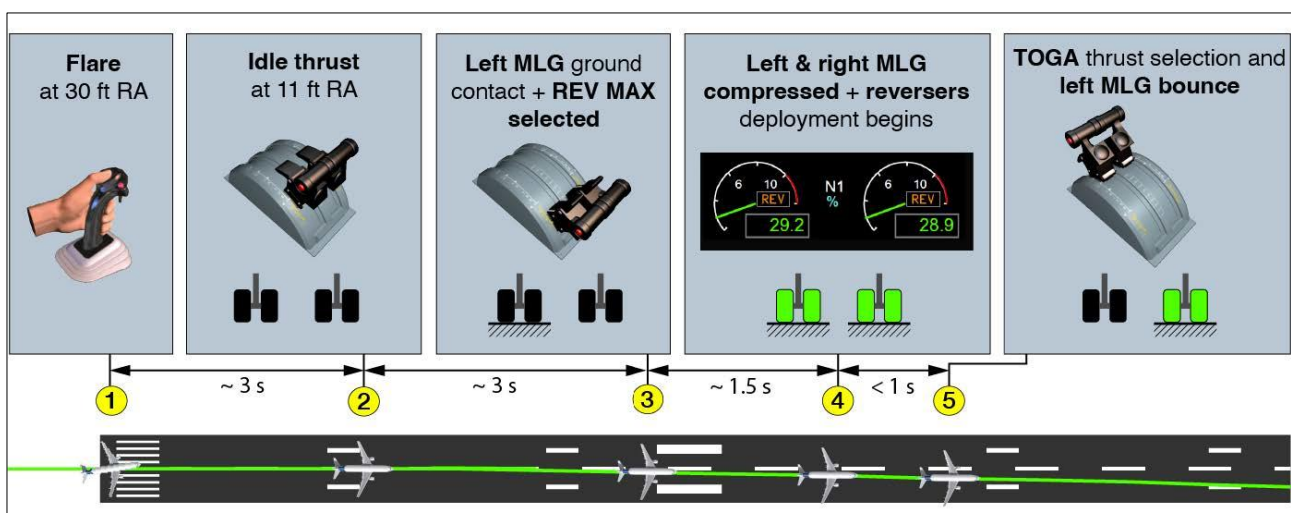
Around the same time as the captain moved the thrust levers forward, the aircraft bounced slightly, and the Weight on Wheel (WoW)/ground signal was interrupted on the left main gear. The left thrust reverser system did not latch a stow command, and three out of four blocker doors on the left thrust reverser remained deployed.

Figure 1. Illustration of the sequence of events, 1 of 2 (Source: Airbus)

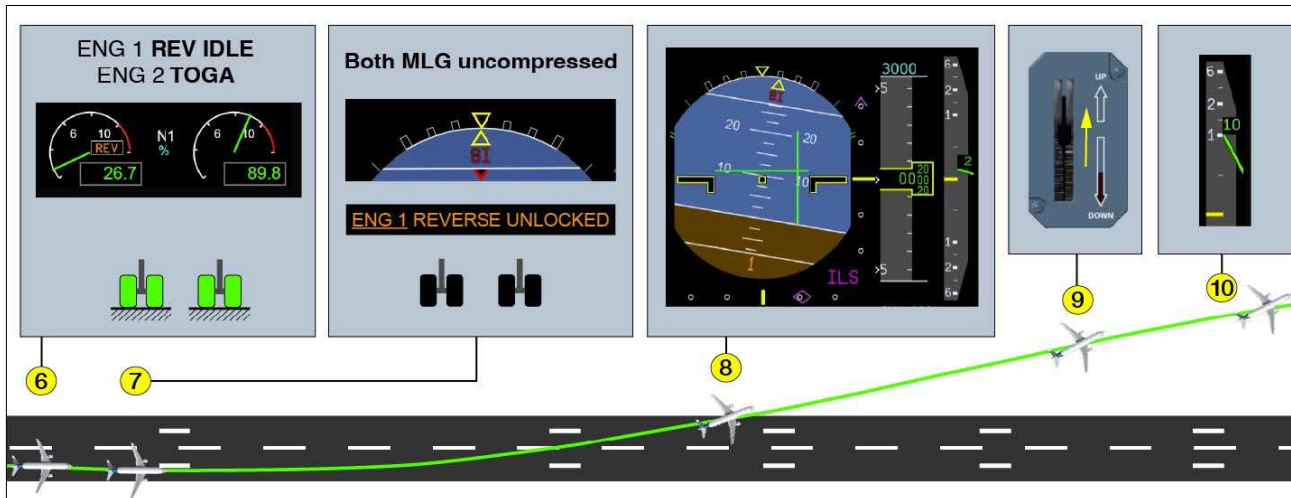
The left engine remained at idle (due to the auto-idle protection), and the right engine accelerated to Take Off and Go Around (TOGA) thrust. The captain struggled to maintain control of the aircraft. The aircraft veered to the left and vacated the left side of the runway with only a few feet of ground clearance.

The aircraft started climbing, and the first officer retracted the landing gear. The left engine was subsequently shut down, and the flight crew landed the aircraft safely at Copenhagen airport.

Figure 2. Illustration of the sequence of events 2 of 2 (Source: Airbus)

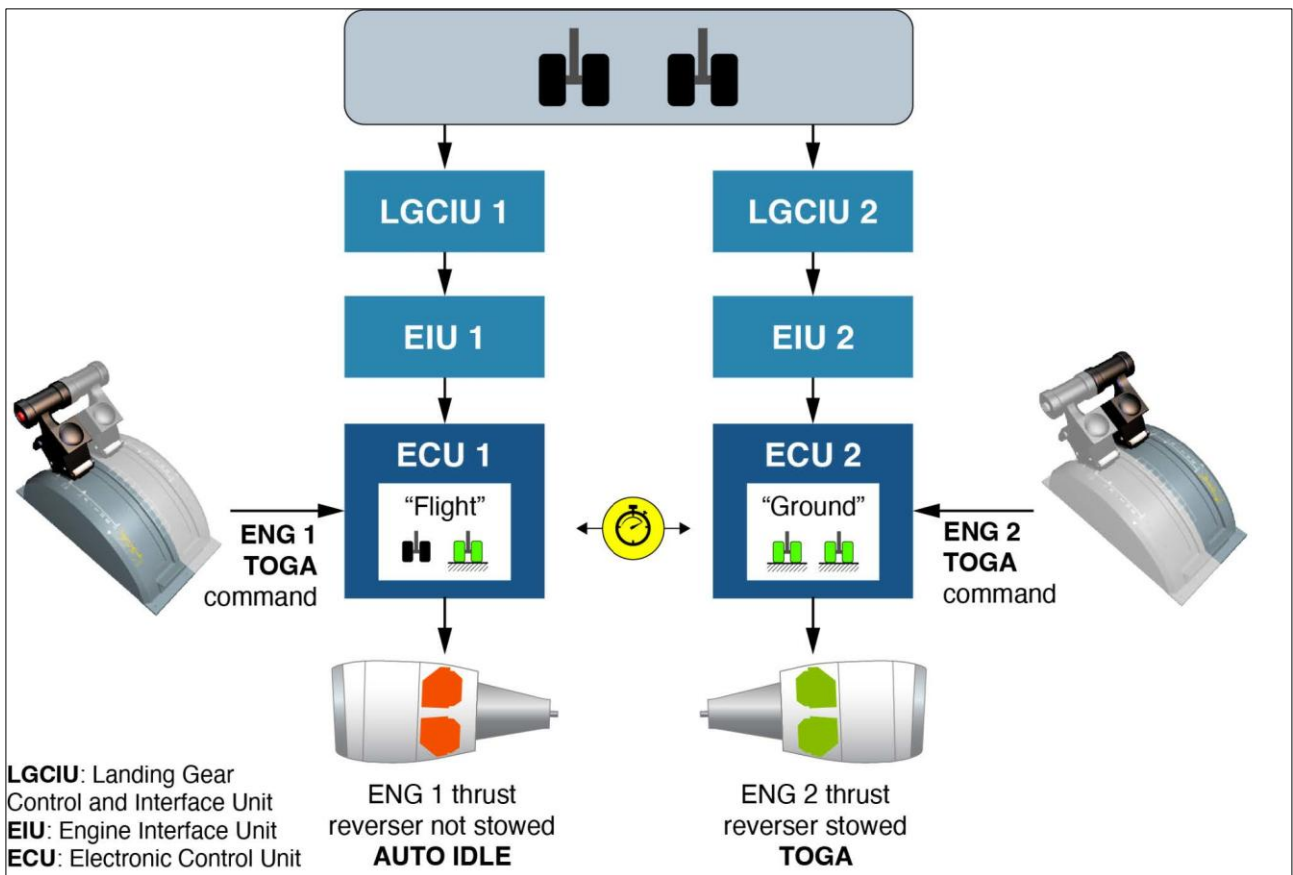
The left and right thrust reverser systems are completely independent, and receives signals from different units. Since the signal pickup and processing is not synchronised between the two sides, it allows for a difference in timing of ground/air signals to the left ECU and the right ECU. As the left ECU did not receive a ground signal when forward thrust was selected, the stow command was not latched, the stow sequence was interrupted, and the left thrust reverser did not stow.

During the serious incident, the aircraft did not have firm ground contact (for two seconds) to allow for stowing of the left thrust reverser.

Figure 3. Thrust reverser system description with illustration of difference in signals acquisition (source: Airbus)

The specific A320 CFM56 ECU software is being modified, and the modification will be mandated by EASA once ready for implementation. But it remains important to consider aborted landings after thrust reverser selection on a more global level.
