ISASI 2012 - 43rd Annual Seminar

Accident Investigation: Reactive, But Irreplaceable Lessons Learned with the JJ3054 Runway Excursion

Fernando S. A. de Camargoⁱ
(CENIPA - Brazil)ⁱⁱ

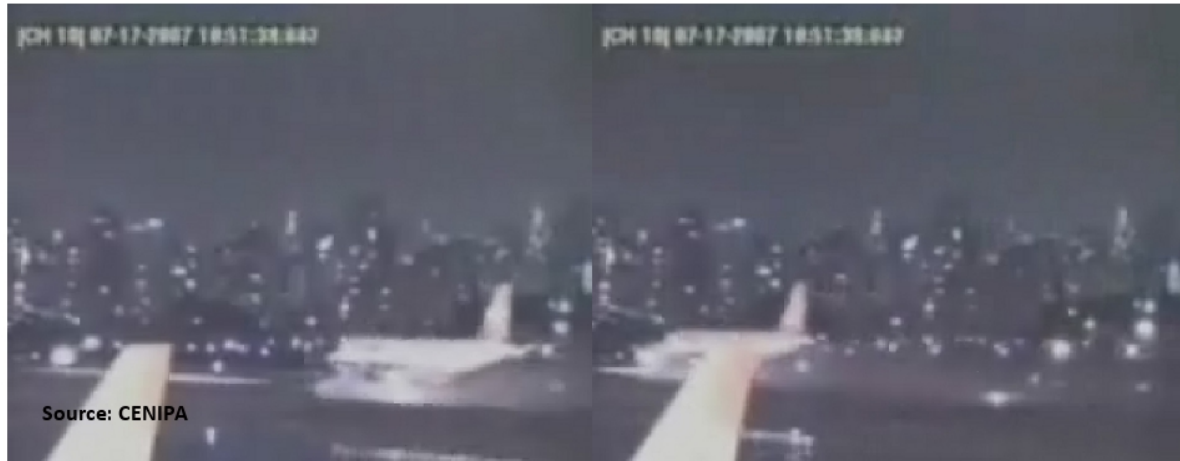
Other feasible actions were developed, such as recovery of the airport surveillance system video, which showed that the aircraft was rolling on the runway after landing at a speed well above the one usually observed in a normal landing (figure 1).

Figure 1: Images from the airport surveillance system.

In interviews with the TWR-SP controllers on duty at the time of the accident, they confirmed the impression of above normal speed depicted by the surveillance video.

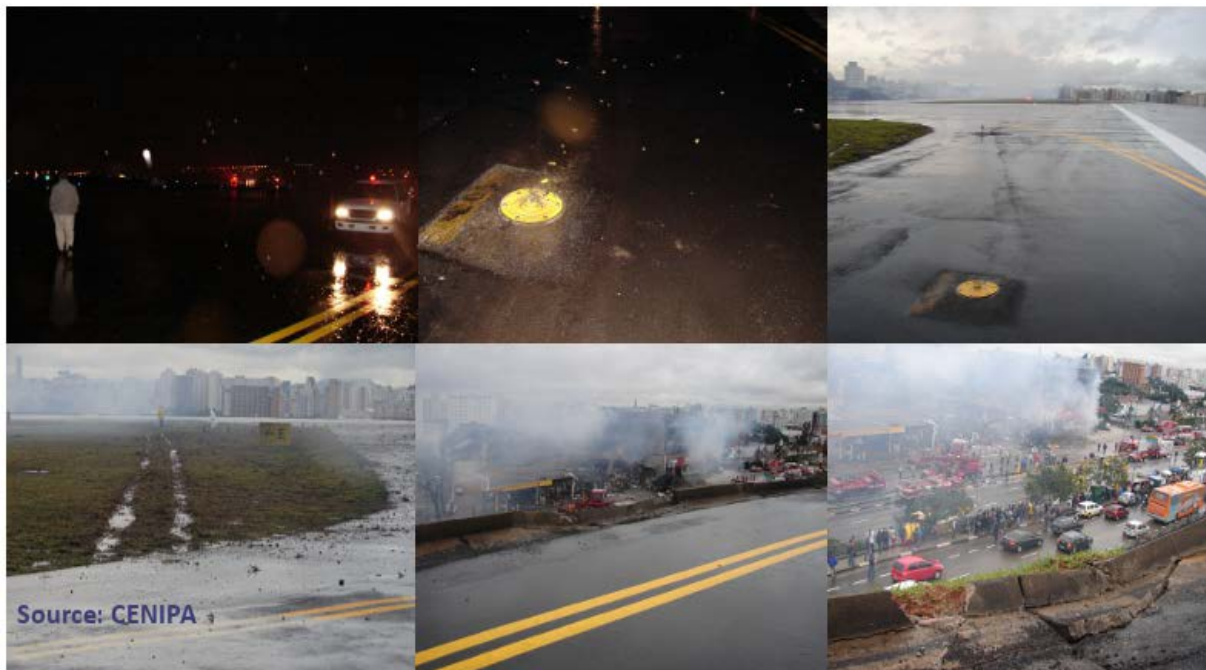
An examination of the runway, started at night under pouring rain, allowed to identify the trajectory of the aircraft down the runway, and the point of escape to the left side (figure 2).

Figure 2: Marks of the aircraft trajectory after landing.

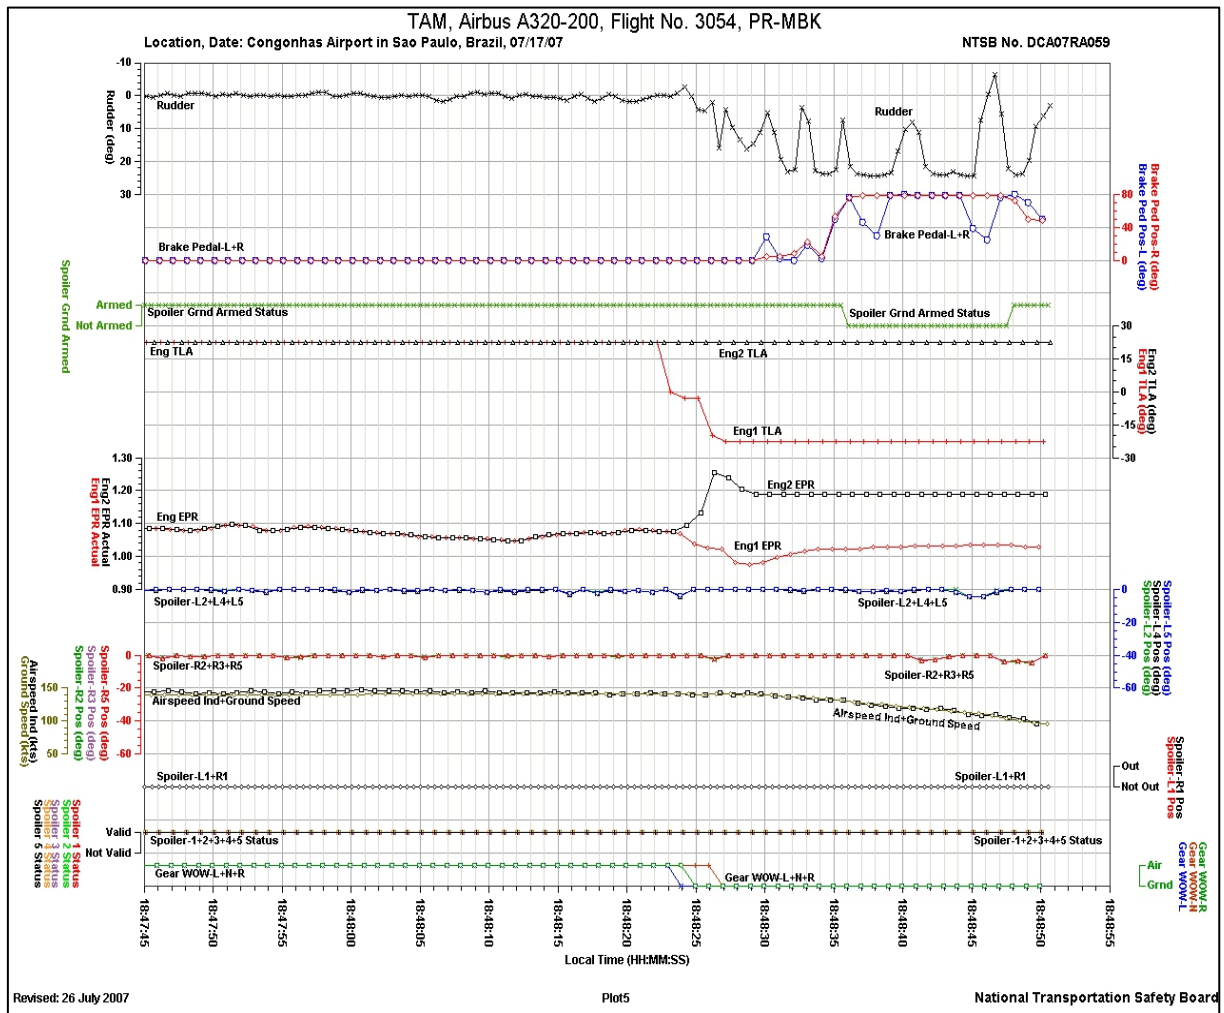
At the landing, the touch of the aircraft landing gear on the runway occurred at a speed of approximately 140 kt., while the FDR recording shows that one of the thrust levers was at "IDLE" and the other at "CL".

Figure 3: FDR plots.

The FDR also recorded that, after the landing, there was neither deflection of the ground spoilers, nor activation of the autobrake.

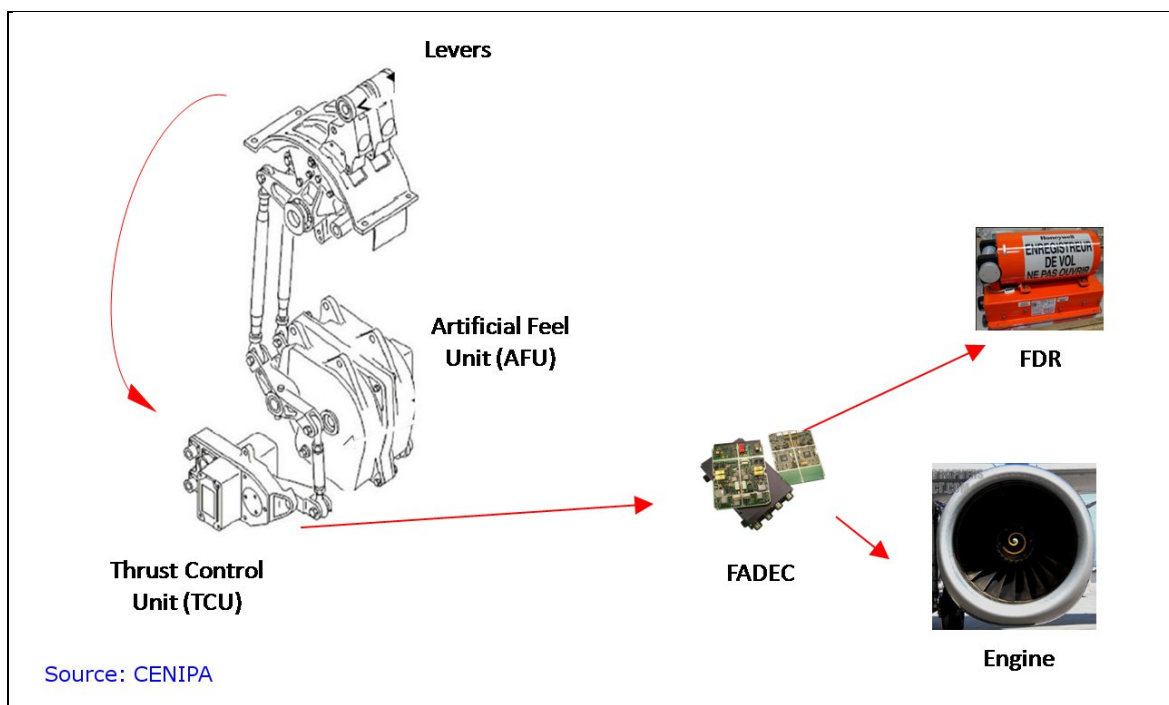
Relatively to the first hypothesis, the operation of the engine power control system follows a chain of commands (figure 4) which starts with the activation of the thrust lever by the pilot. The movement of the lever is mechanically transmitted through the AFU to the thrust control unit (TCU). From the TCU, an electronic signal is sent to the FADEC ("Full Authority Digital Electronics Control"), which governs the engine. The recordings made by the FDR have their origin in the data provided by the FADEC.

Figure 4: Power transmitting system.

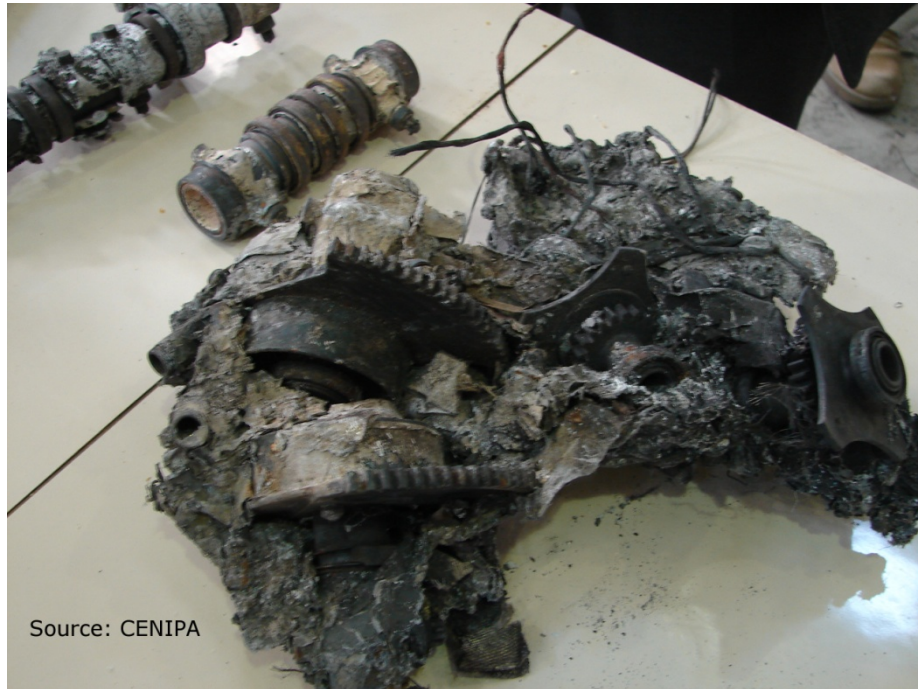
The AFU, recovered in the midst of the wreckage (figure 5), was subjected to several tests in an attempt to find marks of impact that could lead to the identification of the actual position of the engine no. 2 thrust lever during the final moments of flight JJ3054.

Figure 5: Artificial Feel Unit (AFU) found amidst the wreckage.

Due to the lack of success in the examinations, the possibility of an AFU failure could not be ruled out.

However, according to the data provided by the manufacturer, the possibility that a failure like this can occur exactly at the moment of landing is less than 4×10^{-11} per flight hour.
