Bureau d'Enquêtes et d'Analyses pour la sécurité de l'aviation civile

ISASI 2015 Annual Seminar, Augsburg, Germany

Runway Overrun in Lyon, France

Fixing the Holes: Infrastructure, Training and Oversight

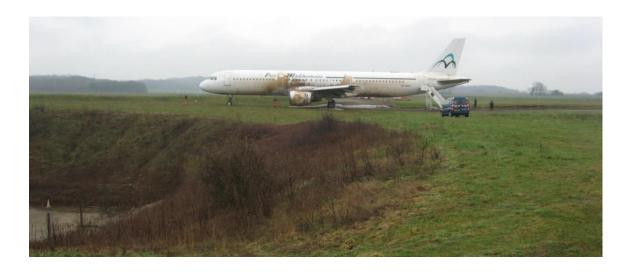
On the evening of 29 March 2013, the crew of an Airbus A321 made a return flight from Dakar (Senegal) to Lyon Saint Exupéry (France) as part of a nonscheduled public transport passenger flight chartered by a French airline. The airport was under LVP conditions. The aircraft landed about 1,600 m past the threshold of runway 36R and overran the runway. During the approach, the crew did not manage the speed effectively and there was a strong tailwind. Furthermore, on short final, the crew faced an unexpected increase in engine power, which they did not identify. Landing with a 100 ft ceiling and in a fog bank the Captain, who was PM, steered the airplane around an ILS antenna and braked to stop the airplane. The airplane came to a halt 308 m past the end of the runway, short of a 15-meter deep hole in the ground. No passengers or crew were injured. However, if the aircraft had continued its roll and fallen into the hole, it is likely that it would have caused injuries or even fatalities.

Filling in that hole after the accident was one of the actions that resulted from the safety lessons drawn from this accident. It was the most obvious and direct one, but the safety investigation recommended fixing other "holes" as well. Namely, those discovered in the operator's organization and in the oversight system.
