Aviation Safety Improvements: Advancing Safety Through Multiple Means

Kristi Dunks, Ph.D.

Transportation Safety Analyst, Office of Aviation Safety
U.S. National Transportation Safety Board*

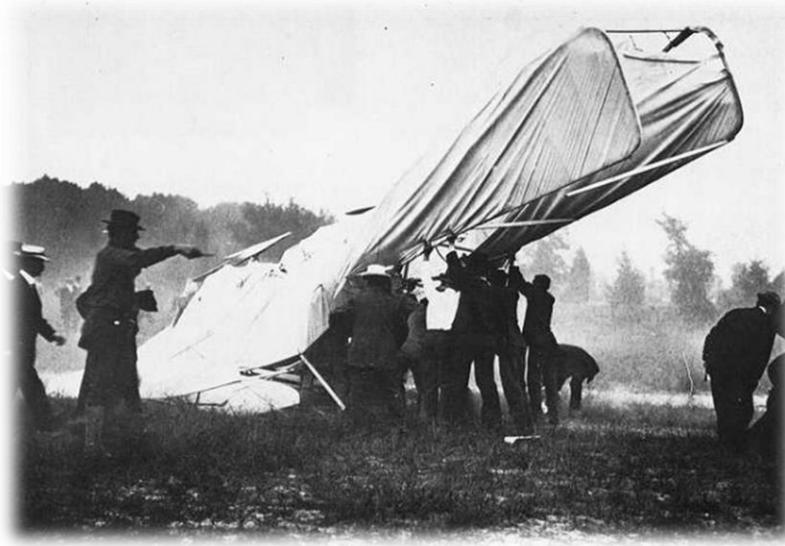
Figure 1. 1908 Fort Myers, Virginia, Airplane Accident (US National Archives)

On September 17, 1908, the first powered airplane passenger fatality occurred. During a test flight for the US Army at Fort Myers, Virginia, a wooden propeller blade split, and pilot Orville Wright was unable to control the airplane (see figure 1). Lt. Thomas Selfridge sustained a skull fracture as a result of the accident and died hours later. Although aviation history has been full of amazing achievements, when accidents occur, industry pauses to investigate the circumstances and learn from these events. After the 1908 accident, US Army pilots were required to wear helmets to prevent

injuries similar to the one sustained by Lt. Selfridge. Even from these early days of aviation, the prevention of similar accidents through safety improvements was of primary importance.

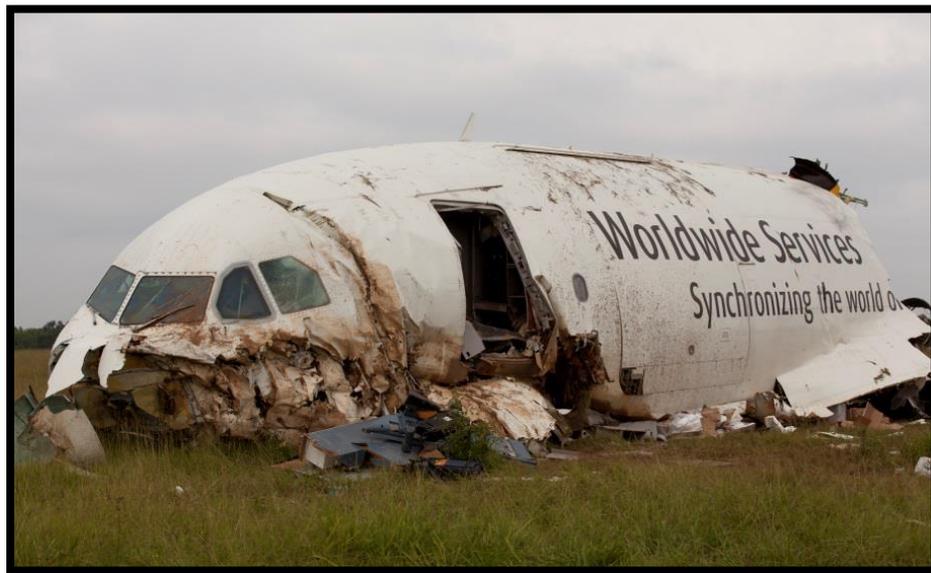
Figure 3. UPS Accident Site

On August 14, 2013, about 0447 central daylight time, UPS flight 1354, an Airbus A300-600, N155UP, crashed short of runway 18 during a localizer nonprecision approach to runway 18 at Birmingham-Shuttlesworth International Airport, Birmingham, Alabama [4]. The captain and the first officer were fatally injured. The airplane was destroyed by impact forces and postcrash fire (see figure 3). The scheduled cargo flight was operating under the provisions of 14 *Code of Federal Regulations (CFR)* Part 121 on an instrument flight rules flight plan. Dark night visual flight rules conditions prevailed at the airport, and variable instrument meteorological conditions with a variable ceiling were present north of the airport on the approach course at the time of the accident.

The NTSB determined that the probable cause of the accident was the flight crew's continuation of an unstabilized approach and their failure to monitor the aircraft's altitude during the approach, which led to an inadvertent descent below the minimum approach altitude and subsequently into terrain. Contributing to the accident were (1) the flight crew's failure to properly configure and verify the flight management computer for the profile approach; (2) the captain's failure to communicate his

As a result of the investigation, the NTSB made 15 recommendations to the FAA, 2 recommendations to UPS, 2 recommendations to the Independent Pilots Association, and 1 recommendation to Airbus. The safety recommendations to the FAA addressed areas related to fatigue, dispatcher training, operating procedures and training, the hazards of dive-and-drive approaches, the need to include information from the remarks section of aviation routine weather reports in automatic terminal information system (ATIS) reports, ground proximity warning system software updates, terrain awareness and warning system alerts and responses, and flight management computer programming. The safety recommendations issued to UPS and the Independent Pilots Association addressed fatigue reporting and assessment. The safety recommendation to Airbus addressed the need to provide a direct cue to flight crews when the flight management computer for applicable Airbus models is programmed incorrectly.

In addition to these safety recommendations, safety improvements were made outside of the formal safety recommendation process. The Birmingham airport authority and the Birmingham control tower replaced the emergency phone system and updated procedures to provide timely notification to emergency response personnel. Also, controllers received refresher training about entering remarks data into ATIS reports and updating those reports. Thus, the safety recommendations addressed the broad safety issues identified during the investigation, and the safety results implemented at the Birmingham airport and control tower addressed local procedures and training (see figure 4).

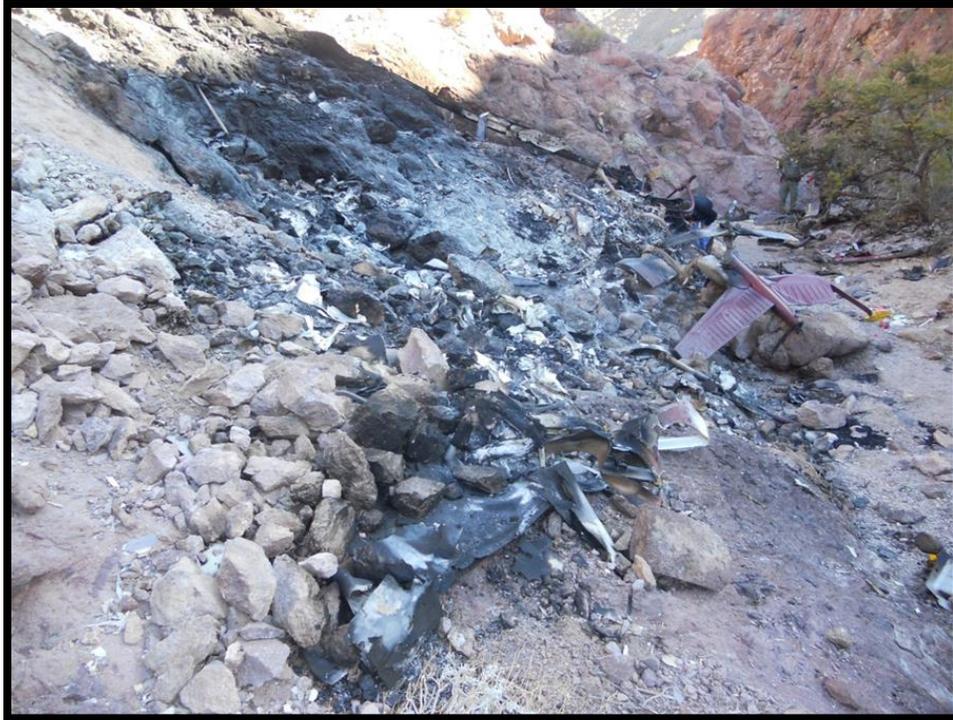
Figure 5. Sundance Helicopters Accident Site

On December 7, 2011, about 1630 Pacific standard time, a Sundance Helicopters, Inc., Eurocopter AS350-B2 helicopter, N37SH, operating as a "twilight tour" sightseeing trip, crashed in mountainous terrain about 14 miles east of Las Vegas, Nevada [5]. The pilot and four passengers were fatally injured. The helicopter was destroyed by impact forces and postcrash fire (see figure 5). The helicopter was registered to and operated by Sundance Helicopters as a scheduled air tour flight under the provisions of 14 *CFR* Part 135. Visual meteorological conditions with good visibility and dusk light prevailed at the time of the accident, and the flight was operated under visual flight rules.

The NTSB determined that the probable cause of the accident was Sundance Helicopters' inadequate maintenance of the helicopter, including (1) the improper reuse of a degraded self-locking nut, (2) the improper or lack of installation of a split pin, and (3) inadequate postmaintenance inspections, which resulted in the in-flight separation of the servo control input rod from the fore/aft servo and rendered the helicopter uncontrollable. Contributing to the improper or lack of installation of the split pin was the mechanic's fatigue and the lack of clearly delineated maintenance task steps to follow. Contributing to the inadequate postmaintenance inspection was the inspector's fatigue and the lack of clearly delineated inspection steps to follow.

As a result of the investigation, the NTSB issued three recommendations to the FAA. These recommendations addressed establishing duty-time regulations for maintenance personnel, implementing best practices for conducting maintenance under 14 *CFR* Parts 135 and 91 Subpart K, and human factors training for maintenance personnel.

During the investigation, several safety improvements were completed. Sundance Helicopters was a member of the Tour Operators Program of Safety (TOPS). Investigators determined that Sundance Helicopters did not meet the TOPS audit requirements but had successfully passed the audit. After discussions with the NTSB, TOPS formed a committee to evaluate its auditing process. TOPS then revised its audit

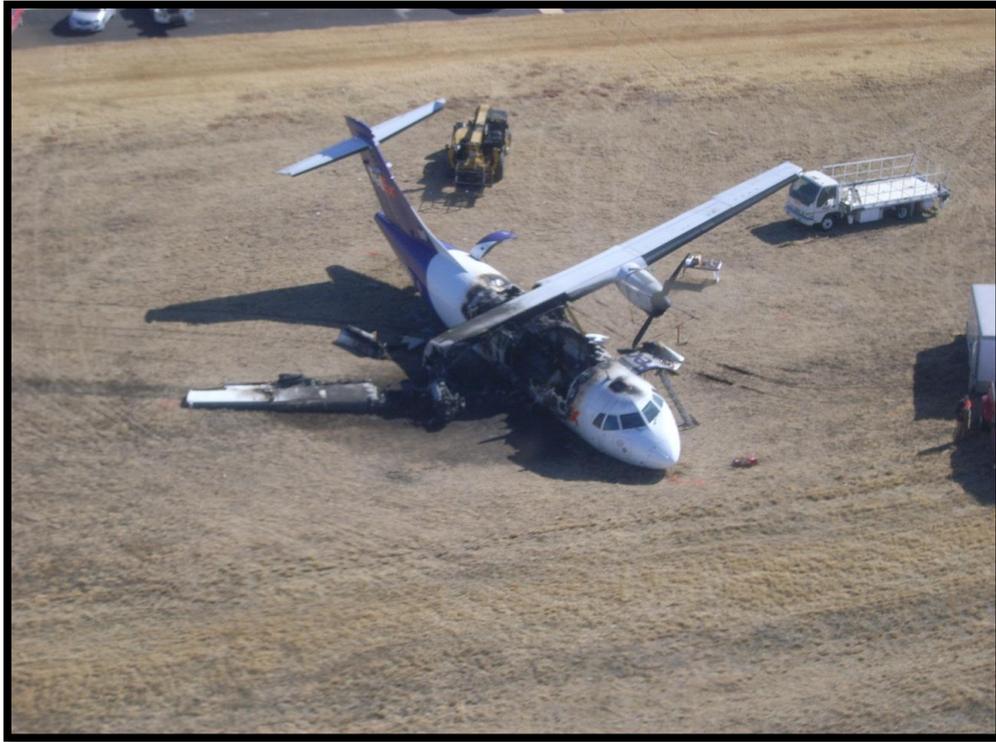
Figure 7. Empire Airlines Accident Site

On January 27, 2009, about 0437 central standard time, an Avions de Transport Régional Aerospatiale Alenia ATR 42-320, N902FX, operating as Empire Airlines flight 8284, crashed short of the runway while on an instrument approach to Lubbock Preston Smith International Airport, Lubbock, Texas [6]. The captain sustained serious injuries, and the first officer sustained minor injuries. The airplane was substantially

damaged (see figure 7). The airplane was registered to FedEx Corporation and was operated by Empire Airlines, Inc., as a 14 CFR Part 121 supplemental cargo flight. Instrument meteorological conditions prevailed at the time of the accident, and an instrument flight rules flight plan was filed.

The NTSB determined that the probable cause of the accident was the flight crew's failure to monitor and maintain a minimum safe airspeed while executing an instrument approach in icing conditions, which resulted in an aerodynamic stall at low altitude. Contributing to the accident were (1) the flight crew's failure to follow published standard operating procedures in response to a flap anomaly, (2) the captain's decision to continue with the unstabilized approach, (3) the flight crew's poor crew resource management, and (4) fatigue due to the time of day during which the accident occurred and a cumulative sleep debt, which likely impaired the captain's performance.

As a result of the investigation, the NTSB issued nine recommendations to the FAA. These recommendations addressed improving first officer assertiveness, prohibiting operations in known freezing rain or freezing drizzle (unless the airplane manufacturer has demonstrated that the airplane model can safely operate in those conditions), flight training on the dangers of operating in freezing precipitation,

Numerous safety accomplishments resulted from the work of the investigative team. In the months after the accident, Empire Airlines issued training guidance on flap anomalies, issued flight bulletins addressing airspeed bugs and prohibitions on operating in freezing rain or freezing drizzle, and implemented special emphasis icing training. FedEx held a safety summit to its feeder operators to address the circumstances of this accident and facilitate improved training, developed “no-go” weather items that prohibit takeoff or landing operations in known or reported freezing rain or freezing drizzle, and installed ice evidence probes on all company ATR airplanes without such equipment. Also, in March 2010, the FAA issued Safety Alert for Operators (SAFO) 10006, “In-Flight Icing Operations and Training Recommendations,” to encourage all operators to review and, if necessary, amend their flight crewmember and dispatcher training programs to ensure that the programs address supercooled large droplet (SLD) icing conditions.
