Air Safety Through Investigation

Proceedings of the 38th Annual International Seminar 'International Cooperation: From Investigation Site To ICAO'

Aug. 27–30, 2007
Singapore, Republic of Singapore

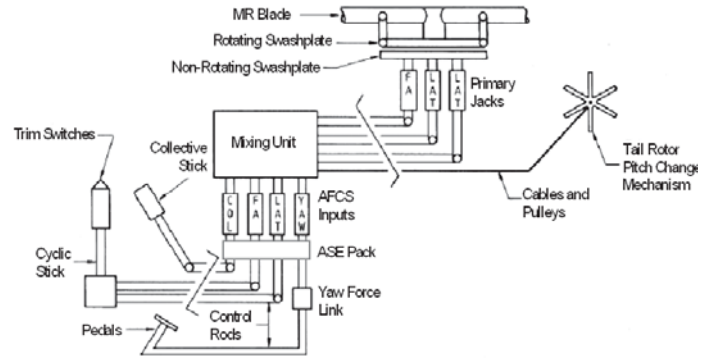
Figure 14. Schematic of the flight control system. Note: To simplify the schematic, the inputs to the mixing unit (i.e., collective, fore/aft, lateral, and yaw) are not shown in the correct order.

The ASE pack provides servo assistance through four separate channels, fore/aft (pitch), lateral (roll), collective (altitude), and directional (yaw) to the control linkage of the primary servo jack units and tail rotor. The unit, which is located within the auto-

On April 9, the high strength steel mixing unit shaft was found in the main fuselage wreckage. The mixing unit couples and directs pilot control inputs to the main and tail rotor systems of the helicopter. A detailed view of the mixing unit and fore/aft bellcrank assembly is shown in Figure 14 and Figure 15. The mixing unit

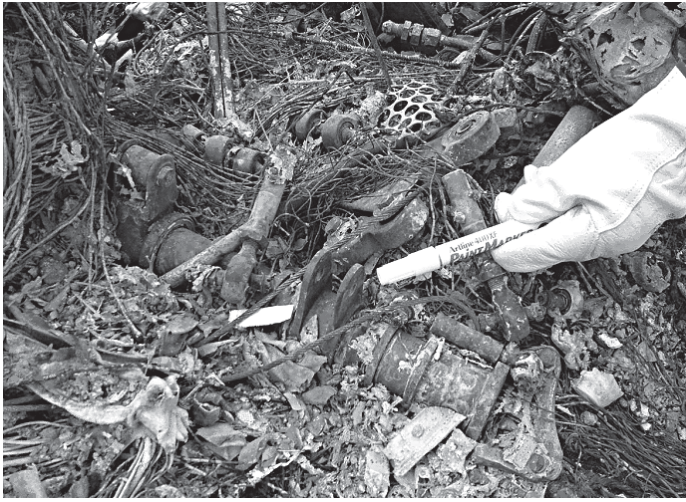
Figure 16. Location of the mixing unit, showing the lugs for the attachment of the fore/aft bellcrank.

On-site examination of the high strength steel lugs of the mixing unit (for the attachment of the fore/aft bellcrank) with a 10X magnifying glass revealed no evidence of damage or deformation to the internal and external surfaces of both lugs. The lack of any damage or deformation strongly suggested that the bolt for the attachment to the mating bellcrank had not been forced out of the lugs as a result of the accident. While the adjacent aluminum alloy bellcranks and attachment fittings had melted,⁶ the temperature of the fire in the region of the mixing unit did not exceed the melting temperature of the high strength steel fore/aft bellcrank, or of the steel bolt and nut that attached the fore/aft bellcrank to the steel mixing unit lugs⁷.

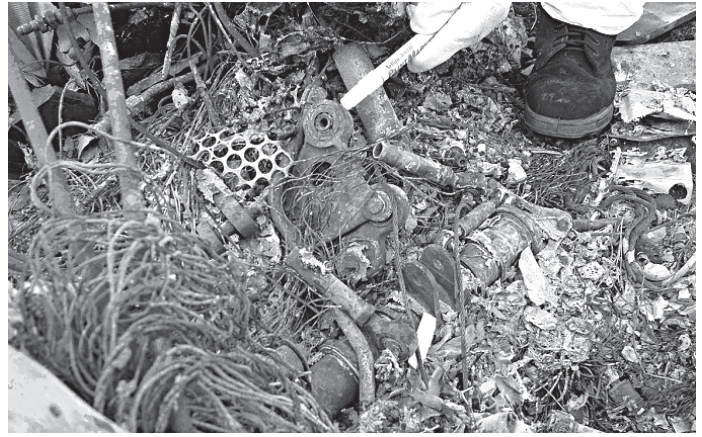
Figure 17. Location of the fore/aft bellcrank near the mixing unit.

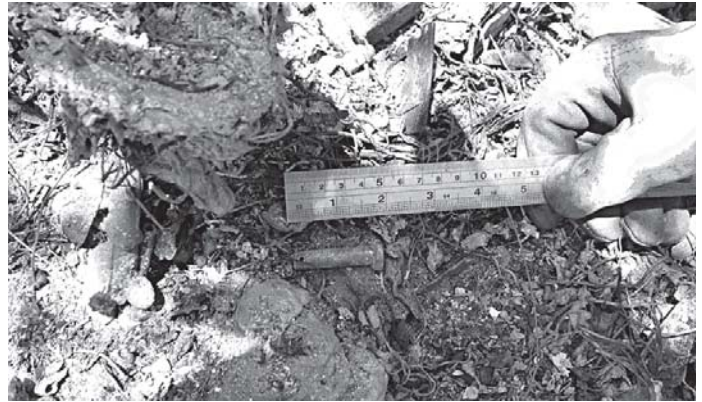
Figure 18. Area of location of the fore/aft bellcrank attachment bolt, discovered under debris.

The bolt that connects the fore/aft bellcrank to the lugs on the mixing unit in the Sea King helicopter is unique in that no other bolt (in the Australian Defense Force inventory) of the same material, head size, and shank diameter has the same length. On April 15, a bolt of similar description to the missing item was found in the area adjacent to the mixing unit (Figure 18). The bolt was not attached to any part of the aircraft structure or mating nut, washer, or split pin. The bolt was complete with no visible damage. A castellated nut was discovered in the grid area comprising the mixing unit on April 17. The nut was fused to a melted piece of aircraft wreckage (Figure 19), which was not normally associated with this piece in the aircraft. The nut was complete and had no damage to the internal threads. Unlike the bolt, the castellated nut for the attachment of the fore/aft bellcrank to the mixing unit is not a unique item. Further examination of wreckage surrounding the mixing unit failed to find the associated split pin. It was apparent that meticulous sifting of the aircraft wreckage debris would be required at the DSTO Laboratory in Melbourne.

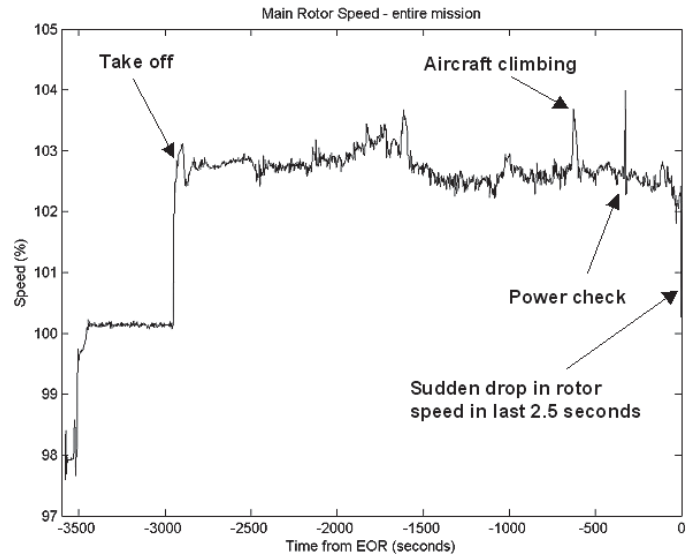
Figure 23. Graph of the main rotor speed for the entire mission.

The main rotor speed over the entire mission (from the time rotors are up to speed to the end of the CDR data) is shown in Figure 23. The main rotor was engaged at EOR-59:57 and take-off occurred at EOR-49:10. The aircraft climbed at EOR-10:30 and, at EOR-05:00, the crew performed a power check. The first indication that the crew was aware of any problem with the aircraft occurred at approximately EOR-2.5; at this point there was a vocal response from the crew accompanied by a brief increase

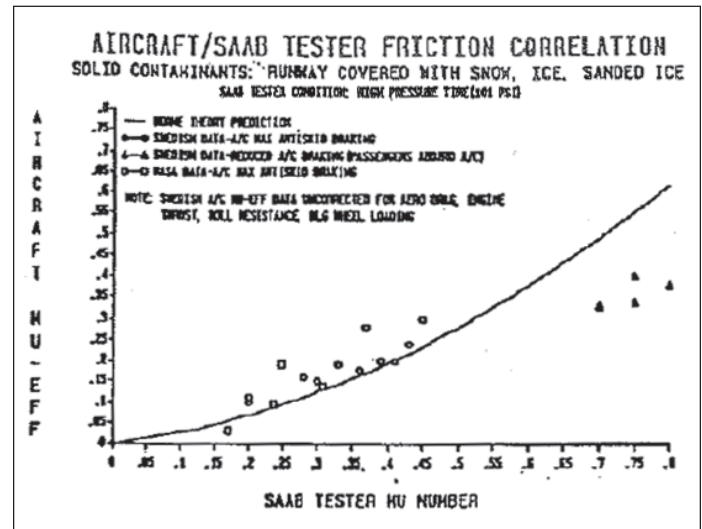
Figure 2. NASA Aircraft/SAAB tester friction correlation.

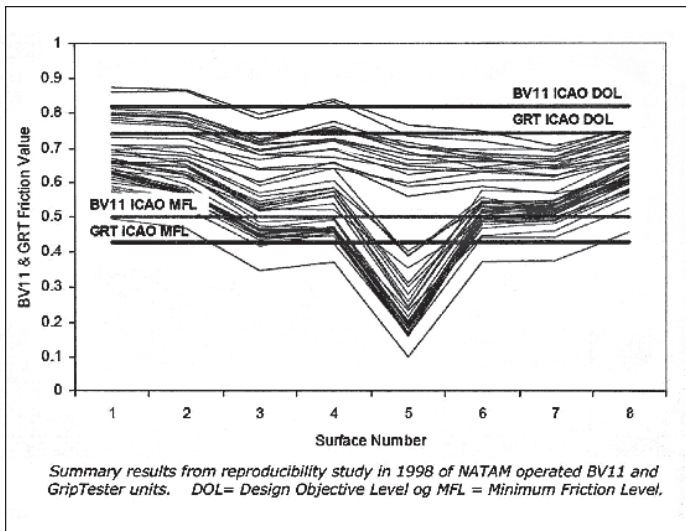
Figure 6. Norwegian wet runway FC measurement results with SKH and GRT on different MTD surfaces.

Figures 6 and 7 show some results from Norwegian wet runway testing by Avinor from testing SKH (BV-11) and GRT on different runway surface textures identified by individual surface numbers¹⁵. As can be seen from the Figure, the uncertainty is of the order of ± 0.10-0.20. Based on these test results, Avinor discontinued the practice of measuring runway friction values by use of wet runway friction measurements as per ICAO Doc. 9137, Airport Services Manual, Part 2, Chapter 3. Norway has filed a deviation to ICAO with regard to the recommended procedure of maintaining the design objective level (DOL) and the minimum friction level (MFL) for runways by wet runway friction measurements.

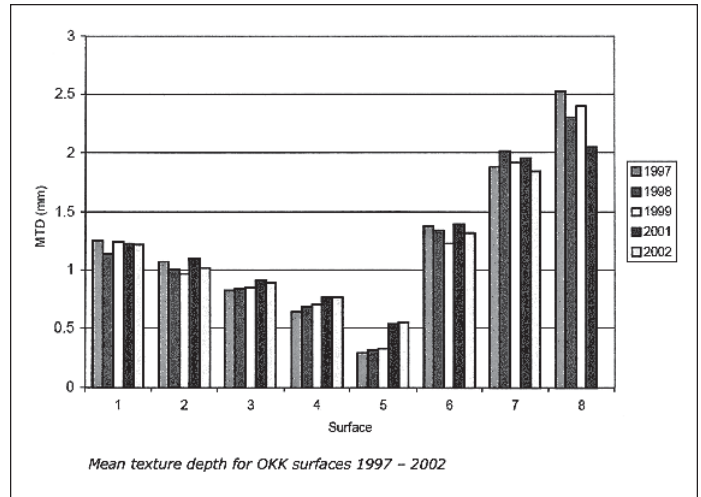
Figure 7. Norwegian Avinor MTD runway friction test surfaces (See Endnote 16).

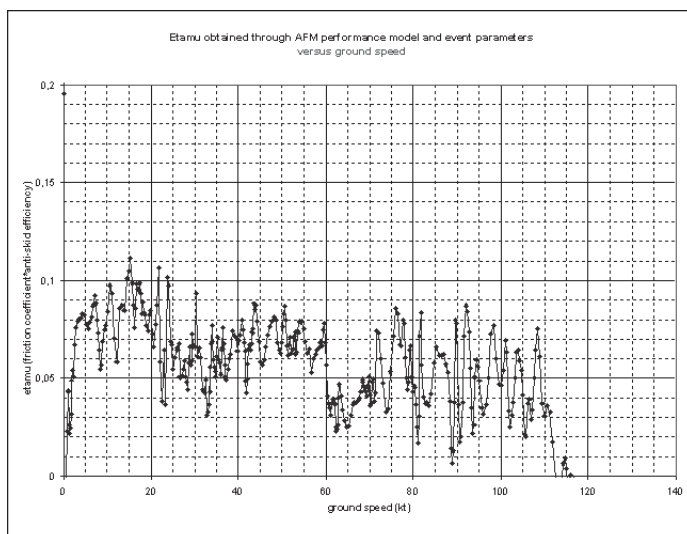
Figure 10. Effective airplane (ABC) based on FDR data from an Airbus 321.

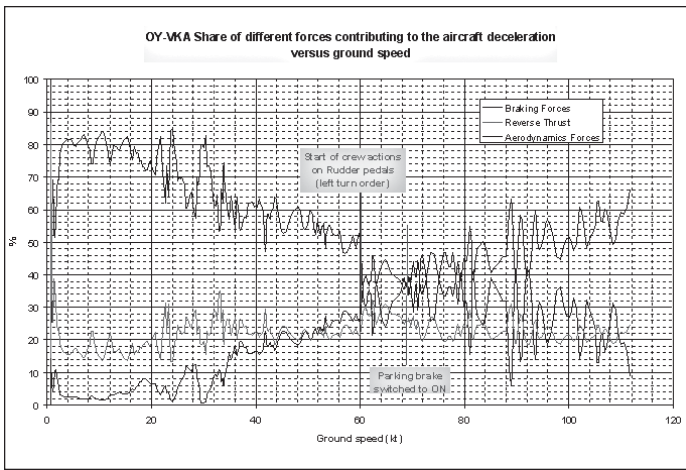
Figure 11. Distribution of the three braking forces: spoilers, reverse thrust, and wheel braking.

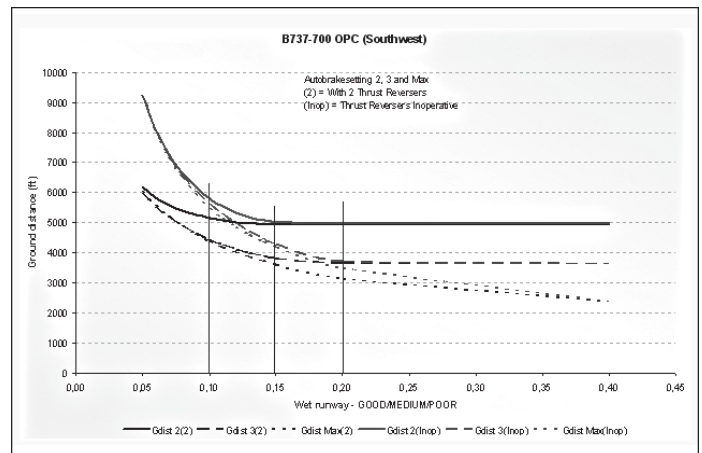
Figure 12. B-737-700 OPC-calculated ground distance with and without use of thrust reversers.

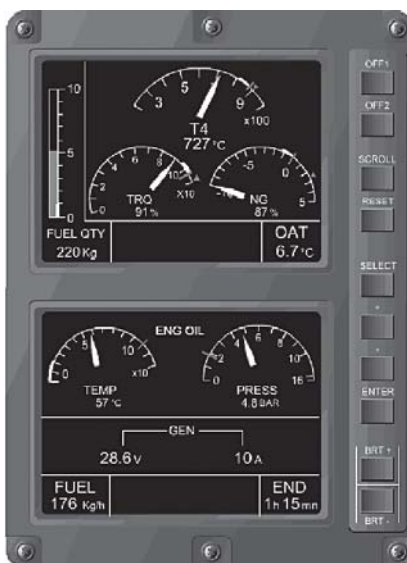
Example of VEMD display on takeoff.

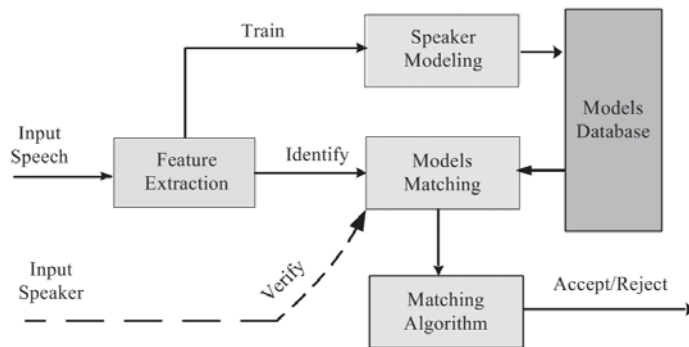
Figure 7. Framework of Automatic Speaker Recognition System.

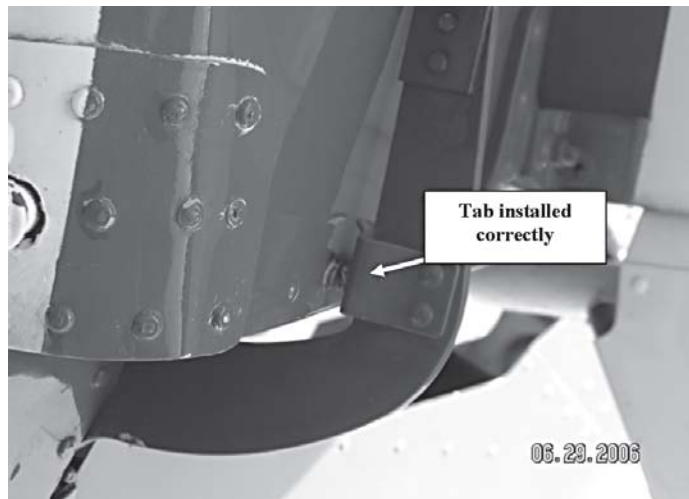
Figure 5: Exemplar Cessna 152 rudder stop installation—view of left stop plate against its stop bolt, i.e., full right rudder deflection.
