Use of Modern Technologies and Methodologies to Improve Helicopter Accident Investigation

Prof. Dr. Thomas Gogel, Seth Buttner, Airbus Helicopters
Dr. Marcus Bauer, MSimulation

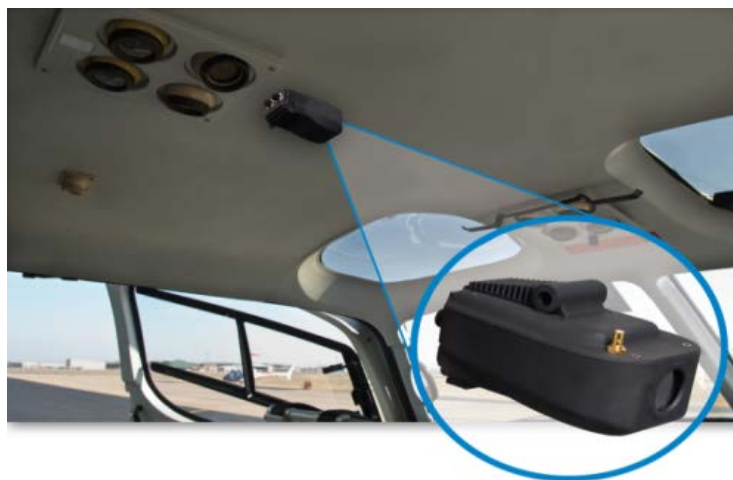
Fig 1: Vision 1000 system and mounting on cockpit ceiling on an AS350

The system features a forward facing image acquisition of the cockpit of 4 fps, with 2.2 Mega Pixel resolution, audio recording (ambient noise and intercom system), GPS position data, and an Inertial Measurement Unit (IMU) to record attitude. The weight is 300 g for the unit. A removable memory can store 4 hours of image and audio, and 200 hours of inertial data (position and attitude). The hardened internal memory is capable of storing 2 hours of image and audio, and also 200 hours of inertial data.

The unit is installed in the helicopter to provide a view on the instrument panel, and partially covering also an outside view (Fig. 1).

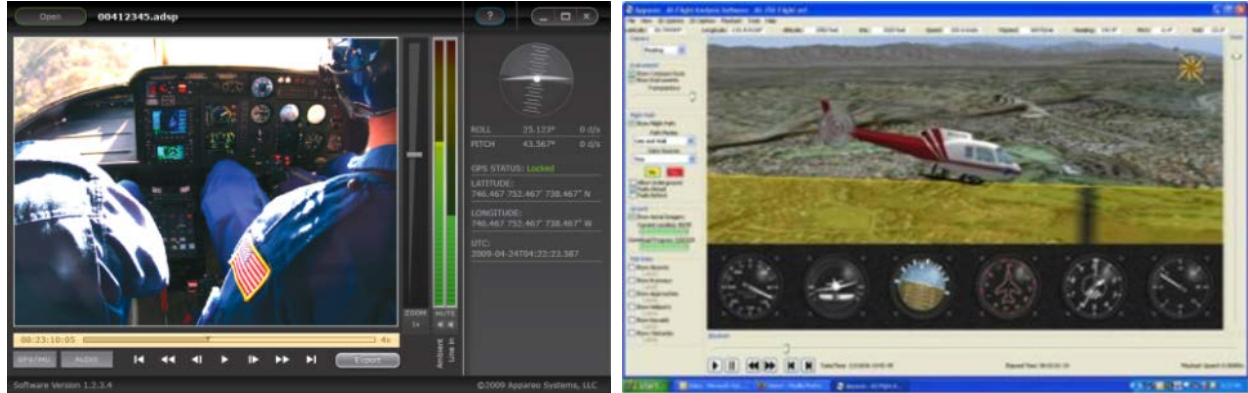
Fig. 2: Typical replay scene and 3D flightpath/attitude depiction, including instrument view

A visualization software enables a synchronized replay of images, audio and 3D depictions including a display of the flight instruments (Fig. 2)

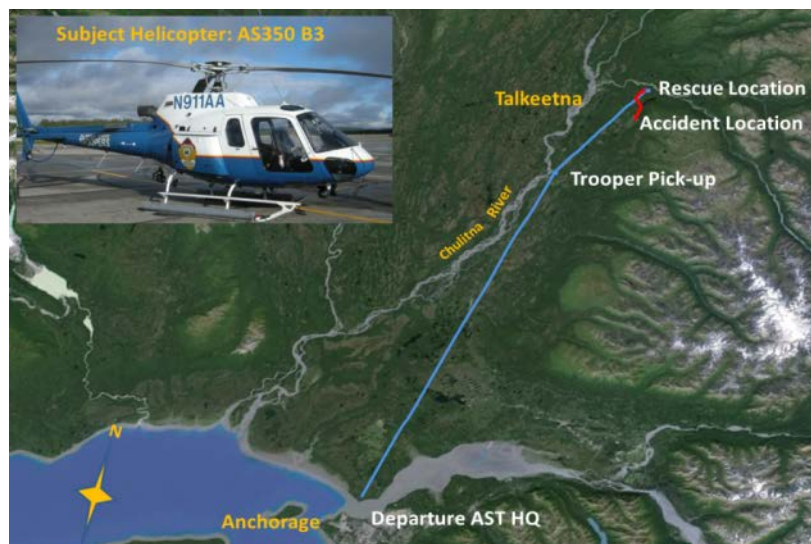
Fig. 3: Helicopter and location map of the accident flight

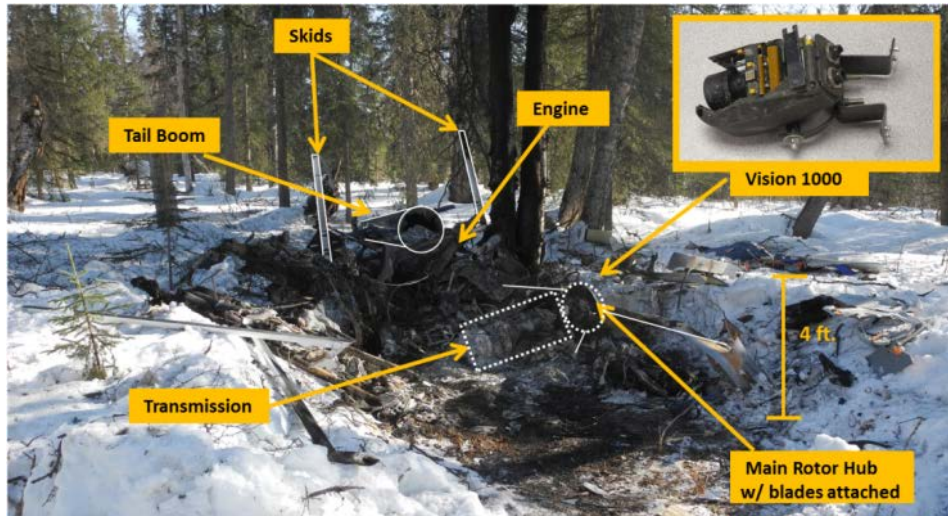
Fig. 4: Accident site and location of wreckage and Vision 1000

The aircraft was totally destroyed from the impact forces and post-crash fire. However, the helicopter's Vision 1000 unit was recovered from the rubble at the accident scene (Fig. 4). The unit had been mounted on the cockpit ceiling center between the two forward seats, but became separated from the aircraft structure during the impact event and found lying amongst the wreckage debris. Although the unit exhibited impact damage on the exterior case and power connector; the crash hardened memory module and removable card were still intact and undamaged.

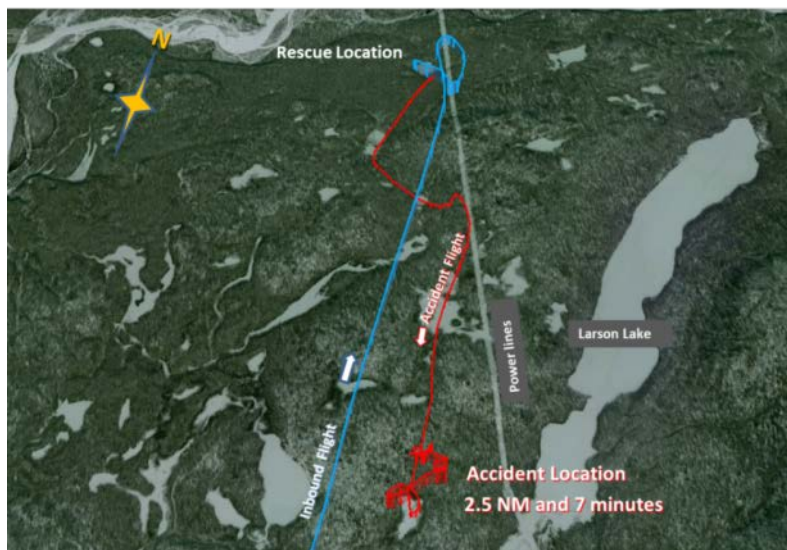
Fig. 5: Inbound flight track and Accident leg flight path

The unit was shipped to the NTSB's Recorders Laboratory in Washington D.C. where its data was downloaded, reviewed and analyzed. The extracted data was plotted by the NTSB's recorders lab in the same manner as the parametric data reports of traditional flight data recorders are processed. Several plots were created to cover the entire flight. The recovered data included approximately 2 hours of image and ambient audio data and 100 hours of parametric data. The images captured a forward looking view of the cockpit from behind the pilot that included the navigation and system instruments and displays, the master caution warning panel, and a partial view out the cockpit windscreen. Additionally it captured some of the pilot's left arm and head motions and the TFO's right shoulder (the pilot was seated in the right seat and the TFO was seated in the left seat).

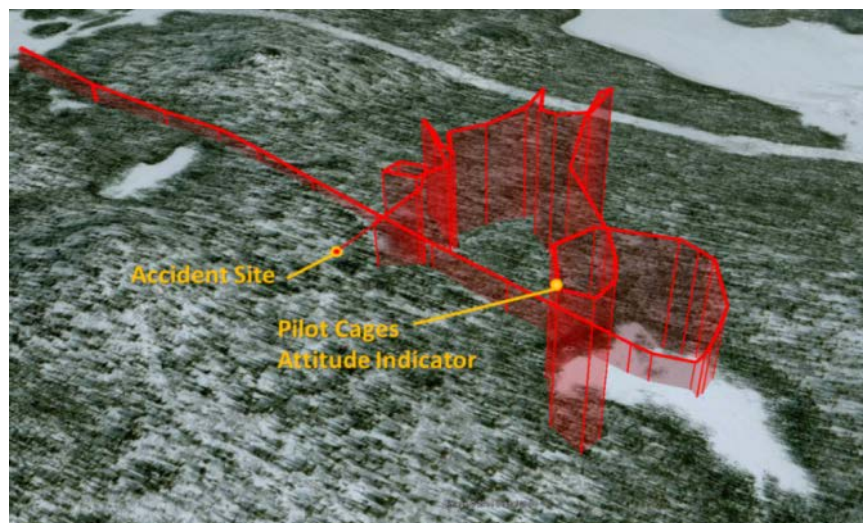
Fig. 6: End of the flight path; pilot cages gyro and accident site

With just the track information from the Vision 1000 overlaid with a mapping software, like Appareo's AS-Flight Analysis or even GoogleEarth, the investigation team was able to retrace the flight (Fig. 5 and Fig. 6). The first leg was a straight and level flight path at a fixed altitude (~1,200 feet MSL) from Anchorage to the staging area for the TFO pick-up, and again a direct leg to the frozen lake near the rescue location. However, when the mishap flight departed the frozen lake in a southwest direction, it was noted that its flight path track was at a much lower altitude (~700 feet MSL), apparently tracking a nap-of-the-earth profile. Approximately one mile out from the departure point, the pilot made an abrupt 90 degree turn to the east. This was the first indication that the pilot may have been disorientated. Shortly after the turn, it appears that the track has been re-aligning with cross-country high-tension power lines that run generally north-south. Then, the flight continued low-level with a southerly heading. After approximately two miles the flight comes to a clearing in the trees where the final stages of the track are shown making non-coordinated maneuvers in both direction and altitude. In close proximity to this area the flight track ends at the accident site on a heading of 030 degrees.

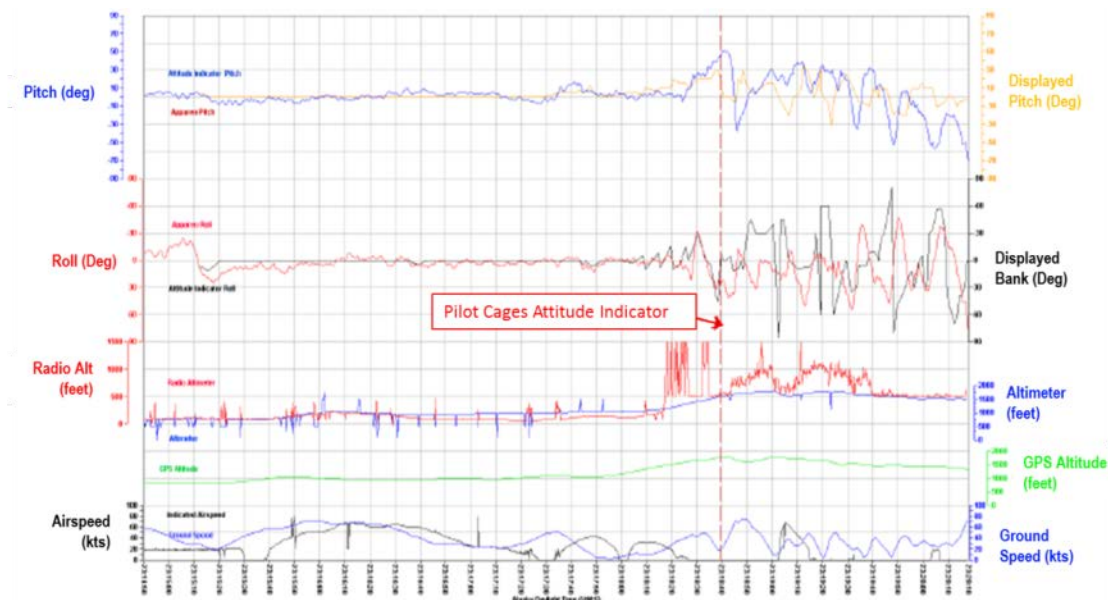
Fig. 7: Plot of last 5 Min. Combined Appareo & Image Derived Data

In Fig. 7 the parametric data confirms the pilot's action of caging of the Attitude Indicator gyro that was seen in the recorded images. This is indicated by the dashed red vertical line.

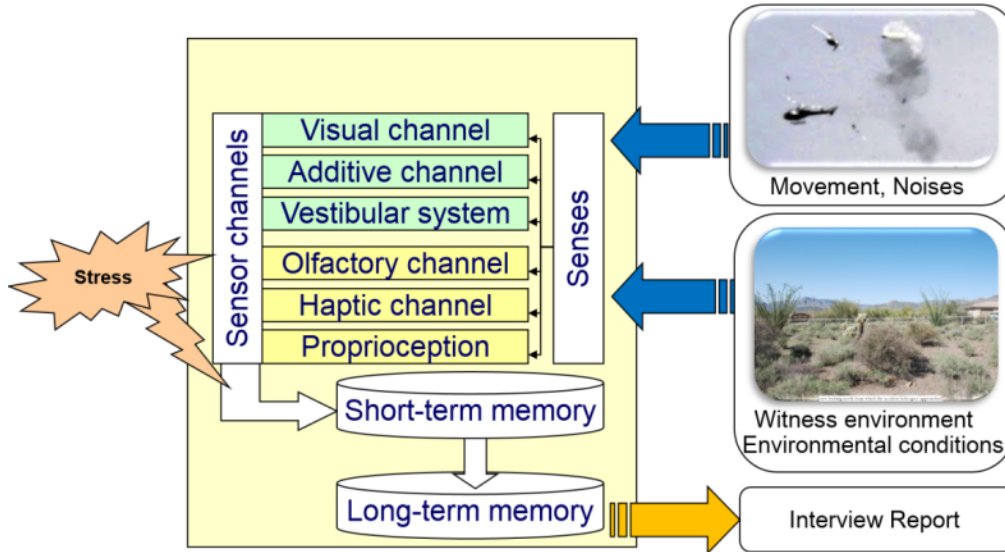
Fig. 9: Witness awareness and memory [5]

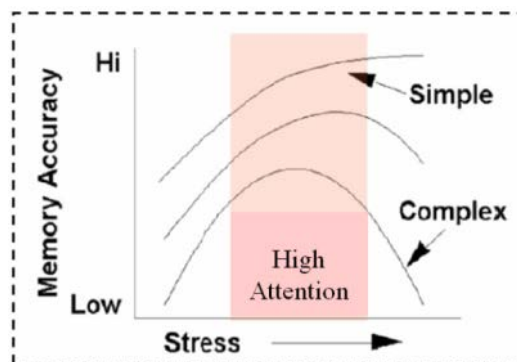
Fig. 10: Human memory and influence of stress [3]

The accuracy of a testimony has been differentiated between a simple (linear flight, in example an aircraft flying by) and a complex observation (dynamic flight, in example an acrobatic air show flight with many manoeuvres). According to psychology studies, Fig. 10 shows that the memory accuracy of simple and complex observations differs with higher stress that occurs to the eyewitness.

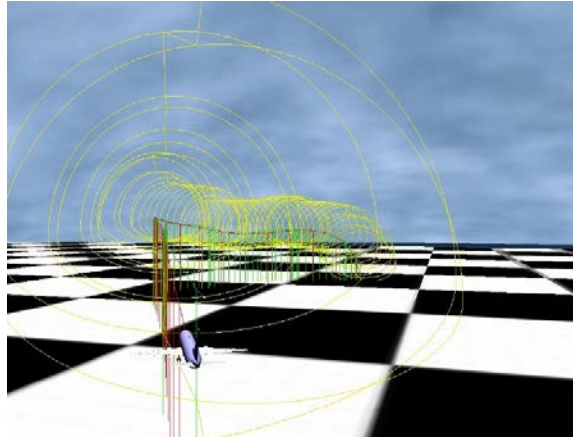
Fig. 11: Approximated flight path (red) with error tunnel (yellow) [5]

As shown in Fig. 11, a yellow error tunnel can be visualized to localize the area where the aircraft was flying with the utmost probability. This approximation considers errors like the accuracy of witness testimony, GPS accuracy, accuracy of location of reference objects, witness area position and photo camera adjustment. A final reconstruction is calculated based on Newton's iterative method and the total residuum declares the maximum error of the reconstructed flight path.

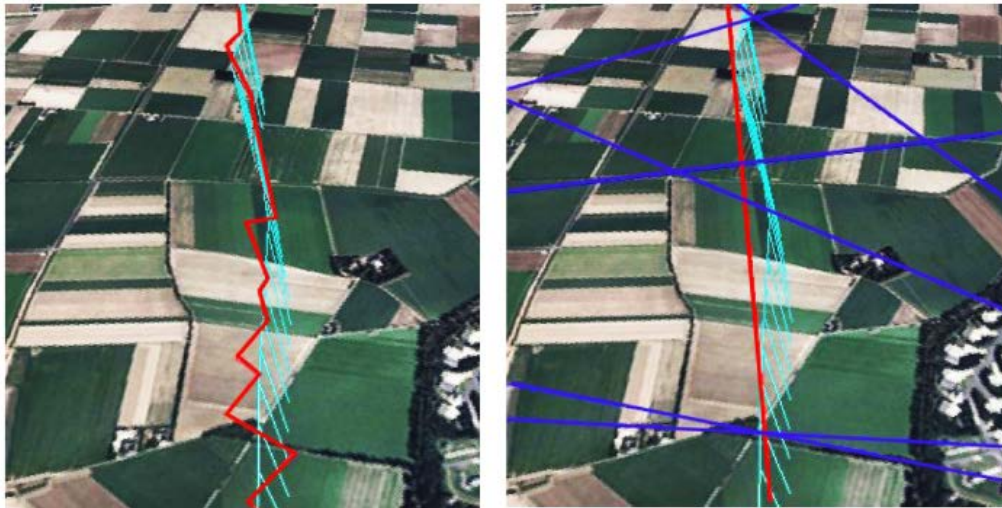
Fig. 12: Reconstructed flight path, approximated (left) and Newton's iterative method (right) [5]

The error calculations had been validated within a trial as shown in Fig. 12, the radar data in light blue and the reconstructed flight path in red. The left image shows the prior rough calculation and the right image the result of the Newton's iterative method with weighted witness lines of sight shown in dark blue.

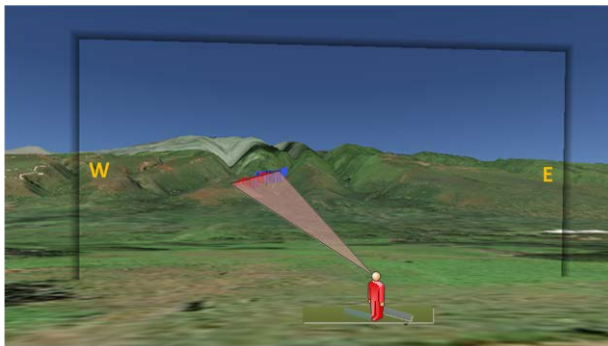
Fig. 13: Illustrated observations of Red Witness

To illustrate the usefulness of the method, a flight path of an event has been reconstructed using information obtained from two witnesses ('red' and 'blue' witness). The witnesses described an observed flight path that depicted a relatively horizontal track, seemingly from east to west, only slightly descending as it moved across the horizon from their vanish point, Fig. 13 and Fig. 14.

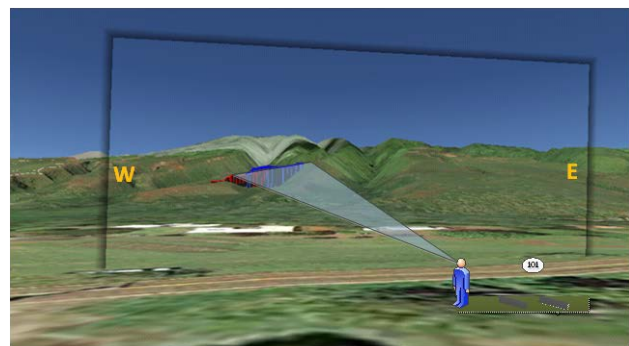
Fig. 14: Illustrated observations of Blue Witness

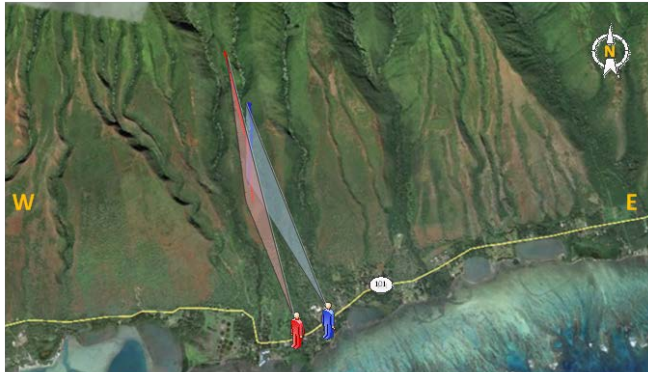
Fig. 15: Actual flight path is north to south

It is obvious that both witnesses' observation are matching, increasing their credibility; and secondly, that in reality the observed flight path once mapped into the 3 dimensional mountainous terrain was not from east to west, but in fact from north to south, as seen in the top down view of Figure 15. Without the use of this method the written statements alone would have told a wrong story.
