## ISASI 2011

### AF447 Underwater Search and Recovery Operations A Shared Government-Industry Process

Olivier Ferrante (BEA)<sup>1</sup>, Michael Kutzleb (Phoenix International)<sup>2</sup> and Michael Purcell (WHOI)<sup>3</sup>

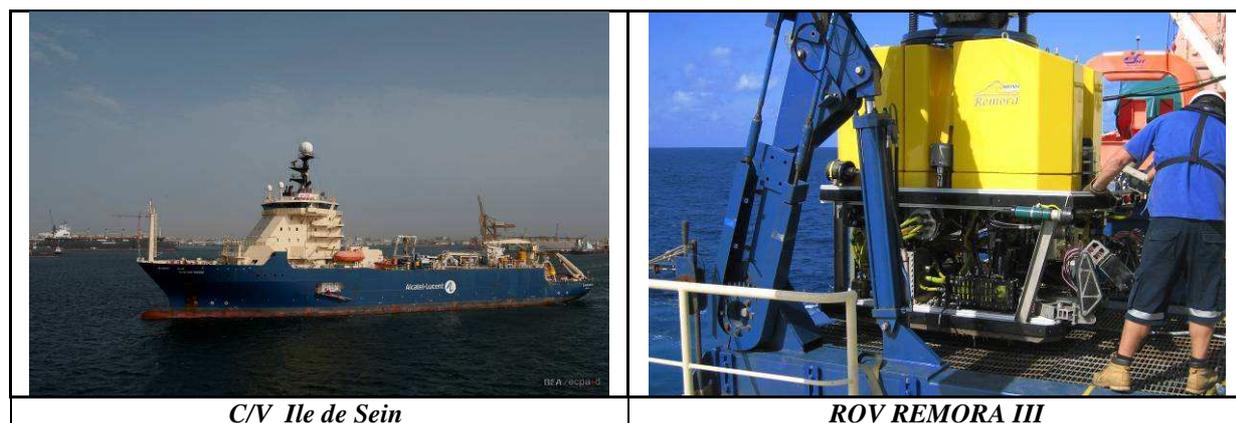
To undertake the fifth phase of maritime operations, the BEA ultimately selected the cable vessel C/V *Ile de Sein* operated by Alcatel-Lucent and Louis-Dreyfus Armateurs (LDA), equipped with the REMORA III Remotely Operated Vehicle (ROV) from Phoenix International that can operate at maximum depth of 6000 meters.

Figure 8: Phase 5 ship and equipment

The complete system is comprised of a vehicle, fiber optic cable and winch, a launch/recovery system, and operations and maintenance vans. The REMORA's design strikes a balance between power and capability, meets a wide range of operational requirements, and is sized for air transport and rapid mobilization on vessels of opportunity anywhere in the world. This small and powerful vehicle has axial lateral thruster geometry that allows precisely controlled maneuvers in the tightest of spaces and minimizes the probability of entrapment or entanglement. Given the REMORA's size and weight, added benefits include lower transportation and support vessel costs. The REMORA was installed on the C/V *Ile de Sein* in Las Palmas, Canary Islands.

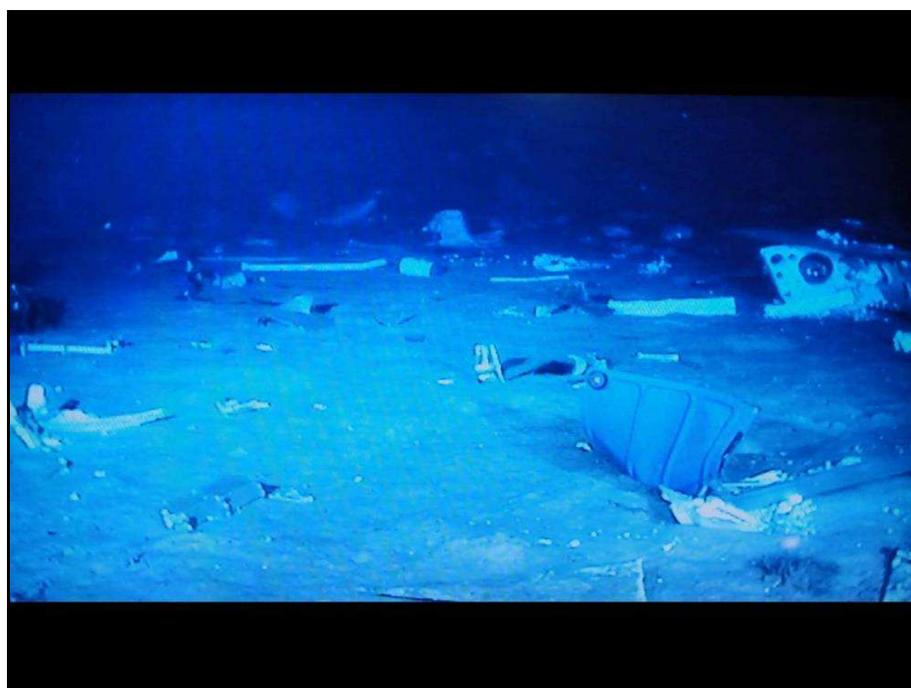
When the accident site was discovered, it was observed that, apart for some large debris, the airplane was very fragmented. The small size of the flight recorders represented a challenge to overcome given the sheer number of items of debris scattered on the sea floor, as shown in the following picture (figure 10).

*Figure 10: Debris scattered on the seafloor*
