Towards the next generation of HUMS sensor

Dr Matthew Greaves¹ (MO5700)

This paper describes work undertaken as part of EASA project 'EASA.2012.OP.13 VHM'. This is an introduction to the project, and as such will outline the project phases, the work undertaken and some of the achievements.

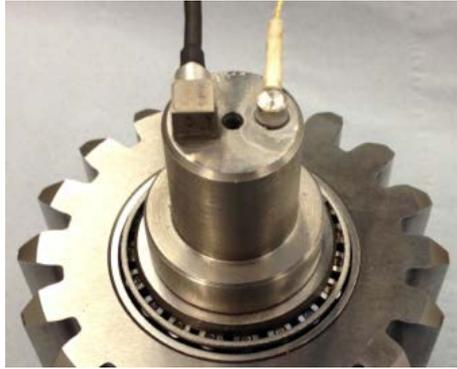
A miniature triaxial accelerometer was mounted on the idler shaft next to a miniature AE sensor as shown in Figure 2.

Figure 2. Triaxial accelerometer and AE sensor mounted on idler shaft

The piezoelectric-wafer active sensor (PWAS) is a small sensor often used for NDE testing and condition monitoring [37]. A 7 mm diameter, 0.2 mm thick sensor was selected for comparison. The s9225 sensor is a miniature (3.6 mm x 2.4 mm) acoustic emission sensor from Physical Acoustics weighing less than 1 gram, with an operating range from 300 kHz upwards. The Physical Acoustics Pico sensor, is a miniature (5 mm diameter, 4 mm height) acoustic emission sensor weighing less than 1 gram. This was the sensor used in the lab-scale testing and is shown in Figure 2.

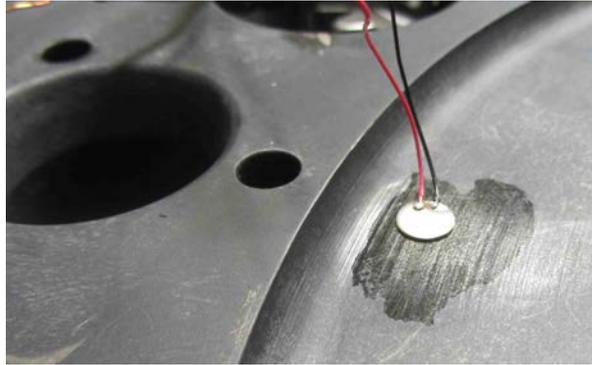
In its current form, the wireless transfer system is only able to support a single sensor, and therefore it was necessary to select a single location at which to attach the sensor. One of the restrictions to the positioning of the sensor was the need to keep the sensor clear of the main upper face of the planet carrier to allow it to be used as pressure face when changing the planet gears. The sensor was bonded in a position on the 'dish' of the planet carrier, as shown in Figure 4 and Figure 5 below.

Figure 4. Sensor position on dish of planet carrier

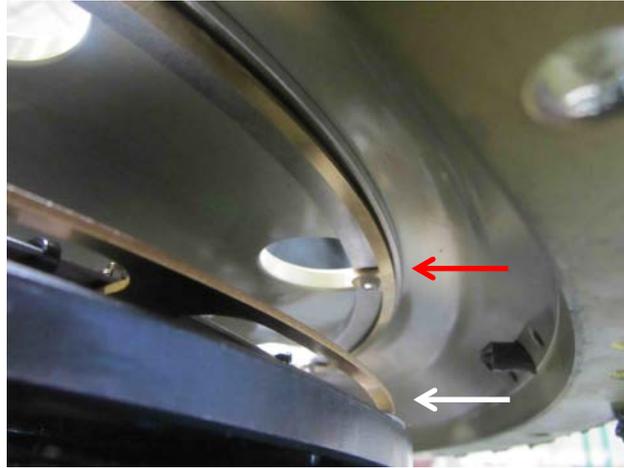
Figure 6 shows the two coils in position before the top cover was pressed onto the planet carrier.

Figure 6. Coils in position before rejoining top cover (static coil red arrow, moving coil white arrow)

Electrical isolation of the coils from the mounts and surrounding metallic structure was achieved through the use of nylon washers and bushes. The main electrical difference between the lab-scale coils and the full-scale coils is their proximity to metal, and in particular, the mounting ring which forms a "shorted turn". The proximity causes a drastic reduction in inductance, which then requires an increase in loading capacitance to maintain tune at 13.56 MHz. In addition to the reduction in inductance comes a large reduction in the Q factor of the coupled circuit. Fortunately, the electrical power transfer requirement in the gearbox was significantly reduced compared to the prototype, as the spacing between the coils was relatively close. This meant that even with reduced Q, there was enough power transferred to run the opamp buffer circuit. One advantage of reduced Q factor is that dispersion is reduced in the baseband signal. This is because the steepness of the phase/frequency response is reduced in the vicinity of the resonance at 13.56 MHz.
