**Use of sUAS in Developing  
Photogrammetric Model for Wind Simulation**

Michael Bauer, William English, and Michael Richards - National Transportation Safety Board

International Society of Air Safety Investigators (ISASI)

ISASI 2018 Seminar Dubai

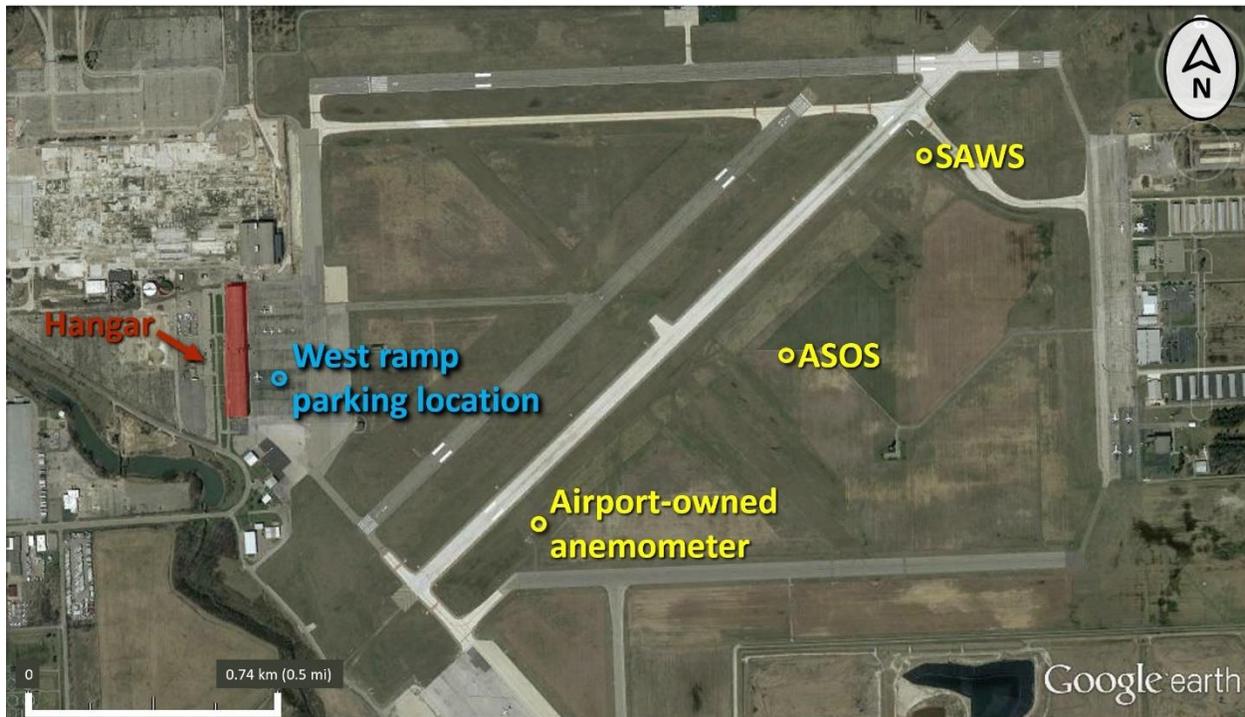
Figure 1. Airport map showing the relative locations of the hangar (dimensions highlighted in red), the accident airplane’s parking spot, and various weather observing equipment.

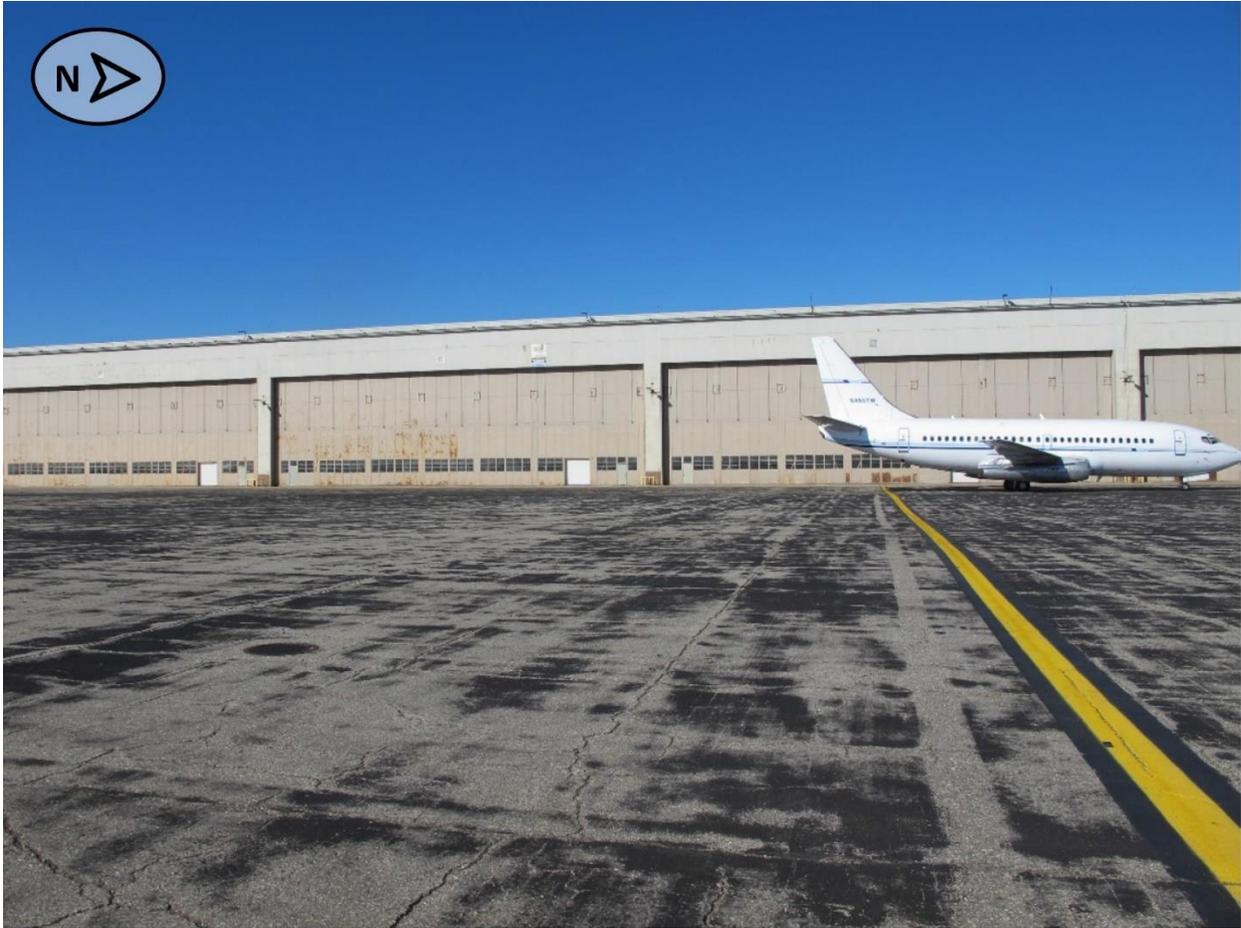
Figure 2. View looking west toward the hangar, taken from the approximate parked location of the accident airplane. (Airplane in picture is much closer to the hangar).

Although the ASOS anemometer provided reliable, authoritative airport wind information while it was operative, the airplane had been parked facing north immediately downwind from (on the east side) of a large hangar. The hangar was more than 0.4 kilometer (km) (0.25-mile) long and equipped with duct work, chimneys, ladders, and detailed architecture; it was also surrounded by bushes, trees, and varied terrain near a retention pond. All of these characteristics would likely disrupt windflow. Due to the size and characteristics of the hangar obstruction and surrounding terrain, as well as the distance of the airplane’s parked location from the ASOS, investigators suspected that any available airport wind data from the ASOS likely did not represent the localized airflow at the airplane’s parked location. (See figure 2 [NTSB 2017d 66].)

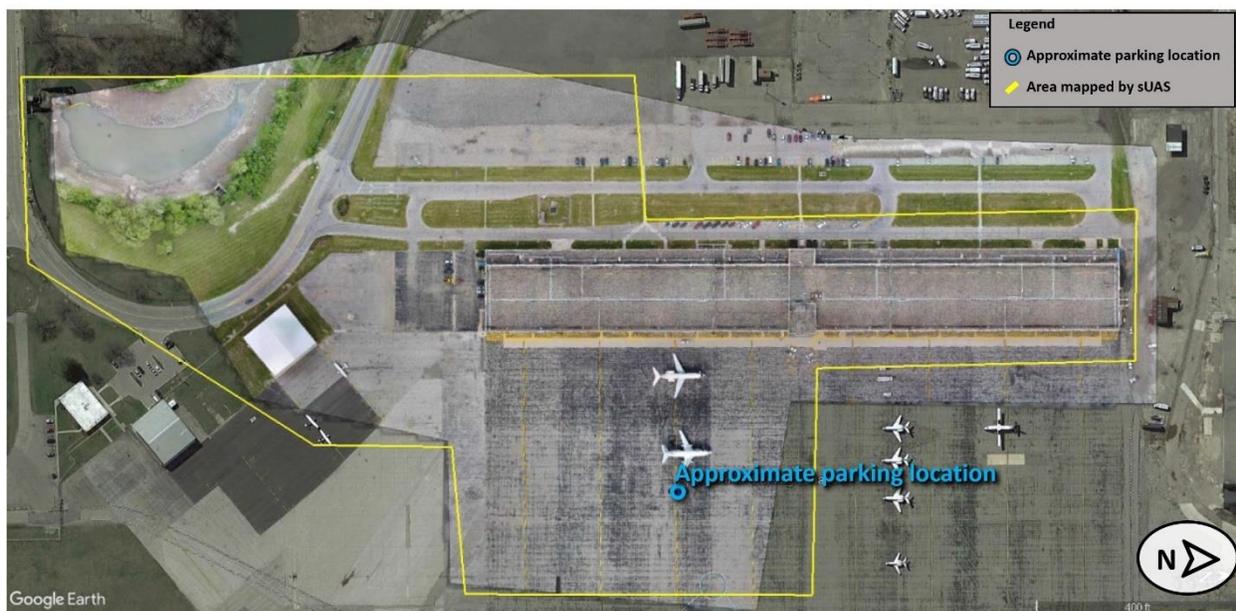
Figure 3. Orthomosaic image showing planned sUAS mapping area in yellow.

background, such as sky and ramp. The team positioned additional grids over the terrain and a small hangar to the south and east of the main hangar (see figure 3 [NTSB 2017a, 4]). Pre-planning the flight missions resulted in an estimate of more than 1 hour of expected flying and more than 1,000 images.

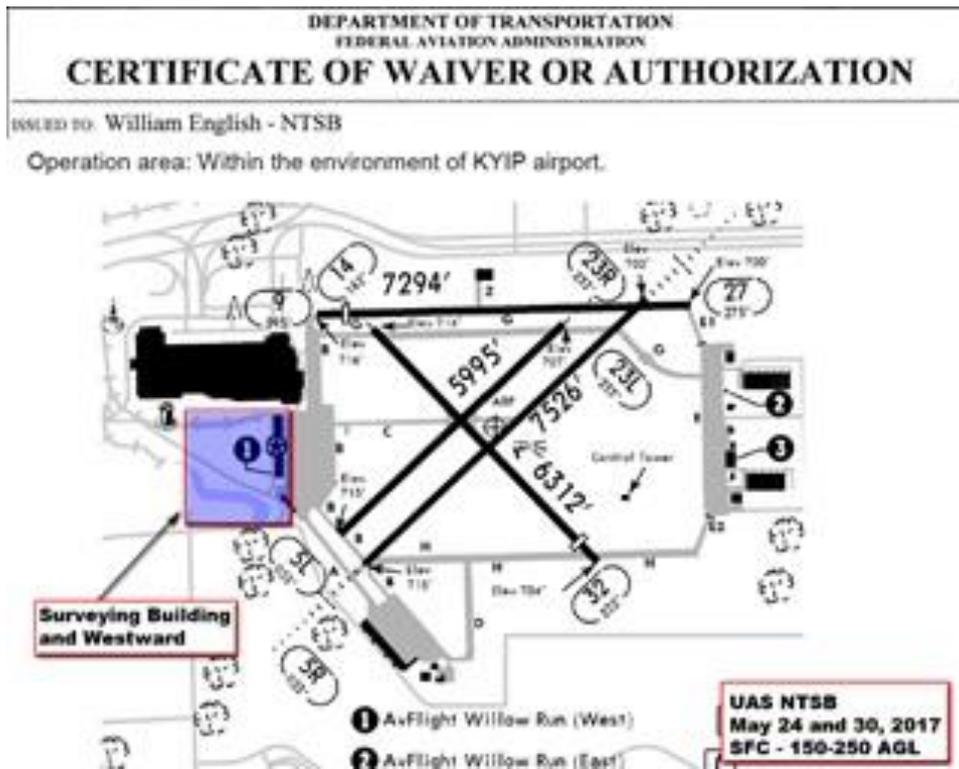
Figure 5. eCOA showing the authorized sUAS operations area and altitudes.

Fortunately, with excellent FAA cooperation, the eCOA was developed and issued with ample lead time before the mission. The NTSB UAS Program Lead provided a detailed map of the operating area and proposed flight plans (see figure 5), and FAA headquarters personnel coordinated with YIP air traffic control (ATCT) personnel to develop procedures for the flights. These combined efforts determined that operations under the eCOA were subject to the following requirements:

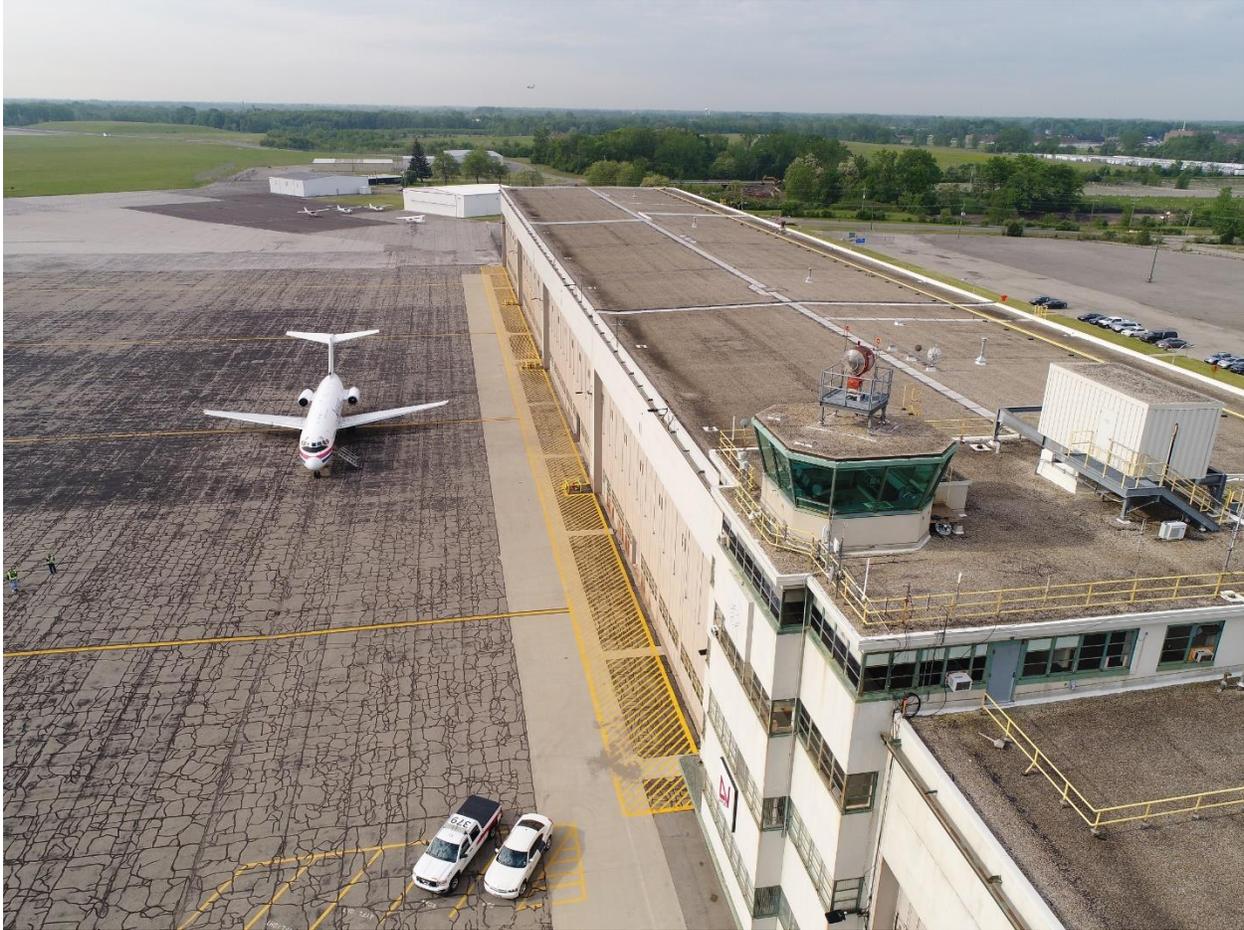
Figure 6. Image captured by the drone during the mission. (Note business jet on approach to runway 5.)

UAS Team members later asked ATCT personnel if they could see the drone when it was flying. The tower controller stated that they had been looking for it on each sortie, but never saw it, and noted also that no pilots reported seeing it. The Cessna pilot also stated that he did not see the drone. This information regarding the difficulty (or inability) of ATCT personnel and pilots of manned aircraft to see drones served as a good reminder to the RPIC and VO regarding the importance of maintaining required VLOS with the drone and communication with each other, ATC personnel, and, if needed, pilots of manned aircraft when operating in an active airport environment (see figure 6).

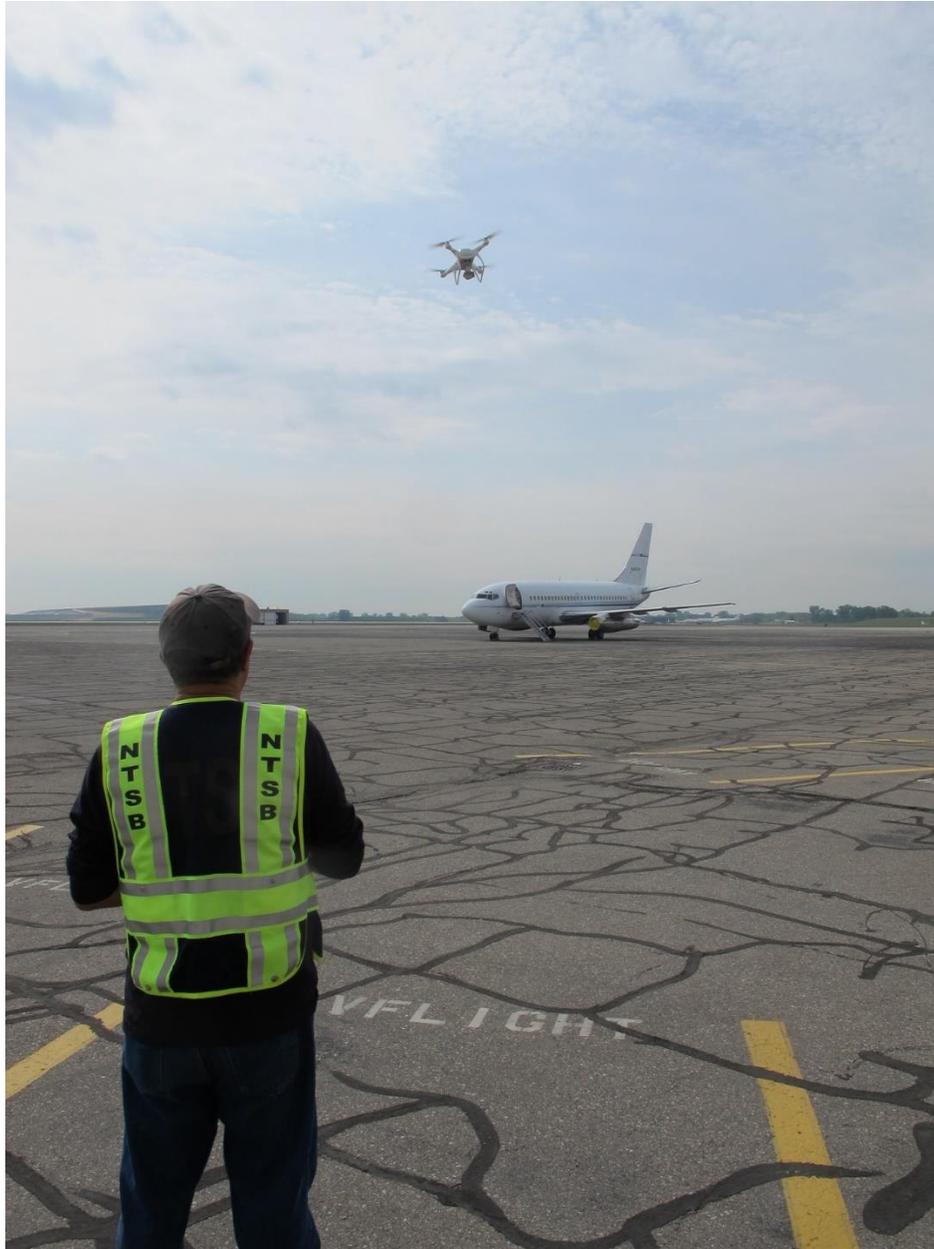
Figure 7. RPIC flying a Phantom 4 Pro drone during a mission sortie.

backup. The primary aircraft was a DJI Phantom 4 Pro (see figure 7) equipped with an FC6310 camera using the Sony Exmor 1-inch (in) (2.5 centimeter [cm]) complementary metal-oxide semiconductor (CMOS) sensor, which provided still photo resolution of 20 megapixels (mp) in .jpg or .raw format. The camera was equipped with a mechanical shutter, which was ideal for use in capturing images via drone to support a photogrammetry application. (Mechanical shutters avoid introducing image errors and distortions that can result from the use of an electronic rolling shutter from a moving drone.)

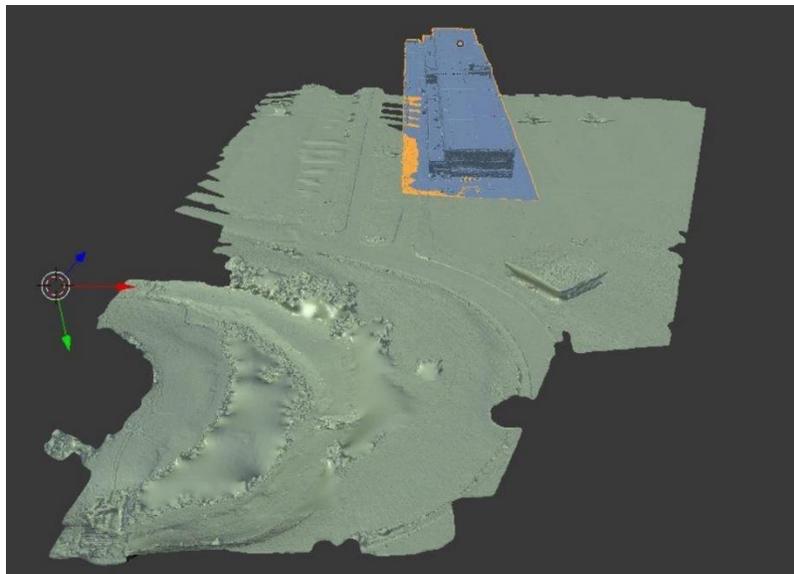
Figure 8. Three-dimensional model of hangar and surrounding terrain developed in Pix4D using imagery captured by the sUAS.

Two separate final mesh files (one of the main hangar building structure and the other of the surrounding terrain, trees, brush, vehicles, and other nearby structures) were exported as a 3D model in .obj file format and provided to the CFD wind simulation specialist at Boeing (see figure 8 [Boeing 2017, 2]).

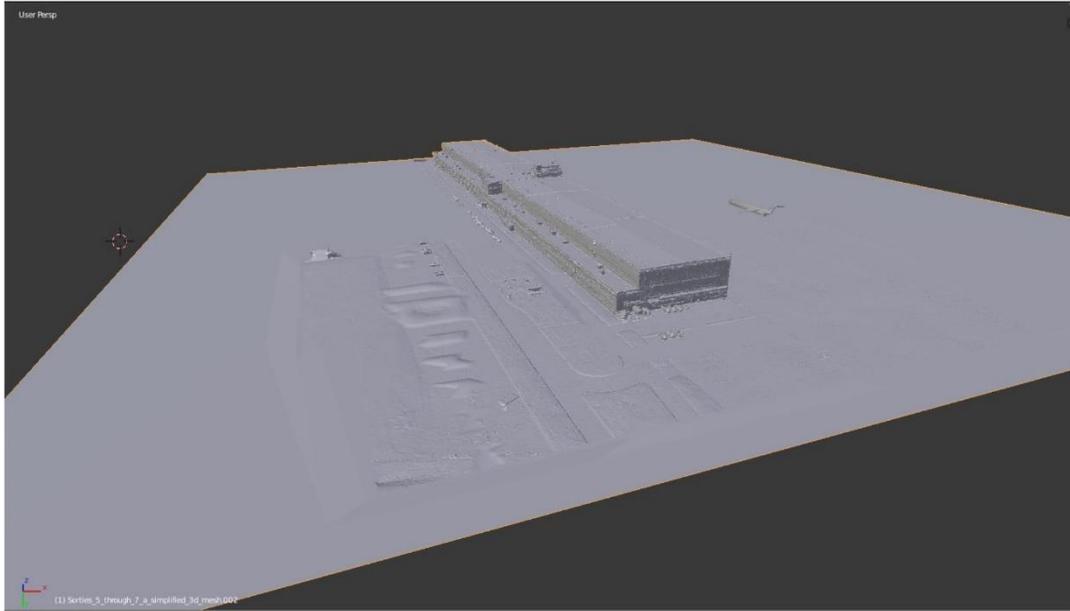
Figure 10. Final 3D mesh used for CFD model wind simulation.

The Boeing CFD specialist found that, before the 3D model mesh files provided by the NTSB UAS Team could be used effectively in OpenFoam (a widely used open-source CFD modeling software), more processing was needed (Boeing 2017, 1). The specialist combined the mesh files and used the open-source software Blender to manually make the combined mesh “watertight” with essentially no holes. The watertight combined mesh file was further processed using an OpenFoam utility to apply settings that allowed for model stability (Boeing 2017, 1). The final mesh used for the CFD model wind simulation was a blend of the combined drone mesh data inserted into a 500 by 500 m flat plane. (A flat, smooth plane was necessary along the model boundaries for model stability.) Finally, an MD-83 model was positioned in the mesh to represent the parked location of the accident airplane (see figure 10 [Boeing 2017, 2]).

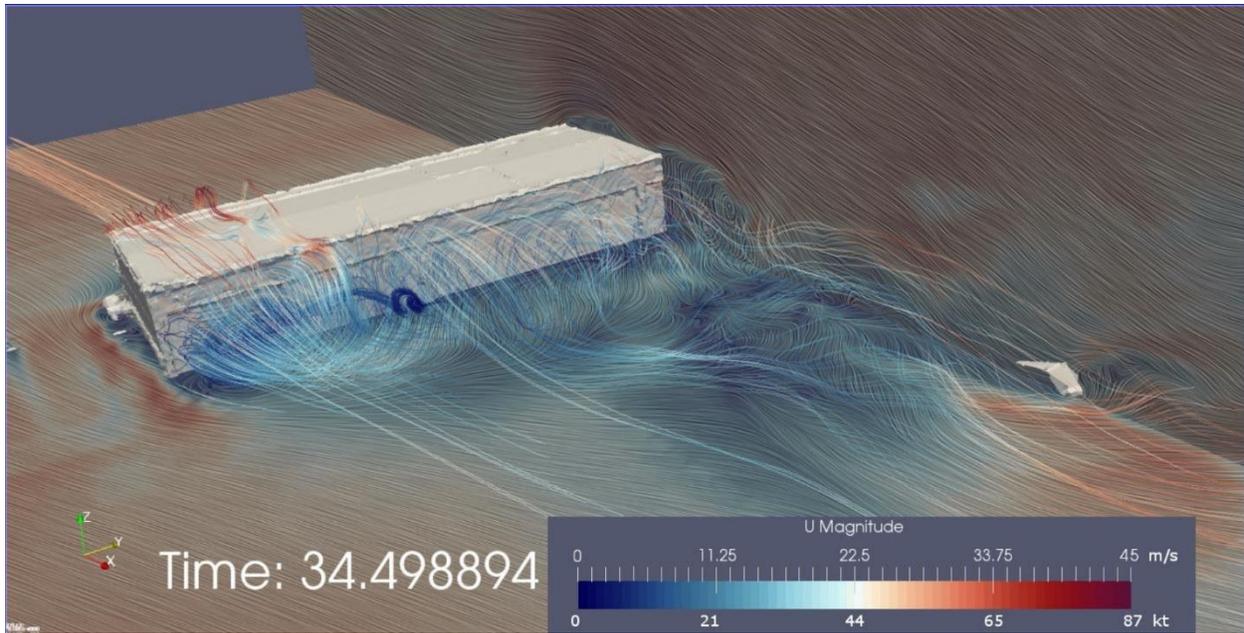
Figure 11. Three-dimensional visualization of wind simulation results for a discrete time showing turbulence generated downwind of the hangar. Note: Accident airplane’s elevators can be seen on lower right side of image.

The wind simulation revealed that, at the accident airplane's parked location, the elevators could have been subjected to hangar-generated turbulent flow that included a small-scale 30+ m/s (58+ kts) gust moving over the airplane (Boeing 2017, 10). According to the simulation, another possibility included small-scale -15/+15 m/s (-29/+29 kts) vertical vector couplets that moved horizontally toward the airplane with the turbulent gusts and waves that were being generated downstream of the hangar (Boeing 2017, 11). Figure 11 (Boeing 2017, 10) and figure 12 (Boeing 2017, 15) provide visualizations of select wind simulation results.

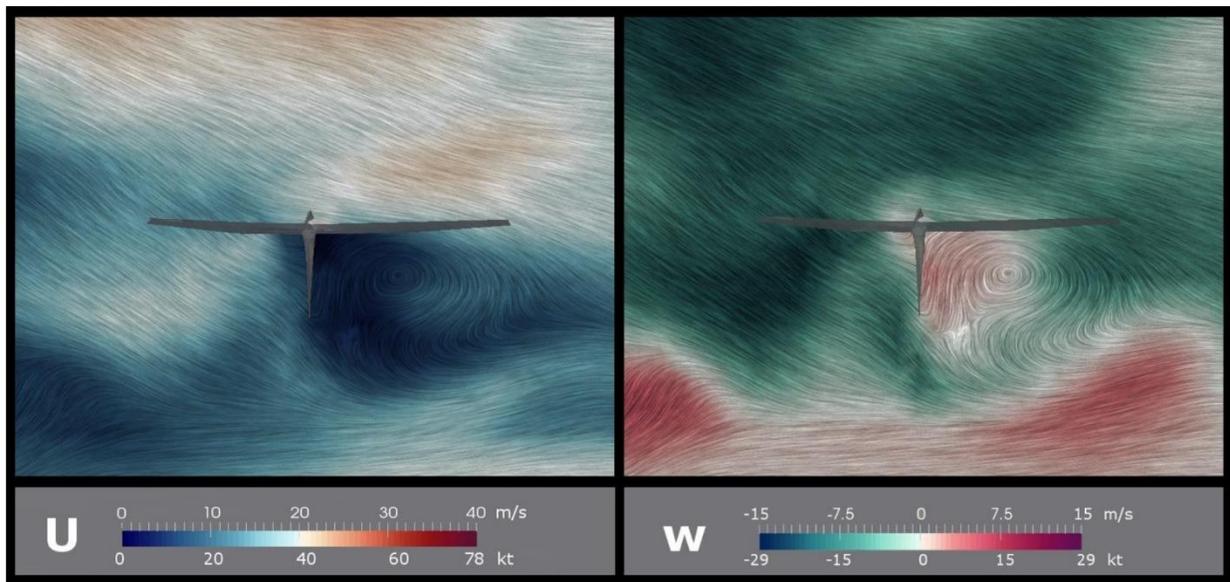
Figure 12. Vertical cross-section visualization of wind simulation results for a discrete time showing horizontal (“U”) and vertical (“w”) wind magnitudes in area of the accident airplane’s elevators.

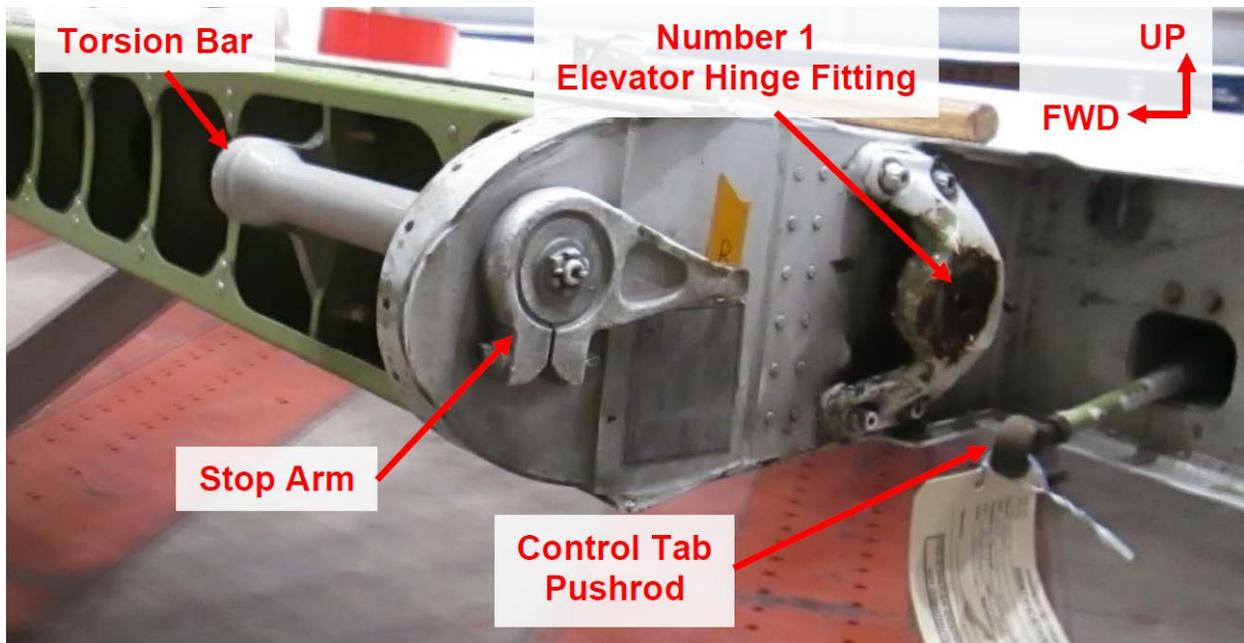
Figure 13. Elevator stop arm and torsion bar assembly.

As described previously, the inboard linkage components of the right elevator's geared tab were locked in an overcentered position and bent outboard, effectively jamming the right elevator and preventing airplane pitch response and rotation during takeoff. When the airplane is parked on the ground, the elevators are free to move independently within the confines of the upper and lower mechanical stops, which inhibit elevator movement in each direction. Although the elevator is designed to distribute increased loading via a torsion bar and stop arm assembly when the elevator is in contact with a stop, excessive loading can result in excessive torsion bar deflection, increasing the likelihood that the geared tab linkage could travel to an overcentered position (see figure 13).
