Unstabilized take-off techniques on A340-300

Vincent Ecalle, Bureau d'Enquêtes et d'Analyses (BEA) pour la Sécurité de l'Aviation - France

Flight AF423 Serious Incident

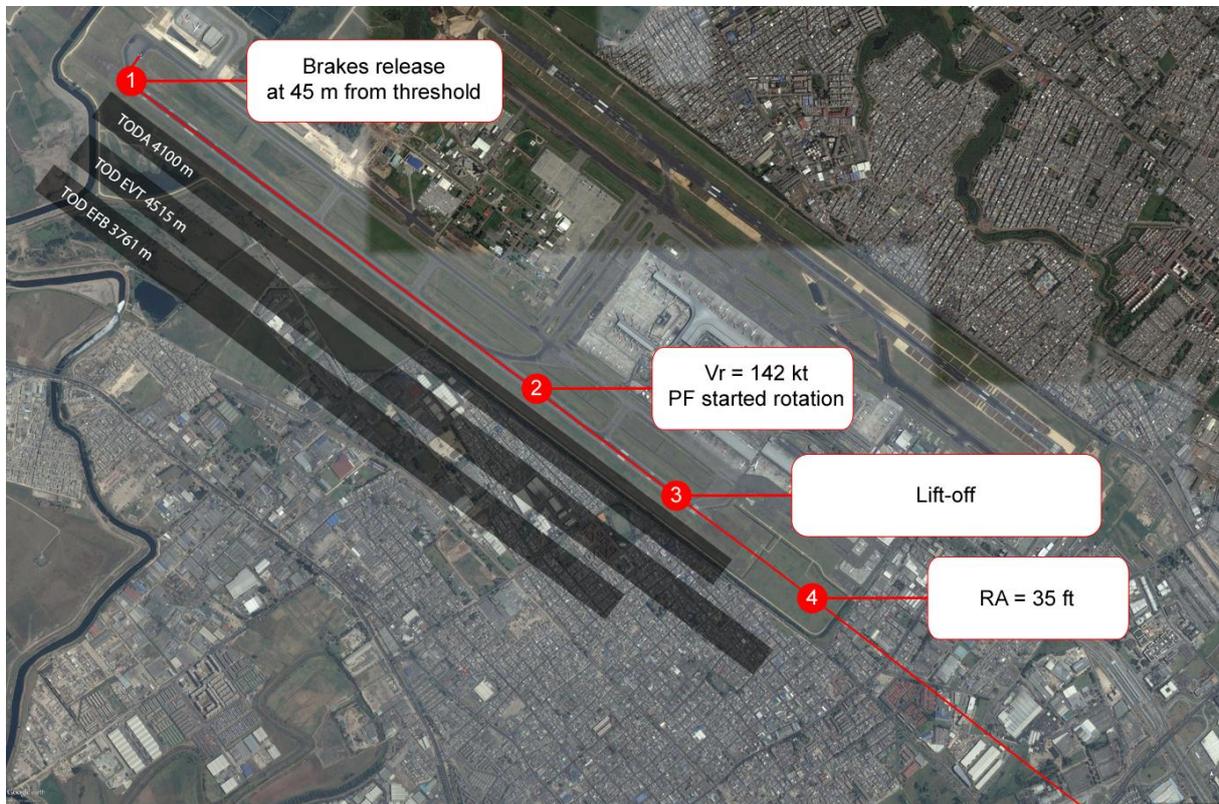
Figure 1: Take-off distances

This serious incident occurred on 11 March 2017 to an Airbus A340-300 operated by Air France-KLM (flight AF423) during take off from the airport of Bogota Eldorado (Colombia). It was a scheduled flight to Paris CDG (France) with 268 passengers and 13 crew members on board. The take-off was conducted at night on runway 13R with a length of 3800m and a clearway extension (CWY) of 300m. When the captain initiated rotation at VR, the aircraft had already rolled 2760 meters from the runway 13R threshold. The rotation rate of the aircraft was low and all three crew members reported hearing the “PITCH PITCH” audio alarm. When the main landing gear lifted off, the aircraft was only 140 meters from the opposite runway threshold. The aircraft overflew the opposite runway threshold at a radio-altimeter height of 6 ft and only had a 12 ft margin with the first obstacle (the ILS antennas).

The investigation showed that the serious incident resulted from the pilot's inadequate rotation technique that extended the take-off distance by 424 m from the certified theoretical take-off distance that included the regulatory safety margins under the operational conditions of the day. This had resulted in a significant increase in the risk of longitudinal runway departure or collision with obstacles.

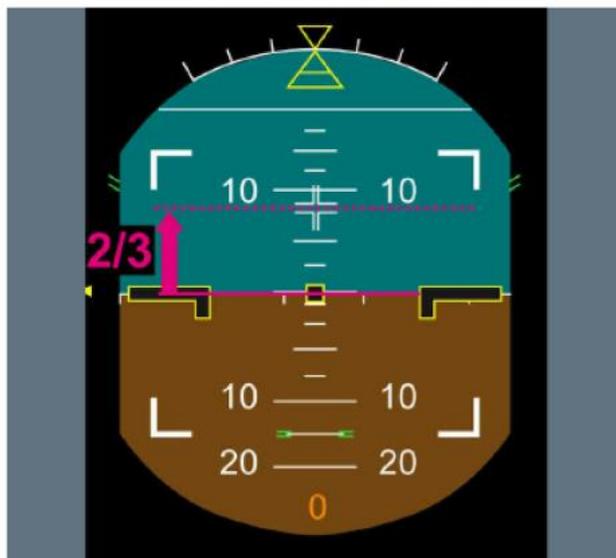
Figure 2: Extract of the FCTM – Standard Operating Procedures - Takeoff

In training, during taxi, the crew may calibrate the appropriate effort and displacement for the initial stick input for rotation (2/3 back-stick), by pulling aft on the stick and observing the position of the stick cross symbol on the PFD, compared to the stick position reference square.

Side Stick Input Calibration During Taxi

Note: the cross is not to be used by PF during the takeoff, whereas the PM can check the validity of the PF initial stick input.

The investigation showed that had the pilot applied the initial nose-up command, typical value recommended by the FCTM (2/3 rear deflection) and maintained it, it would have been not sufficient to achieve the rotation rate of 3 °/s mentioned in the same document, which was the rotation rate used in the certified performance model.

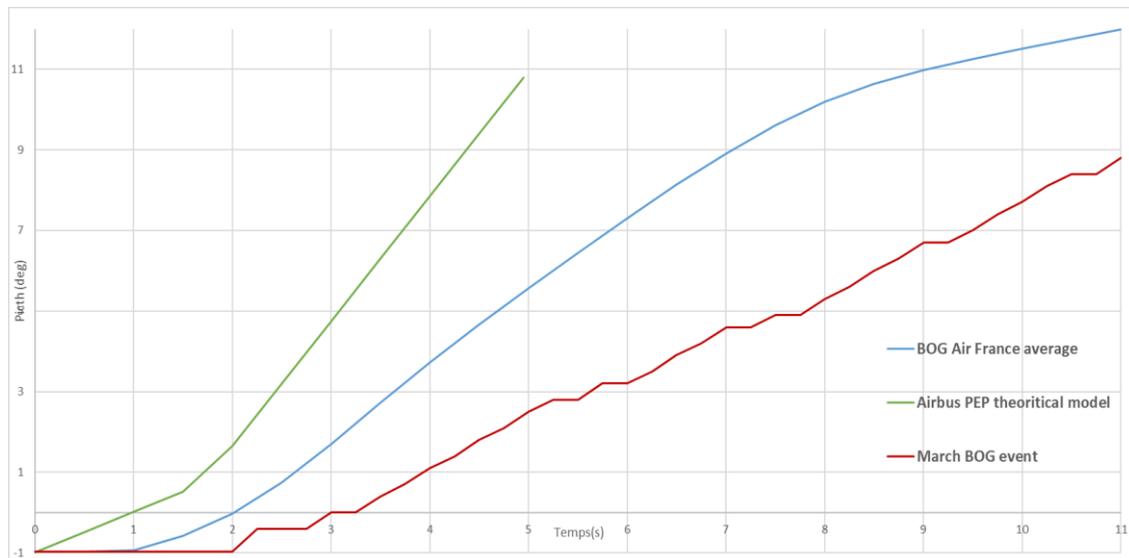
Figure 3: Air France curves

For this investigation, Air France and Lufthansa conducted a FDM study on the average rotation rates of their crews of from flight data representing about 1,900 take-offs of Airbus A340-300 from the Bogota airport and about 750 take-offs from all the airports they serve. They both confirmed a

significant difference between the theoretical take-off performance and those achieved in operation at all airports with similar average rotation rates.

This difference is mainly due to an operational rotation technique resulting in a significantly lower average operating rotation rate than that used in the certified model for calculating aircraft performance. They took safety actions and increased the safety margins for A340-300 take-offs from airports such as Bogota El Dorado.
