**Unique Investigation Technical Assistance by the Manufacturer  
Eric J. East and John D. Miller – The Boeing Company**

*Paper presented at ISASI 2023 Seminar, August 2023, Nashville, Tennessee, USA*

### Atlas Air Flight 3591 Accident – NTSB Wreckage Recovery and Reconstruction

### **Serious Incident Investigation Support at 777X Systems Integration Laboratory**

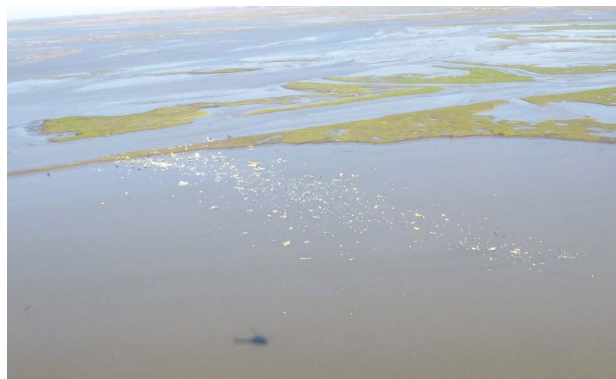
Figure 1 – Main Debris Field (Photo: NTSB)

On February 23, 2019 Atlas Air flight 3591, a 767-300 Boeing Converted Freighter (BCF), impacted a marshy bay area (Trinity Bay) about 40 miles southeast of George Bush Intercontinental Airport near Houston, Texas. The main debris field (Figure 1) extended about 350 yards in length and 170 yards in width beyond the initial impact point.<sup>1</sup> While almost all the airplane wreckage was located in the main debris field the wreckage was highly fragmented and scattered. The water was 0 to 3 feet deep in the main debris field depending on the tide and wind conditions and much of the wreckage was buried up to 10 feet deep in soft mud.

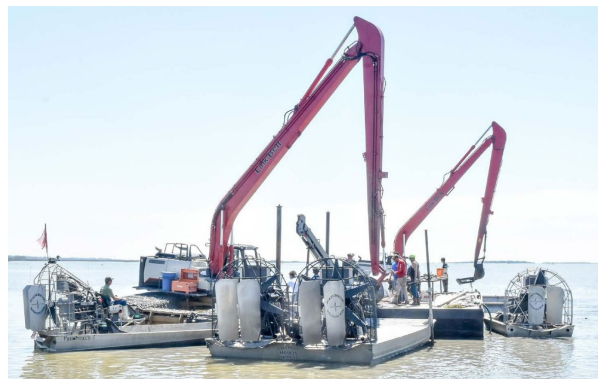
Figure 2 – Debris Field Excavation (Photo: NTSB)

Larger portions of wreckage were recovered and staged on barges using airboats and cranes from a recovery contractor (Figure 2). Excavation of the debris field followed using specialized

screens fitted to excavator buckets that would allow the water and mud to drain while retaining wreckage larger than about 4 inches in size. A grid system was used at the site to ensure complete excavation coverage of the main debris field. Excavation efforts continued for about 6 weeks concurrent with storage and reconstruction efforts described below.

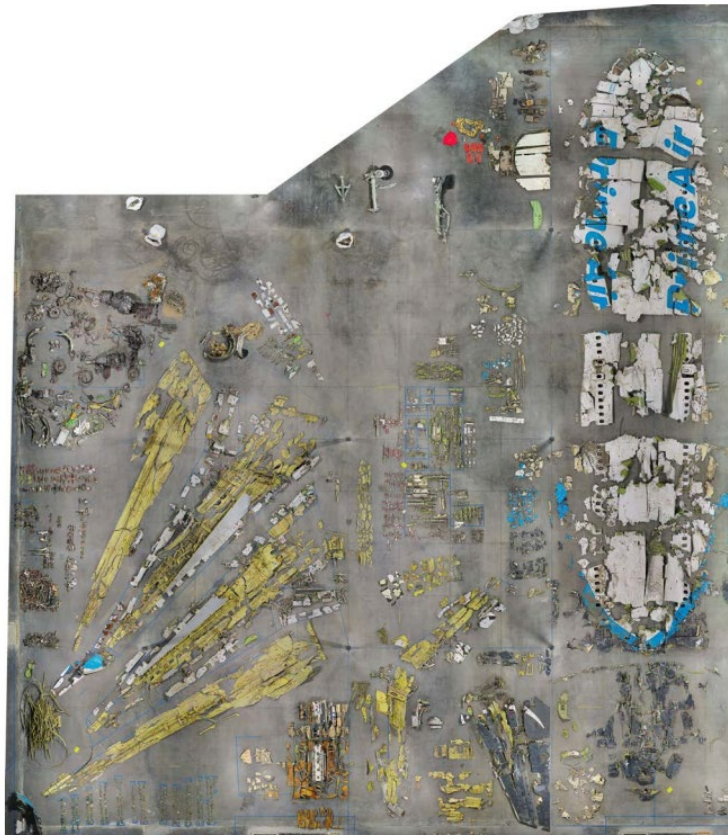
*Figure 4 – UAS Aerial Image of Reconstruction (Image: NTSB)*

The NTSB utilized several techniques for photo-documenting the accident site and reconstruction. The NTSB’s UAS Team acquired high-resolution aerial imagery of the wreckage reconstruction (using two small UAS inside the warehouse) and processed it using commercially available photogrammetry software to develop a three-dimensional model<sup>3</sup> of the reconstruction an overview of which is shown in Figure 4. A full georeferenced orthomosaic map and 3-dimensional point cloud of the reconstruction were created.

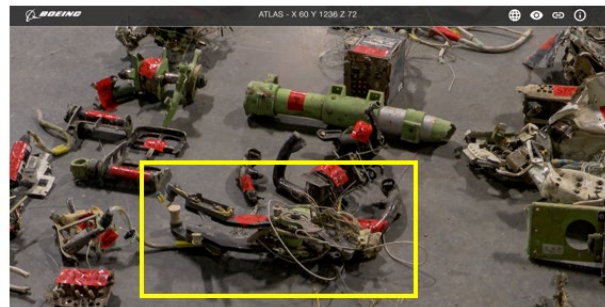
Figure 8 – Thrust Lever Assembly in Reconstruction and Digital X-Ray Composite (Images: Boeing)

These documentation methods preserved the wreckage reconstruction in a highly accurate, digital format. Due to the high resolution and detailed image processing, the catalogued unique identifiers are visible and legible in the virtual tour images. This provided investigators useful information that could be referenced or considered throughout the investigation in other follow-on work such as the system component examination for the thrust lever assembly<sup>4</sup> shown in Figures 7 and 8. Beyond the benefits to the investigation, this format can also be used in

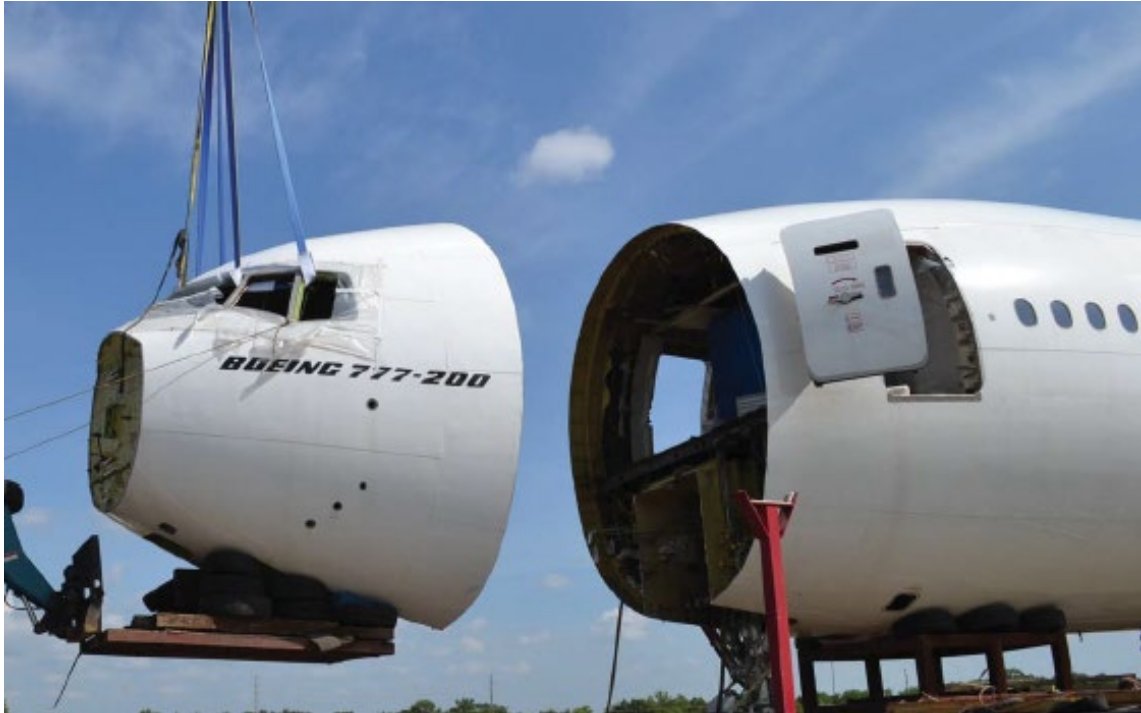
*Figure 10 - 777-200 Line Number 30 Forward Section Removal (Images: Boeing)*

The 777X Systems Integration Laboratory in was in-part built using existing 777-200 pilot control hardware, production line number 30 (originally delivered in 1996), by removing the forward section of the aircraft as shown in Figure 10. Boeing has historically developed Systems Integration Labs across multiple commercial test programs as a method to better integrate and test systems and subsystems before, during, and after flight testing. Because the 777X Systems Integration Laboratory included the same mechanical breakout features from the 777-200 that were also present in the incident aircraft, a 777-300ER, Boeing was able to develop test conditions specific to the interests of the investigation team.
