Unauthorised takeoffs from taxiways – an in-depth analysis of past occurrences

Paper presented at the International Society of Air Safety Investigators 2023 Annual Seminar,
Nashville, Tennessee, August 22 – 25, 2023.

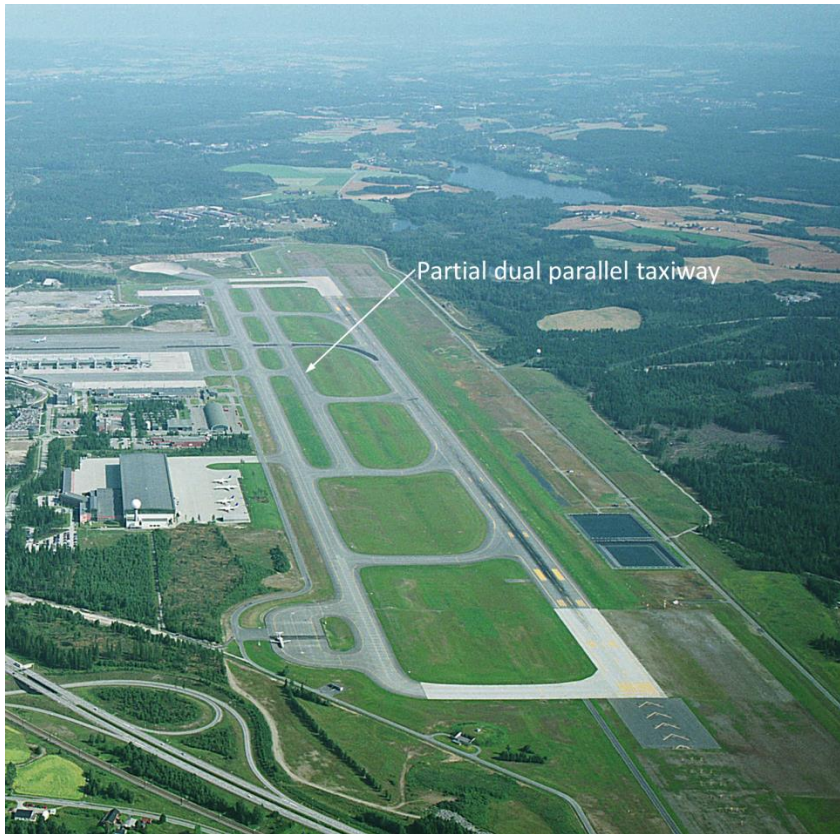
The runway on which the aircraft should have taken off had a dual parallel taxiway layout next to it in eighteen occurrences (72%), including partial dual parallel taxiway (see example in Figure 2). In all these cases the aircraft was taxiing via the outer taxiway and took off from the inner taxiway. Eleven of these occurrences took place on 4 airports. Five aircraft took off from a single parallel taxiway and two aircraft departed from a taxiway that was not parallel to the intended runway. The data clearly show that dual parallel taxiways are a very common factor in taxiway takeoffs and increase the risk. This is not a real surprise as the taxiway has the same direction as the runway⁴. So when making a wrong turn, the crew could have the erroneous expectation to have entered the runway.

Figure 2: Example of an airport with a partial dual parallel taxiway (Photo: Oslo Lufthavn AS)

A factor mentioned a number of times by the investigators was the presence of a dual parallel taxiway on which the aircraft was taxiing via outer taxiway and took off from inner taxiway. Especially during darkness this layout was a large contributing factor in the occurrences analysed.

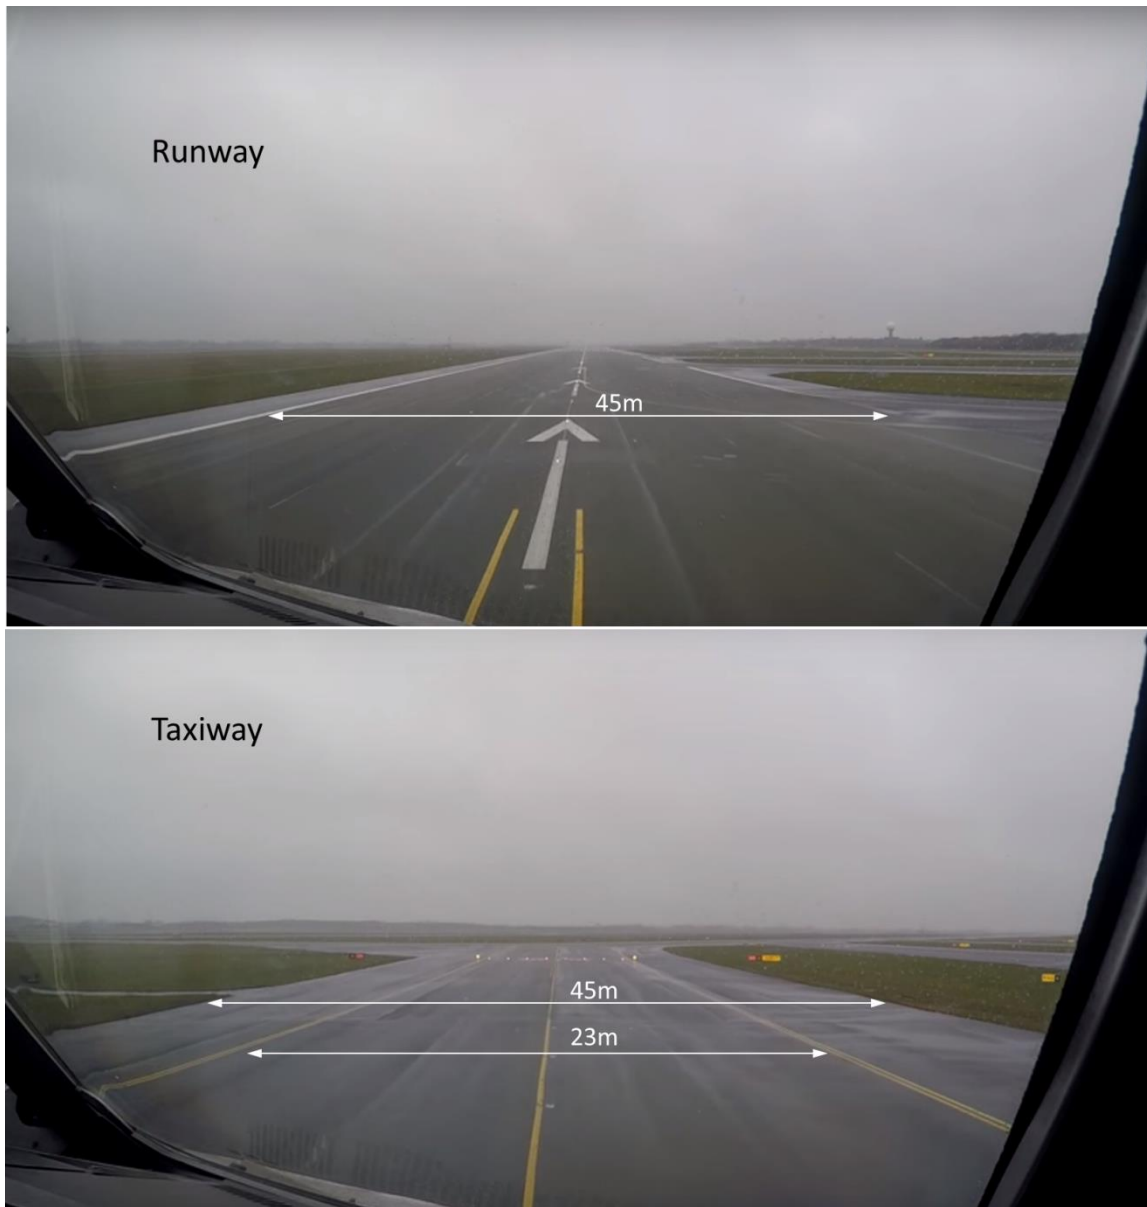
Figure 3: Example pilot view on a taxiway and a runway (source: YouTube)
