Safety Management; Reversing the False Glide Slope Myth

Kas Beumkes – Senior Air Safety Investigator/Project Manager
Michiel Schuurman – Senior Air Safety Investigator/Technical Investigation
Dutch Safety Board

Keywords: accident investigation, Instrument Landing System, Safety Management Systems

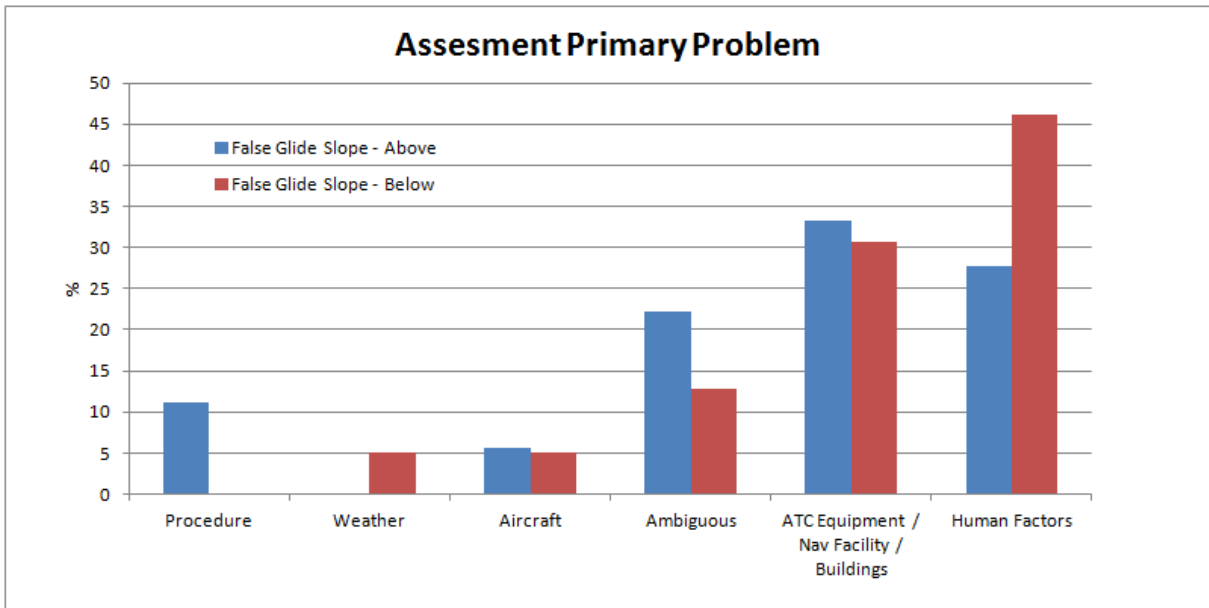
The analysis of the ASRS shows that a distinction can be made between Glide Slope events from above and below. The 19 pitch-up upset events above the Glide Slope attributed to the main cause of a False Glide Slope. The ASRS assessment of the problem is not definitive but the database suggests that human factors and navigation facility equipment plays a major part (Figure 1).

Figure 1: ASRS' assessment of False Glide Slope primary problems.

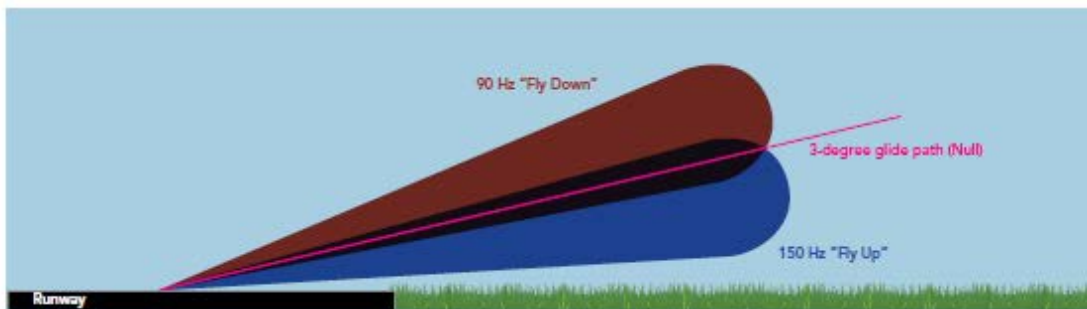
The Glide Slope antenna is situated to one side of the runway touchdown zone. The centre of the Glide Slope signal is arranged to define a Glide Path of approximately 3 degrees above touchdown ground level. The Glide Slope receiver on the aircraft measures the DDM of the 90 Hz and 150 Hz signals similarly to that of the Localizer (Figure 2). For a standard 3 degree Glide Path the relative signal strength of the "Fly Up" (150 Hz) command and the "Fly Down" (90 Hz) command is equal (Null).

Figure 2: Vertical guidance Glide Slope signal with 150 Hz "Fly Up" and 90 Hz "Fly Down".

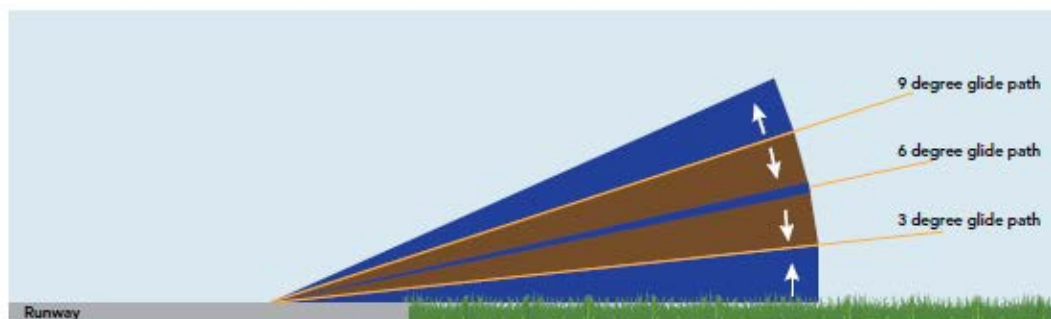
By closely examining the ILS signal characteristics the investigation shed new light on the False Glide Slope. The first False Glide Slope type is a *False Null*. This glide path resembles the normal 3 degree Glide Slope signal (Null) but is actually either at the wrong location in space or has a steeper angle. Following a False Null signal will result in an aircraft having a higher than normal descent rate. The second type of False Glide Slope that can be distinguished is the *Signal Reversal*. This Signal Reversal is 'unstable' as the ILS signal changes from "Fly Down" to "Fly Up". When the autopilot is engaged in the appropriate mode, the "Fly Up" signal will result in a command to pitch-up the aircraft (Figure 3).

Figure 3: Cross section of the M-array ILS "Fly Up" (blue) and "Fly Down" (brown) indication.

Measurements performed on the three Imaging type category ILS Glide Slope antenna systems revealed two different Glide Slope signal characteristics.

- a. Signal reversal sometimes occurs at approximately 6 degree Glide Path angle.
- b. Signal reversal always occurs at the 9 degree Glide Path angle.

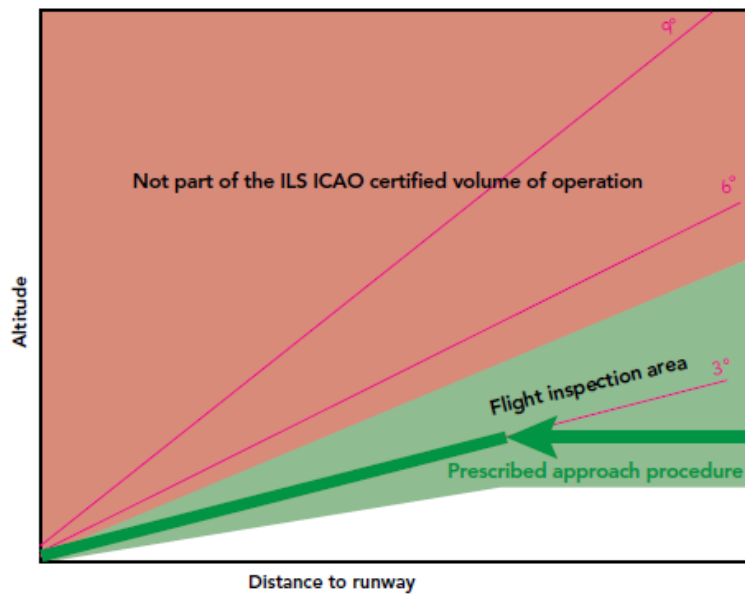
The measurements to determine the Glide Slope field as were done for this investigation were not part of a normal Flight Inspection. Flight Inspection is performed on the 3 degree Glide Path. Above an angle of 5.25 degrees, the Glide Slope field characteristic is neither checked, nor is this required by ICAO regulations. This means that when flying above the 5.25 degree Glide Path the aircraft is flying beyond the reliability envelope which is certified and periodically checked by Flight Inspection (Figure 3).

Figure 4: Cross section of ILS Glide Slope signal that is inspected and certified for operational use.

The inspected area is normally situated between 0 and 10 NM from the runway threshold and approximately 35 degrees left and right of the runway heading (Localizer). The ILS antenna system is checked and if required adjusted at least once a year.
