forum

The International Society of Air Safety Investigators

*Proceedings
of the
Eleventh International
Seminar
of the
International Society of
Air Safety Investigators*

September 30–October 2, 1980

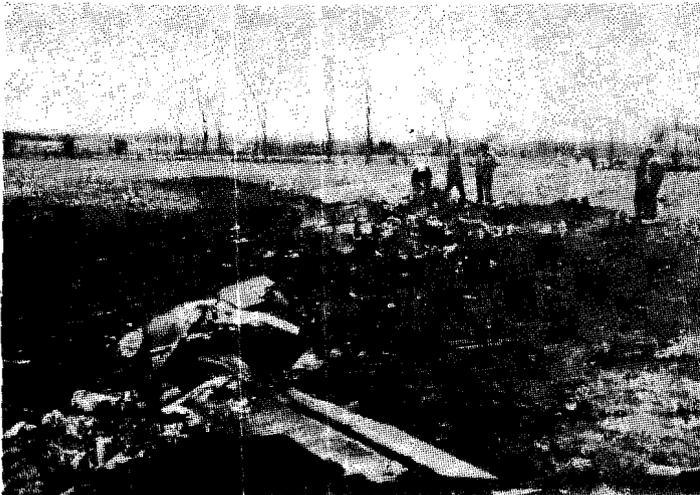
A Beech King Air suffered in-flight wing separation while cruising at about 1,700 feet altitude. An eyewitness below the flight path observed the right hand wing separate outboard of the engine nacelle. The aircraft went into an uncontrollable rolling dive, crashed and burned, killing both occupants (Figure 1).

Figure 1 - Crash scene.

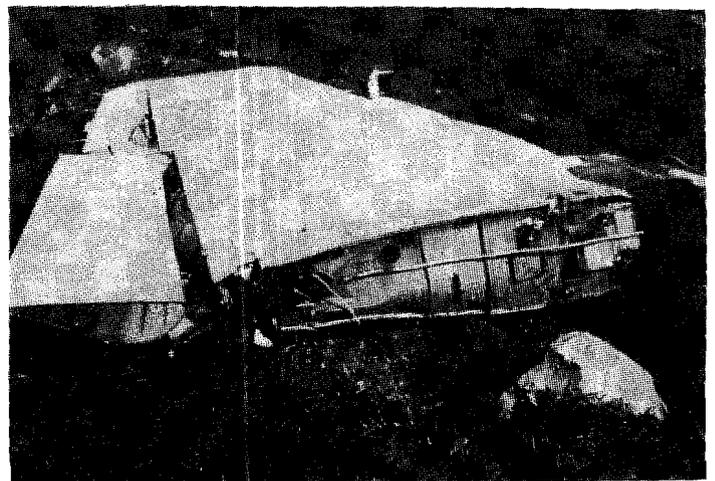
The separated outboard wing section was found some 2,100 feet from the main wreckage (Figure 2). Visual inspection by the field investigators indicated three of the four outboard right wing attachment fittings had failed in ductile overload mode, but the forward lower outboard wing attachment fitting was suspect (Figure 3). It displayed a large discolored zone typical of a massive precrack of a progressive nature (Figure 4). This fitting, normally known as a "bathtub" fitting (Figure 5) because of its shape, is the most critically loaded of the four attachment fittings in normal flight. The remaining three attachment fittings are not (nor are they required to be) capable of carrying flight loads if the subject fitting suffers catastrophic failure. The wing and mating parts therefore were subsequently forwarded to the laboratory for detailed analysis.

Figure 2 - Separated outboard wing section in a farmer's field.

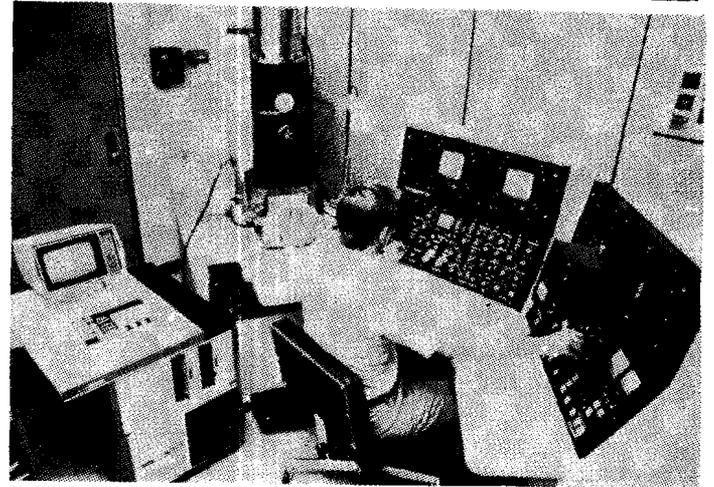
By subjecting the fitting's fracture surface to high magnification scanning electron microscope (SEM) examination (Figure 7), it became possible to identify the origin and mode of crack initiation and propagation. SEM evaluation detected three different zones within the precracked area (Figure 8) as follows:

Figure 7 - High magnification scanning electron microscopic examination of fitting.

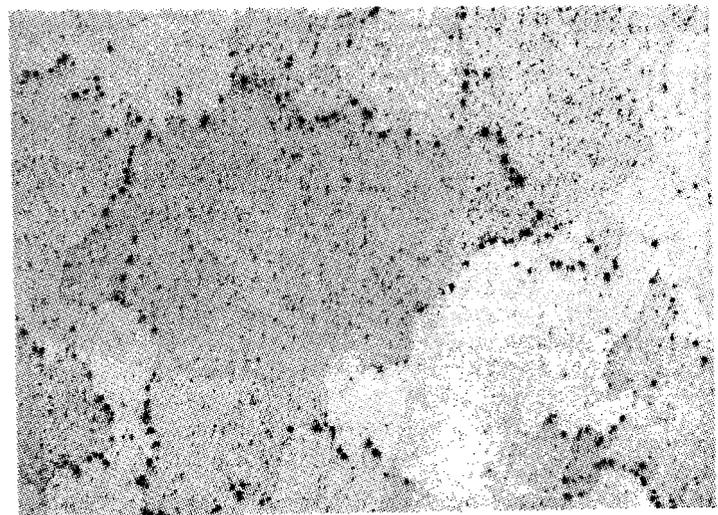
All of the intergranular cracking was characterized by a liberal distribution of hemispherical "holes" on the grain boundary surfaces (Figure 11). Such holes were virtually absent from any transgranular fatigue facet (Figure 12). Subsequent metallurgical examination of sections through the forging showed a multitude of roughly spherical voids distributed throughout the forging. Etching to reveal the internal metallurgical structure (Figure 13) showed these voids were distributed along the grain boundaries.

Figure 13 - Etched metallurgical micro-specimen with spherical holes displayed on the grain boundaries. (X50)

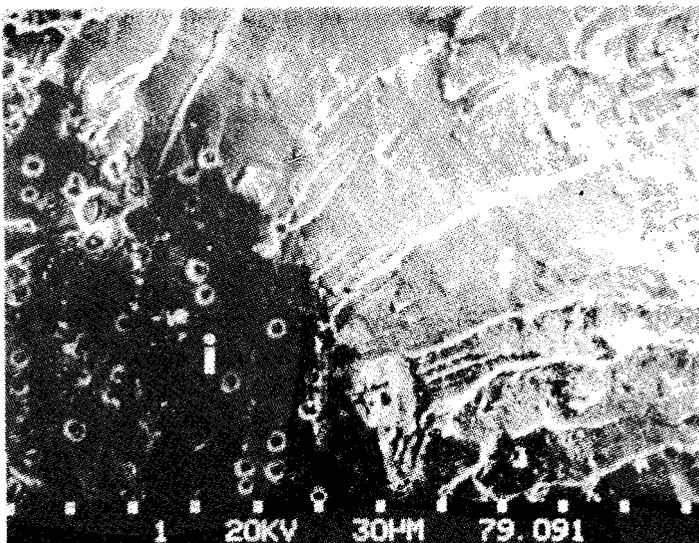
Figure 11 - Hemispherical holes distinctly on intergranular areas but not in fatigue areas. (X300 approx.)

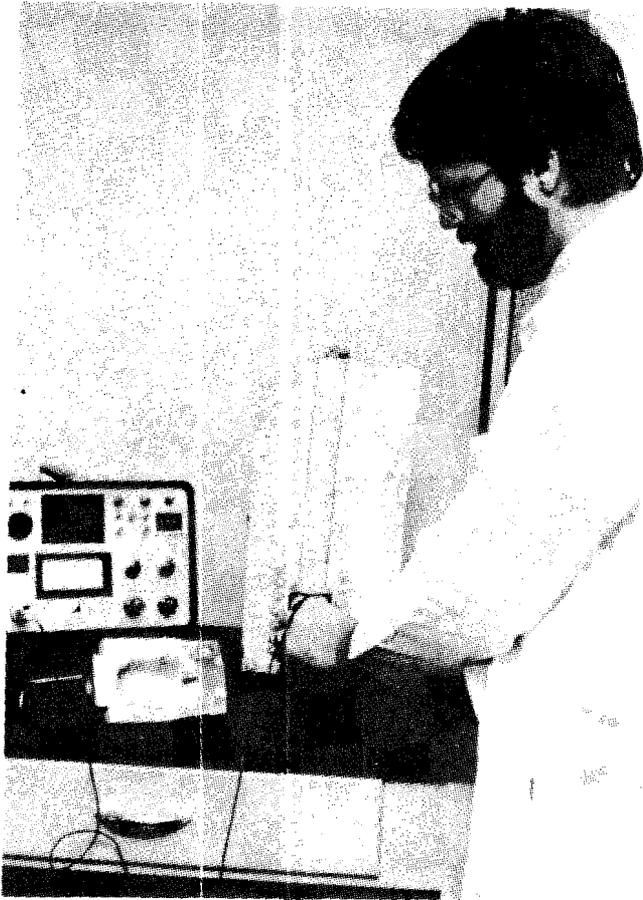
Figure 15 - Unbroken left wing fitting being eddy current cracked for cracks.

The unbroken left wing attachment fitting from the lower front spar was also recovered from the wreckage. It was dye penetrant and eddy current (Figure 15) inspected to determine if it was cracked in the same location as the failed fitting, and no cracking was found. It was then sectioned in the same plane as the failed fitting and a similar grain flow pattern was revealed. No tiny hemispherical holes were found on the microsection. Of significance however was the fact that the grain flow (at the same location as the point of origin of the fractured fitting) was flowing perpendicular to the free surface. This had occurred because during the formation of the bolt hole recess, the manufacturer had machined away the original forging surface, exposing the end grains at this critical location. Such exposure of the "end grain" at the free surface was also oriented such that the short transverse grain direction was aligned with the principal tensile stress developed in service.

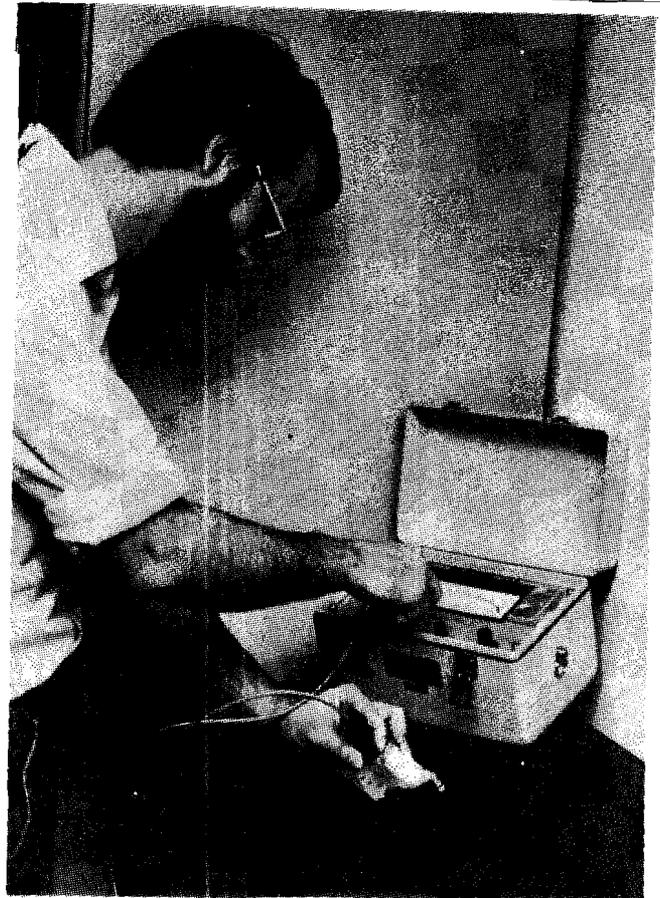
Figure 17 - Conductivity test being performed for heat treatment condition of fitting.

energy dispersive X-ray spectrometric analysis (a technique for analyzing all elements simultaneously) confirmed the forging was made from the specified 2014 aluminum alloy. Conductivity testing (Figure 17) confirmed the forging had been heat treated to the required -T6 temper, and hardness tests (Figure 18) confirmed the correct strength level had been thereby developed. As far as was possible, given the fitting's failed condition, the fitting was found to be dimensionally correct.

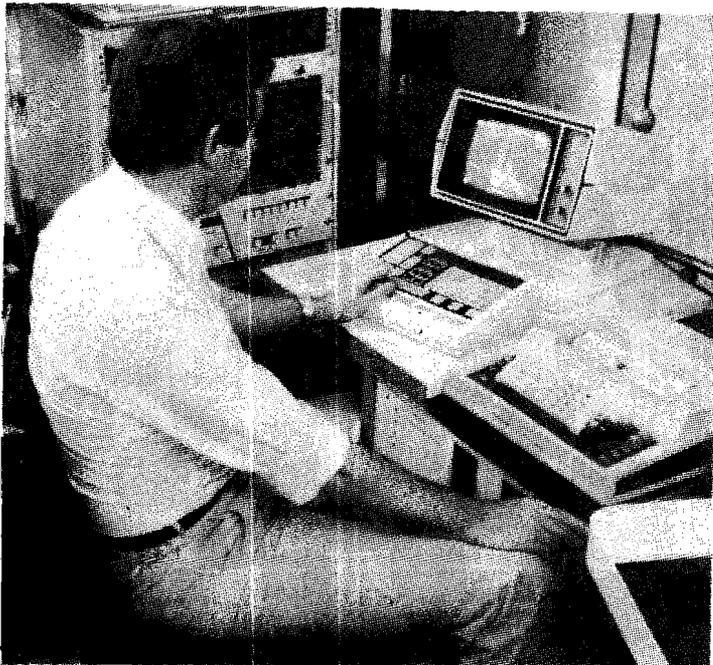
Figure 16 - Energy dispersive X-ray spectrometric analysis being performed on fitting for chemical composition.

General evaluation (Figure 16) of the failed forging via

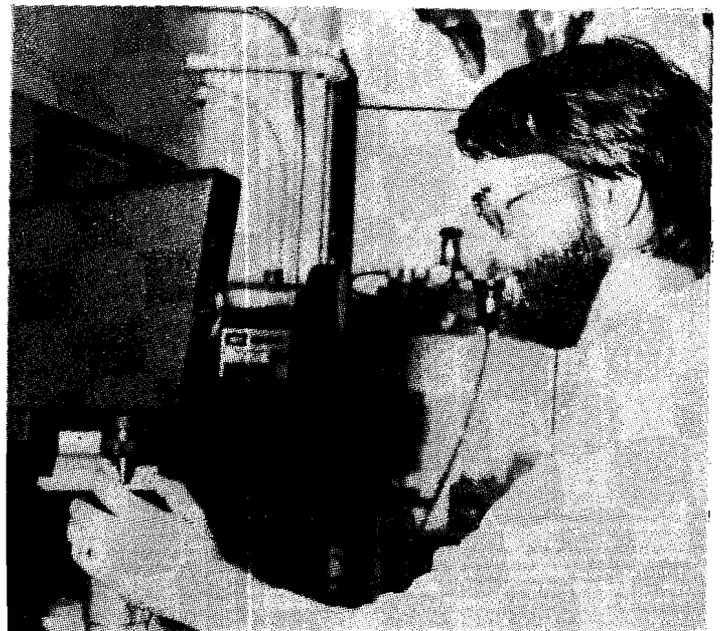
Figure 18 - Hardness tests to confirm correct strength level of fitting.

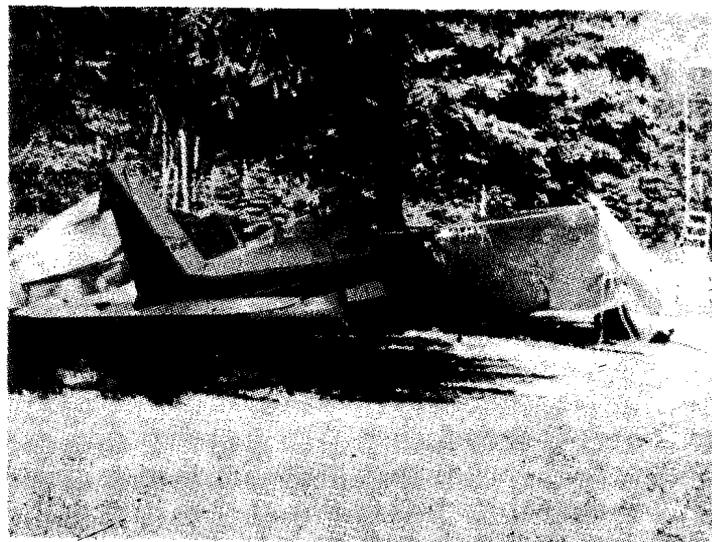
A newly licensed pilot was on the first leg of a cross-country flight in a Piper PA-28R-200 aircraft when he radioed a Mayday, stating that he had "severe vibration problems". He attempted a forced landing in a field but the aircraft undershot the field and struck trees. It crashed (Figure 19) killing the pilot and front seat passenger and injuring three young children. Fortunately there was no post-impact fire.

Figure 19 - Crash scene.

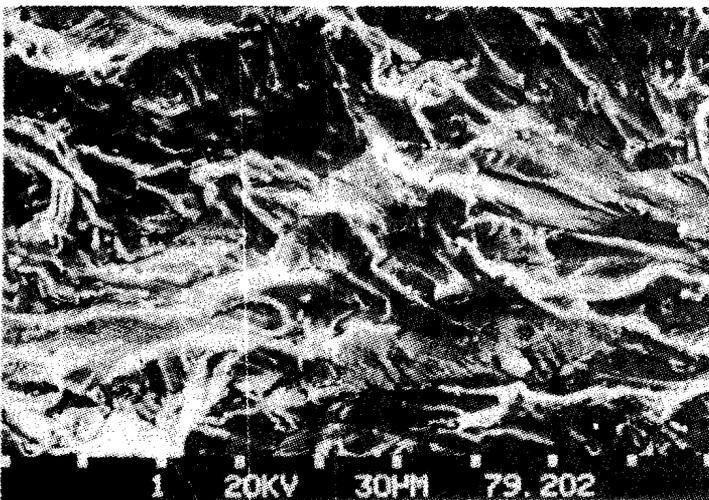
Figure 22 - SEM image displaying faceted cleavage-like surface at origin typical of initial stages of fatigue in aluminum props. (X500 approx.)

cal of aluminum propeller blades (Figure 22). A fatigue mode of failure was confirmed by the presence of isolated patches of striations (Figure 23). The relatively fine spacing of the striations indicated a very high-cycle, low-stress mode of crack propagation. Examination of the origin area on the leading edge of the blade, as was indicated by beach and ratchet markings, did not detect any definite initiation point. It was found that the point of fatigue initiation had been dressed out (Figure 24), suggesting that fatigue propagation had continued from a crack that had been incompletely removed by a repair operation.

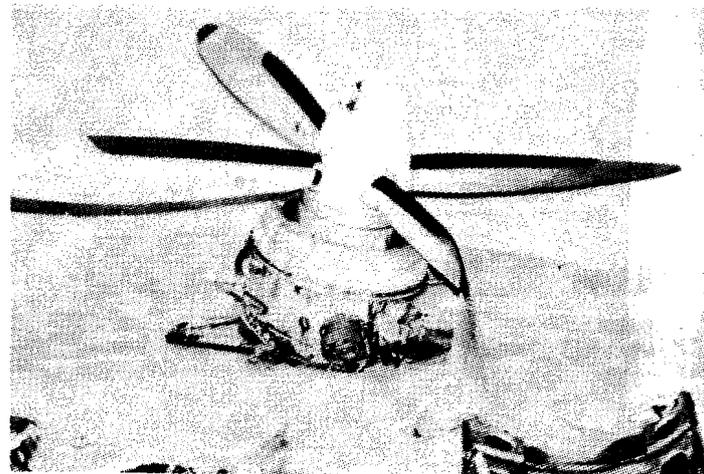
Preliminary on-site investigation suggested separation of the propeller assembly and the front section of the right hand engine (Figure 26) was possibly the result of bursting of the low pressure or first stage centrifugal compressor impeller. The pieces were sent to the laboratory for in-depth analysis. The impeller remains (Figure 27) displayed a major diametral burst fracture. The primary fracture face (Figure 28) was examined in the stereo-microscope in detail, with no obvious differences disclosed in fracture topography. The river markings were highlighted (Figure 29) to identify the primary origins of the impeller rupture. Again no pre-cracks were immediately discovered at the origins. The fractures were subsequently cleaned with acetone to remove any volatiles and a lighter zone was suddenly visually apparent at the bore/rear abutment face corner (Figure 30).

Figure 26 - Section of right engine which separated on take-off.

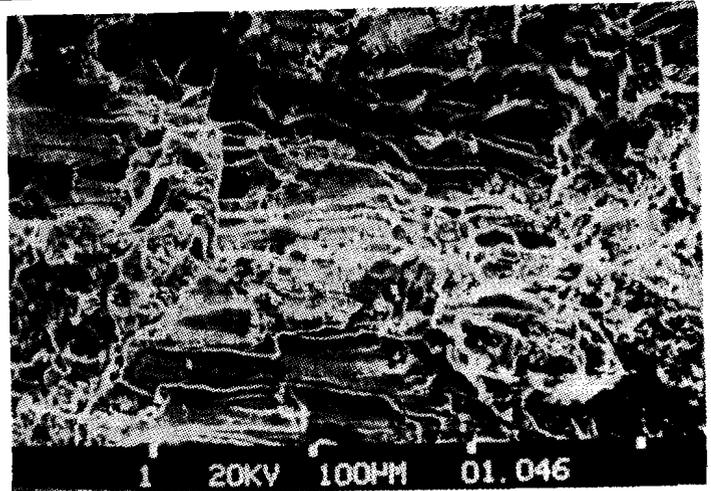
The primary fracture origin (Figure 31) and the large secondary cracks (Figure 33) were then subjected to SEM examination. Typical mixed fatigue and ductile overload zones (Figure 34) were found in the light zone of the primary origin. This explains why the stereo-macroscopic examination discerned no topographical differences between

Figure 34 - SEM image of area in light zone (Figure 31). Zone is mixed fatigue and ductile overload. (X250 approx.)

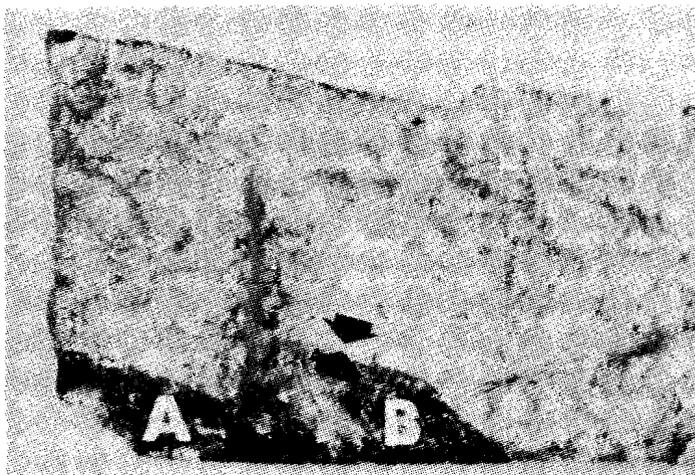
The balance of the rear abutment face and bore face and connecting chamfer were then subjected to careful non-destructive testing to determine if any other precracks were present in the impeller. A large secondary cracking indication was revealed by solvent removable fluorescent penetrant inspection. The crack was broken open (Figure 33) and appeared as two cracks angled at 45° and perpendicular to each other, both gold-brownish in colour. A small silvery zone was evident at the periphery of the brown crack B (Figure 33) which was oriented in the radial/axial plane.

Figure 33 - Two 45° gold-brownish secondary cracks, A and B. Highly reflective flat silver zone below arrows.

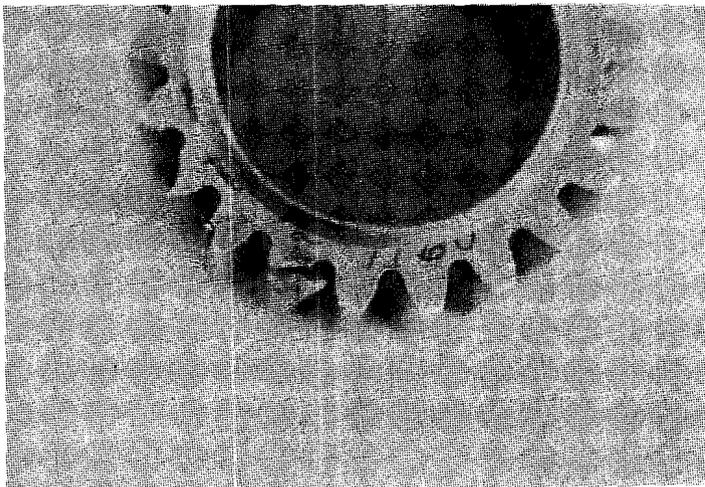
Figure 4 Pinion Gear Showing "Electric Pencil" Marking and Sheared Teeth

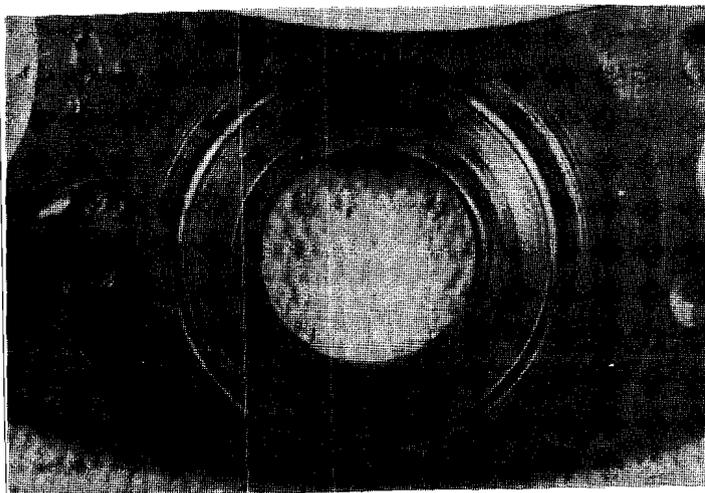
Figure 5 Carrier Plate at a Position where Thrust Washer was Cut Through

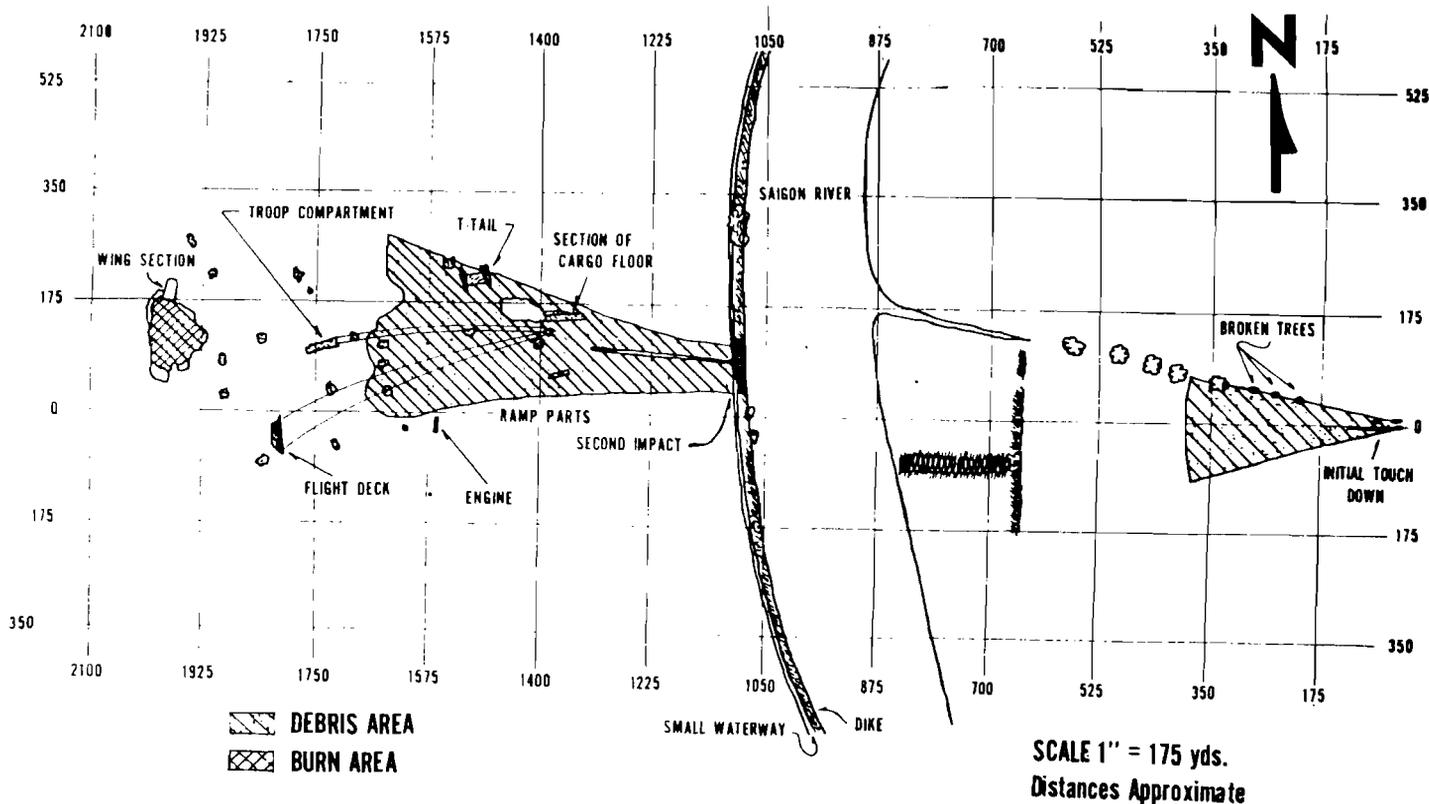
Figure 1

The aircraft, as shown in Figure 1, made its first contact in a muddy rice paddy, slid along for approximately 1,000 feet, dragging off all 28 of its wheels, became airborne at an angle of 12 degrees, stayed airborne for approximately 2,100 feet until it had crossed the Saigon River, and again struck down in a marshy rice paddy on the opposite side of the river. The aircraft slid quite smoothly in a straight line 1,500 feet through the marshy terrain, shedding large and small sections of its cargo compartment. Near the end of the slide, it broke into four distinct sections: the large tail section, the troop compartment which represented the upper third of the fuselage, the crew flight deck section, and the wing. Fortunately, the wing was separated in one piece and took most of the fuel with it. The other three large remaining sections, while badly shredded, did not experience the kind of fuel fire generally associated with an aircraft crash.

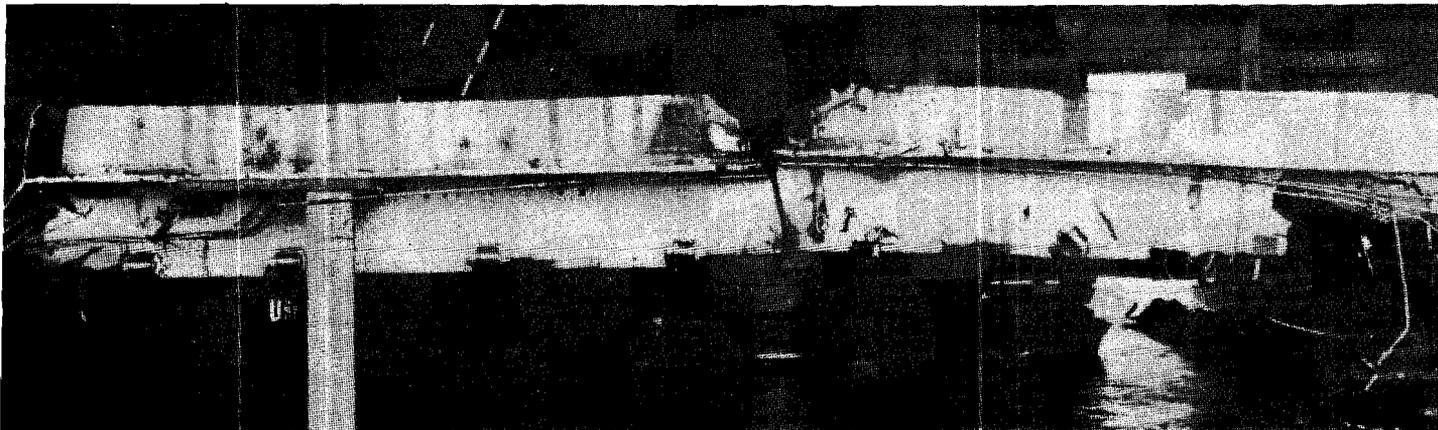
The aircraft crashed at 4:30 in the afternoon Saigon time on the 4th of April. On the 19th of April, with security failing in the area of the crash site, further wreckage search at the crash site was abandoned. Also on the 19th of April, the buy-back program succeeded in obtaining the key MADAR tape. A meticulous backtrack of recorded course and airspeed to locate the point of rapid decompression, coupled with a trajectory analysis of the door and ramp, provided a more precise location for the Navy salvage crews to search. On the 27th of April, the Navy team found a 19 by 12-foot section of the aft ramp and a 7 by 11-foot section of the rear pressure door. This hardware was subsequently flown to Kelly Air Force Base in San Antonio, Texas, for detailed laboratory analysis. A special U.S. Army team was dropped at the crash site with cutting torches and saws. They succeeded in cutting the rear pressure door overhead beam out of the wreckage. This heavy beam was airlifted in two pieces by helicopter back to Tan Son Nhut and subsequently taken on to Clark. Figure 2 is a photo of this beam. The view is looking aft.

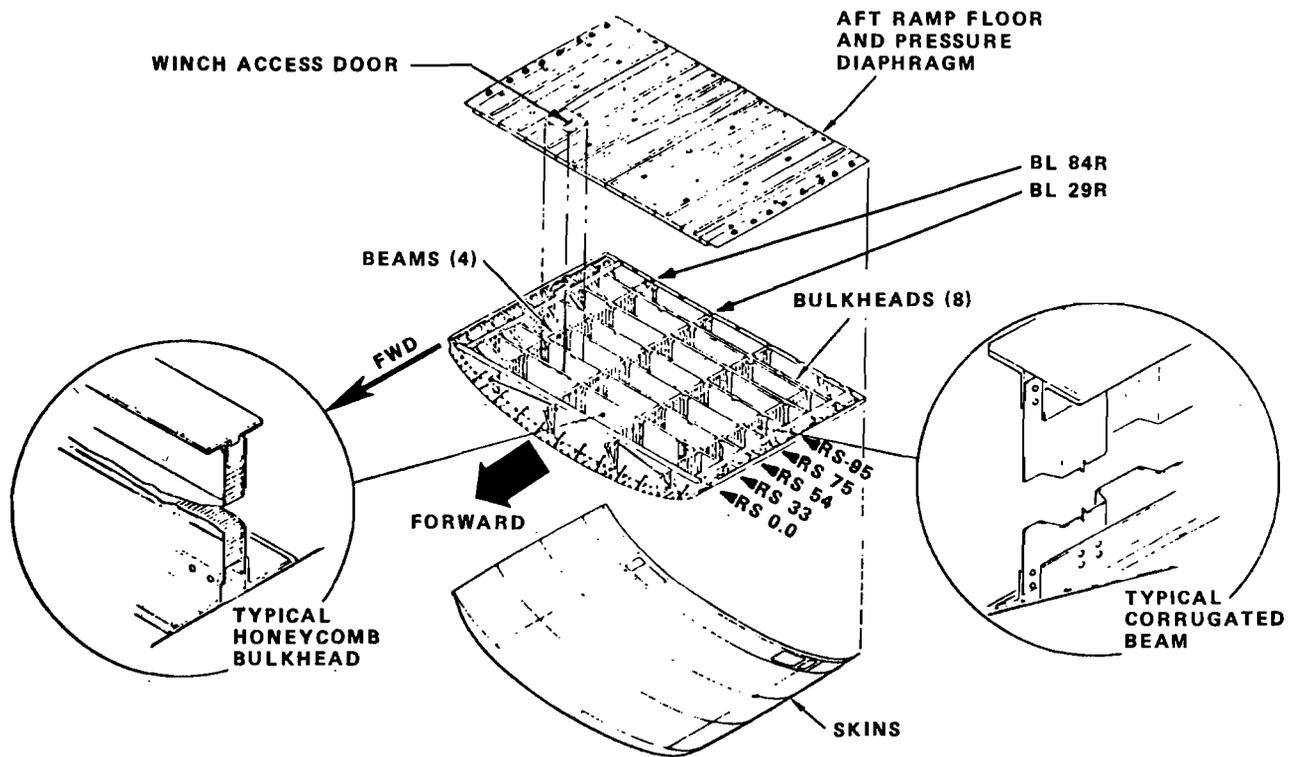
Figure 4

Examination of the aft ramp (Figure 4) structural failure indicated a failure mode of critical bending and shear at the right butt line 84 beam at approximately ramp station 33. This beam lower cap failed primarily in tension at ramp station 33. This same beam upper cap failed in a com-

bined tensile and bending mode at ramp station 19 and examination of the ramp itself showed this upper cap to be deformed upward from ramp station 19 to ramp station 33, indicating rotation of the beam about ramp station 19 and the hinge at ramp station 0. The right butt line 84 corrugated web between ramp station 54 and 75 showed evidence of shear deformation and cracking diagonally. The lower member of the fuselage half of right but line 84 hinge fitting failed in compression, apparently due to a high vertical load at the hinge line. Since there was no evidence of fatigue in the butt line 84 beam, the failure pattern described above can only result if the beam hinge becomes overloaded. A most likely cause of this overload is a sudden transfer of latch loads at the right forward end of the ramp. Structural analysis of the ramp was made. Assuming latches 1, 2 and 3 suddenly lost load-carrying capability, the load carried by the transverse bulkheads at ramp stations 33, 54 and 75 would have been picked up by the butt line 84 beam and then distributed to the hinge at the forward end and to the traverse bulkheads at ramp stations 95 and aft. Analysis of the right butt line 84 beam web indicated that this condition will result in failure of the web at ramp station 33 and consequently failure of the beam caps, followed by progressive failure of the remaining locks on the right side and the remaining hinges. The rest of the failure pattern of the ramp indicated that the right side number 1, 2 and 3 locks failed in some manner, either by unlocking or by structural failure of a lock component. Figure 5 is a sketch of the lock system.

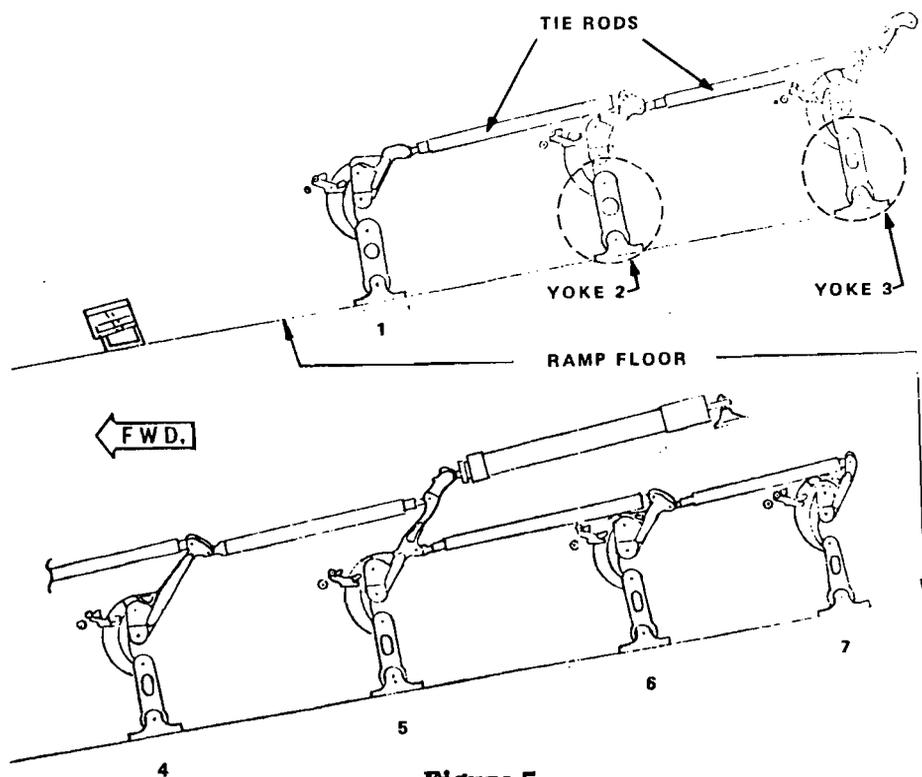
Figure 5

Examination of the right yokes number 2 and 3 showed no evidence of a high overload. Structural analysis of the bellcranks in an unlocked position showed that a failure will occur at a load less than that required to yield the yoke components. None of the components from right lock number 1 were recovered; therefore, no assessment could be made of the condition of the lock. However, as discussed above, lock number 1 must have become unlocked to result in failure of the ramp.

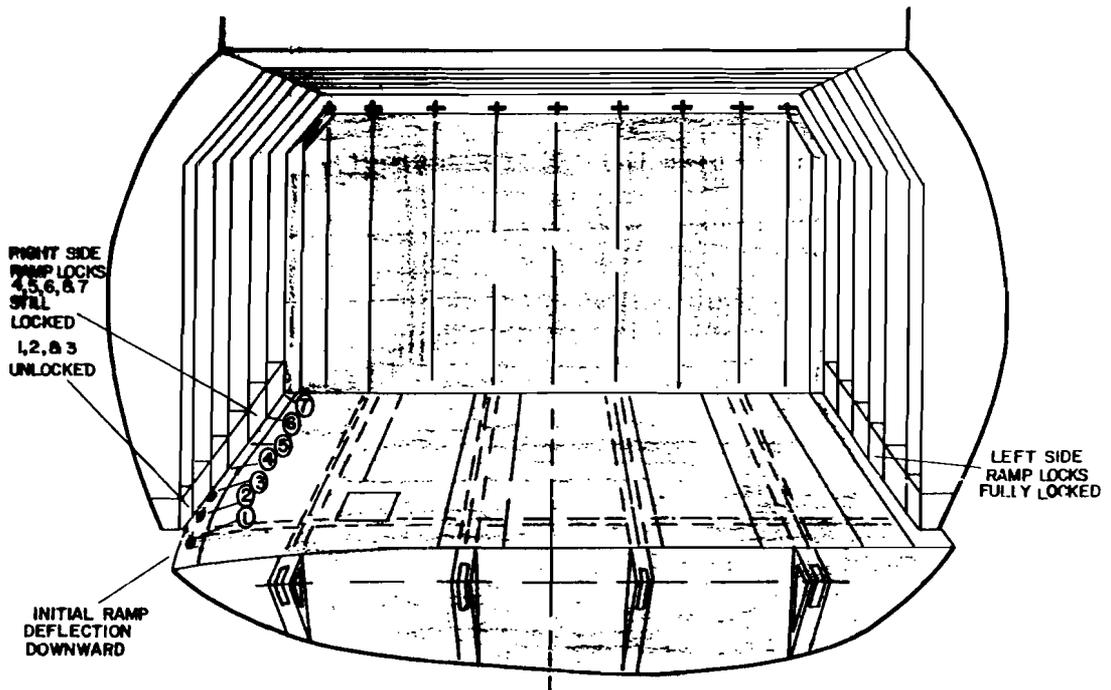
Figure 8

1. The right side ramp locks number 1, 2 and 3, due to a combination of rigging problems together with a sudden detachment of the tie rod between locks number 3 and 4, suddenly dropped their load (Figure 8).

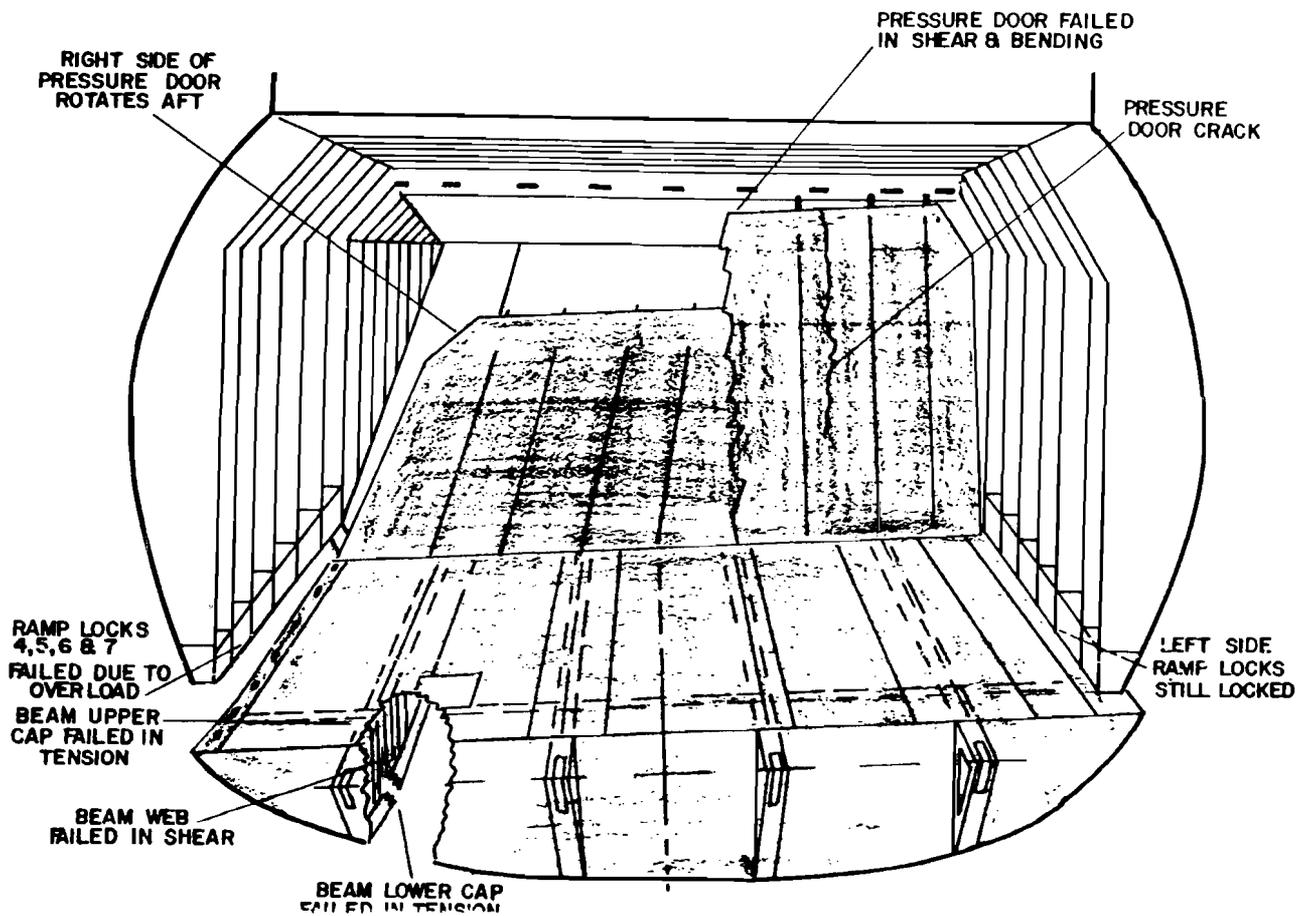
Figure 9

2. The load previously carried by the above locks was dynamically transferred through the ramp structure to the fuselage hinges and the remaining locks 4 thru 7 of the right side (Figure 9).

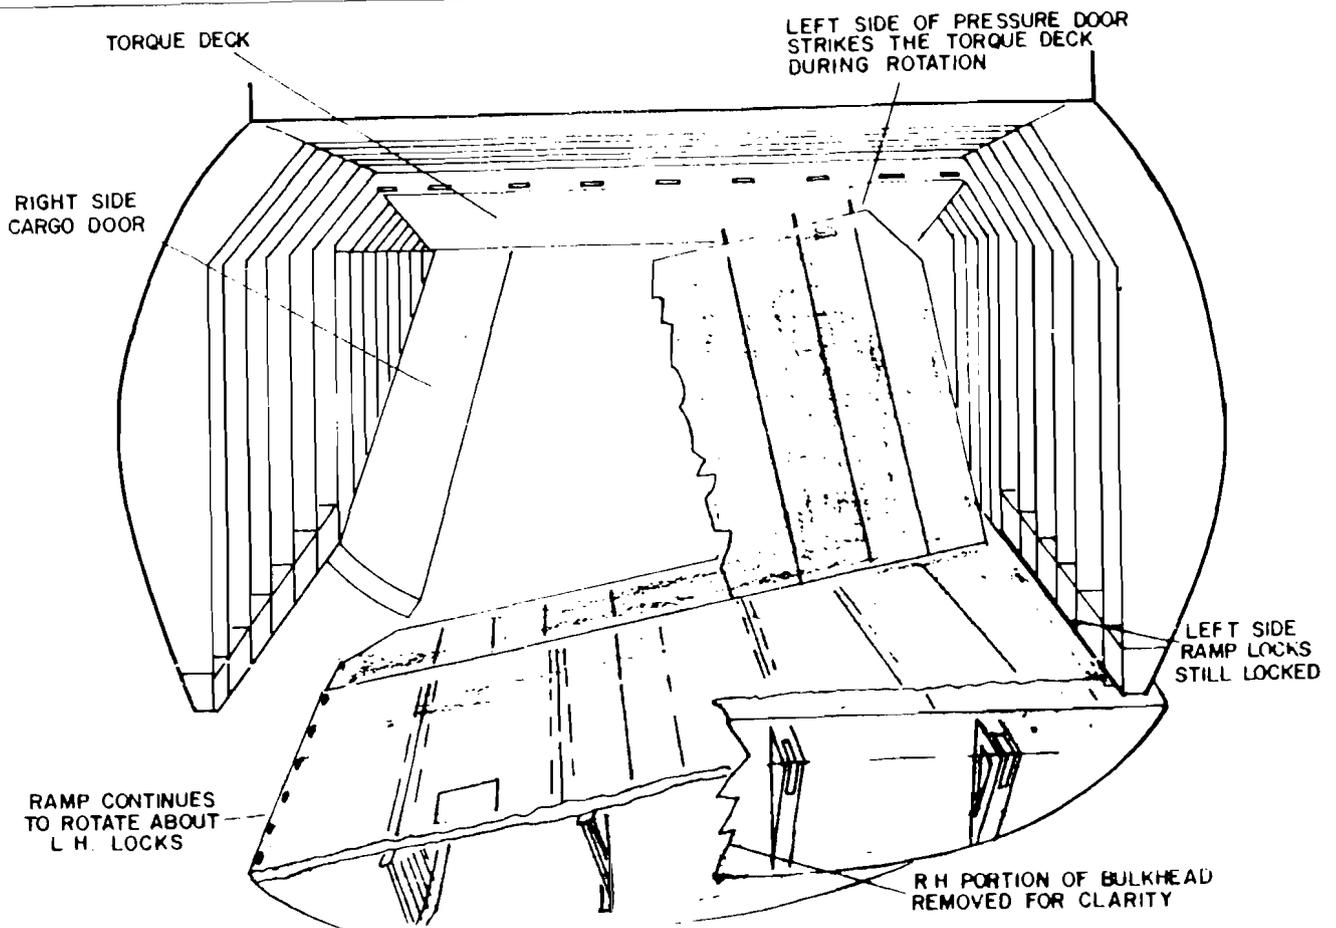
Figure 10

7. The left three pressure door fingers slipped off the rollers (Figure 10), causing the sloping torque deck to be impacted by the rotation of the remaining left side portion of the pressure door, rupturing hydraulic systems number 1 and 2, as well as severing all control cables and the lower portion of the wire runs immediately above the torque deck. The forces of the escaping cabin air contributed to the upward motion of the torque deck structure and failure of the control cables. The right side of the pressure door had dropped sufficiently to clear number 3 hydraulic system lines.

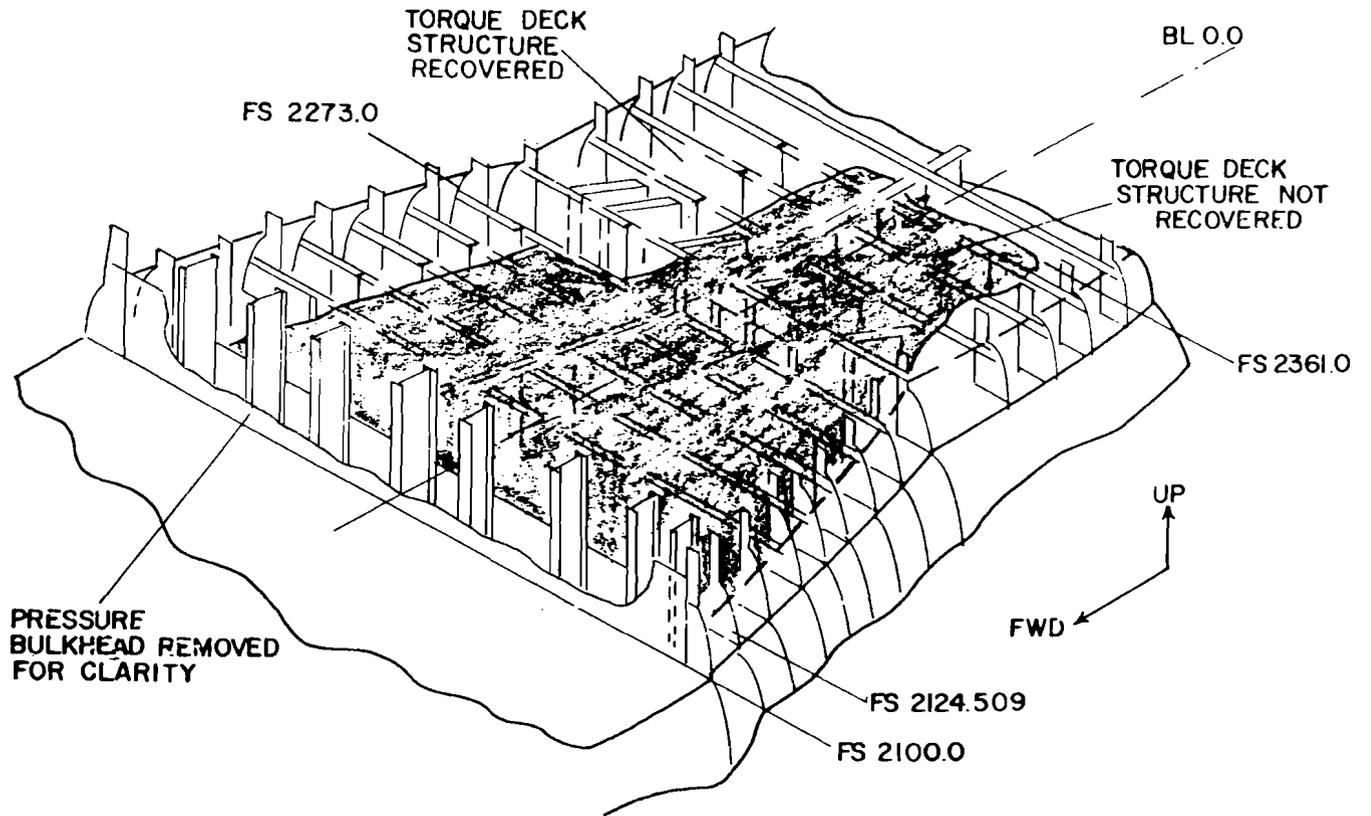
Figure 11

9. A major part of the sloping torque deck located in the center of the fuselage immediately aft of the overhead pressure door beam was torn from the aircraft (Figure 11).

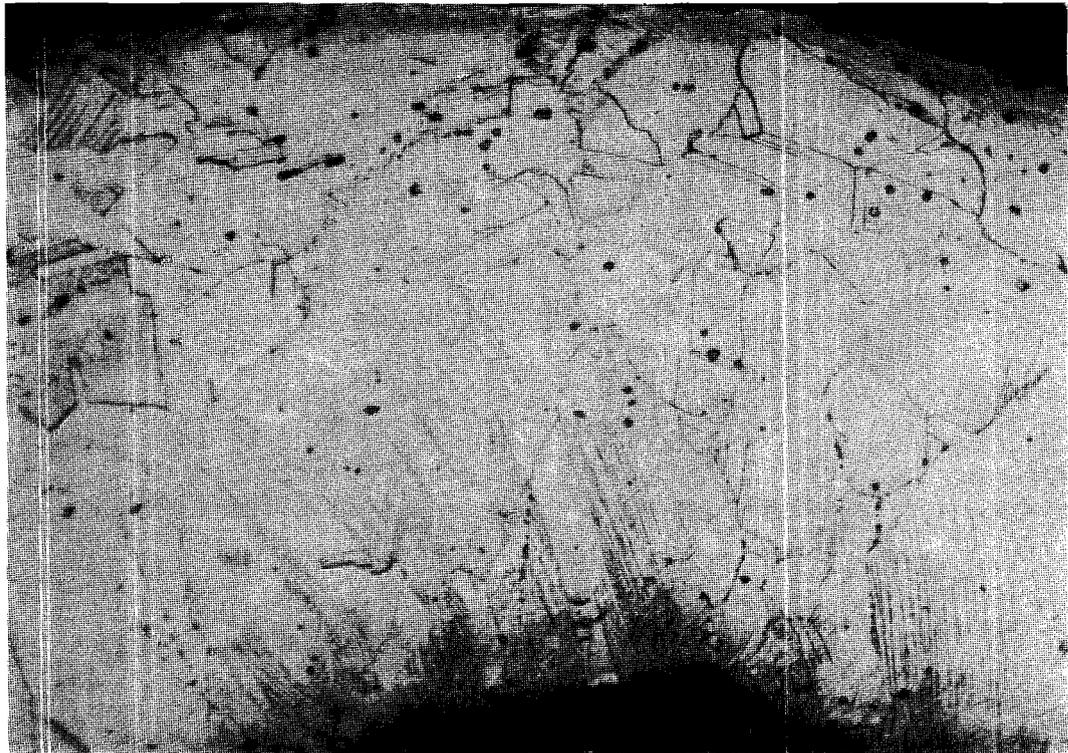
Figures 4 and 5 show the slip lines that occur in a cold-bent test specimen and an example from a non-operating engine. Figures 6 and 7 show the absence of slip lines in a test specimen which was above 400°C when bent and that of an operating engine at impact.

Figure 4 - A polished and etched specimen prepared from a non-operating engine. Note the numerous slip lines.

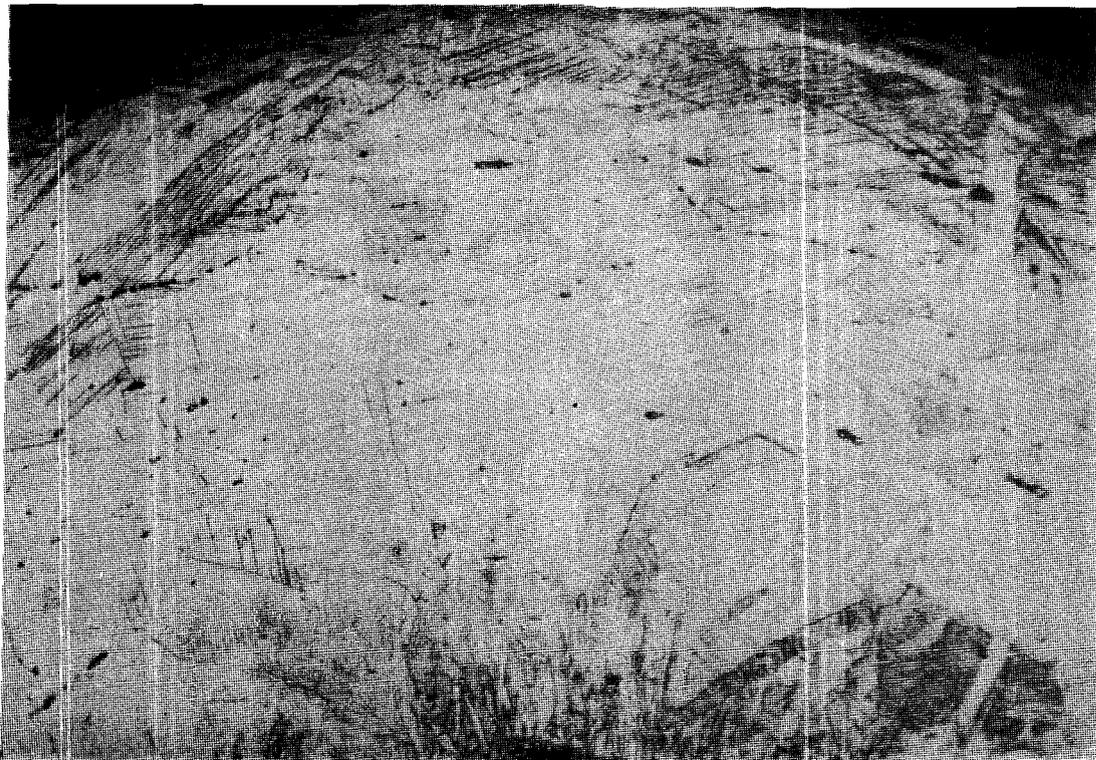
Figure 5 - Specimen bent at room temperature. The microstructure is similar to Fig. 4.

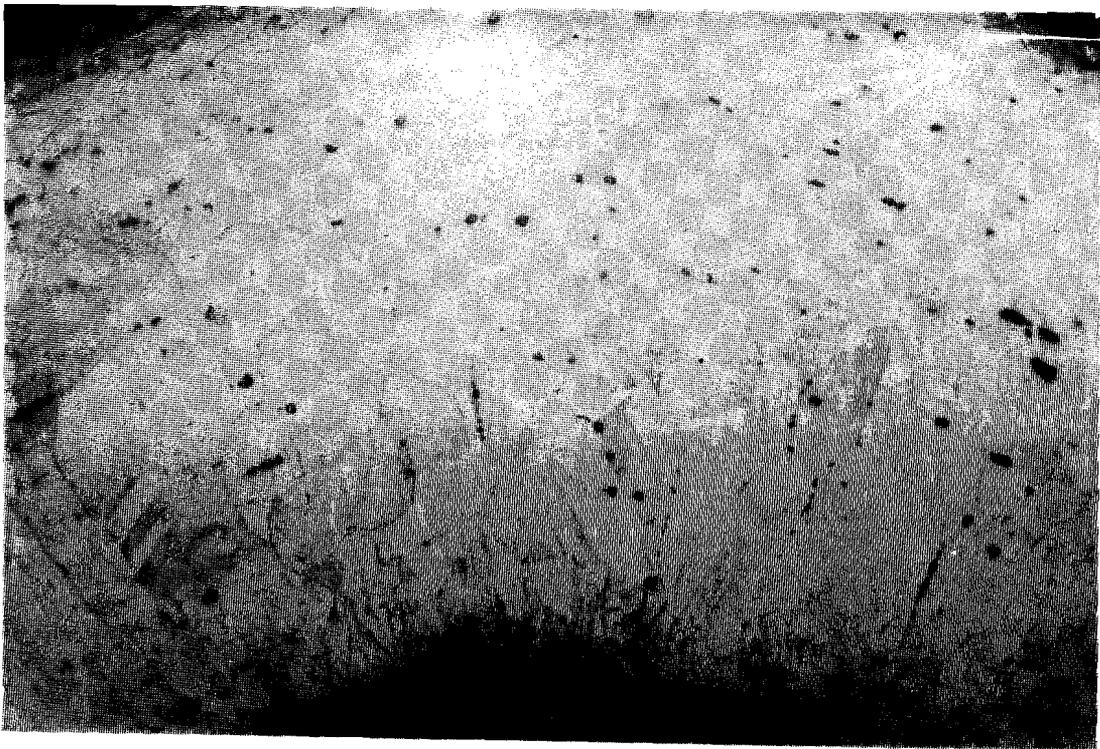
Figure 7 - Specimen bent at about 400 °C. The microstructure is similar to Fig. 6. (Magn. X130)
