MOUNTAIN HELICOPTER ACCIDENT

(AW139 JA139F, main rotors severed tail drive shaft) [1]

Aircraft Accident Investigator

Japan Transport Safety Board, Japan

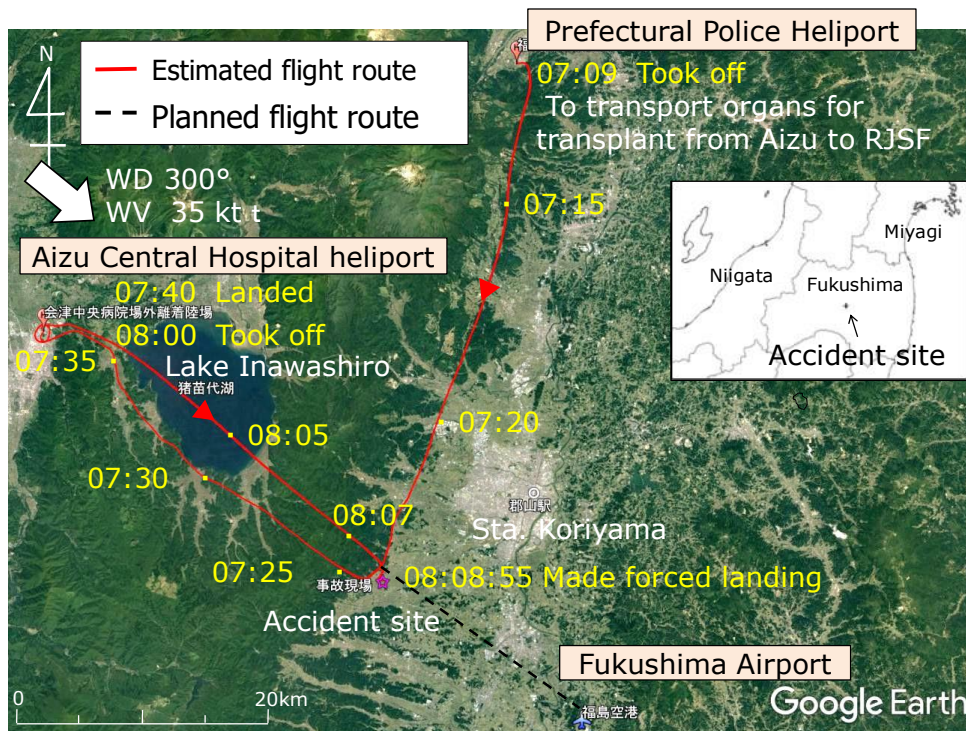
Figure 1 Estimated flight route of the helicopter

On Saturday, February 1, 2020, when an Agusta, AW139, JA139F, operated by the Fukushima Prefectural Police Aviation Unit, took off from the prefectural police heliport at 07:09 to transport organs for transplantation. Passing over Koriyama City to check the weather in advance and heading to the Aizu Central Hospital heliport in Aizu-Wakamatsu City, Fukushima Prefecture. (See Figure 1 and 2) The captain, about 3,000 ft southeast of Lake Inawashiro, confirmed that the wind was blowing from the northwest at about 50 kt, and after consulting with the co-pilot, decided to fly at a higher altitude on the return flight than on the outbound flight. The helicopter then landed at the Aizu Central Hospital heliport at 07:40. After the organs for transplantation and two passengers were seated, the helicopter took off from the Aizu Central Hospital heliport at 08:00 and headed for Fukushima Airport, the destination of the transfer. After climbing to an altitude of 5,700 ft over Lake Inawashiro, the helicopter gradually began to descend. During the descent, the captain recognized that the ground speed had increased from 193 kt to 200 kt due to the tailwind. After passing over the Ou Mountains, at 08:08, at an altitude of about 4,300 ft above Mihoda-machi, Koriyama City, Fukushima Prefecture, the helicopter's indicating airspeed (IAS) rapidly increased to 188 kt, causing the helicopter started rolling to the right. During the right rolling, the main rotor blades severed the tail drive shaft, making it difficult to control. The captain attempted a forced landing in a paddy field in the town, but the helicopter made a hard landing while rotating to the right and rolled over to the right. After the rollover, all crew members escaped through the captain's seat window. There were seven people on board the helicopter, including the captain, the co-pilot, two mechanics, and three passengers, of whom four were seriously injured and three minor injured. The helicopter was destroyed, but no outbreak fire. (See Figure 3)

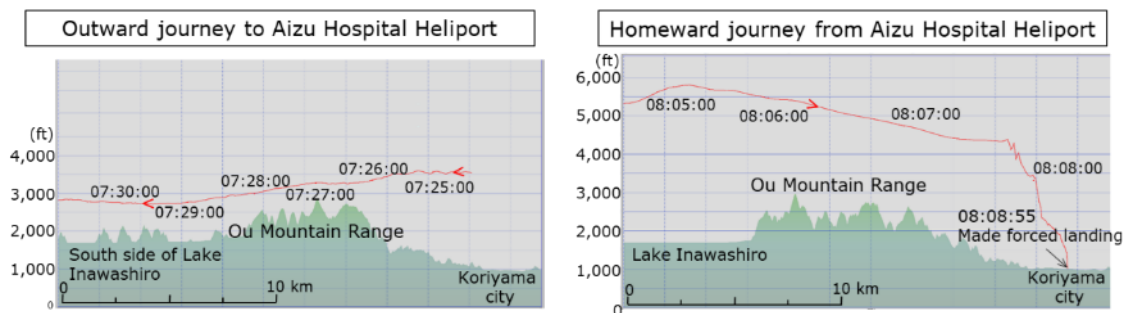
Figure 2 Cross sectional view during the helicopter's flight over the Ou Mountain

Regarding the rapidly increase in IAS and the start of the right rolling movement, while flying in a northwesterly tailwind of about 50 kt on the east side of the Ou Mountains, the helicopter encountered a strong downdraft, at which point the horizontal wind speed of the tailwind suddenly decreased. Due to the inertial force of the helicopter, the ground speed gradually changes, causing the IAS to temporarily increase. When the IAS suddenly increased, the captain pressed the Force Trim Release (FTR), which caused the attitude control function (ATT MODE) to Stability augmentation system (SAS MODE), resulting in a slightly left roll attitude and a nose-down attitude. It is probable that the cyclic was operated significantly to the right rear to counter this attitude change, which triggered the start of the right roll of over 360°.
