forum

*Proceedings
of the
Thirteenth International
Seminar
of the
International Society of
Air Safety Investigators*

October 11-October 15, 1982

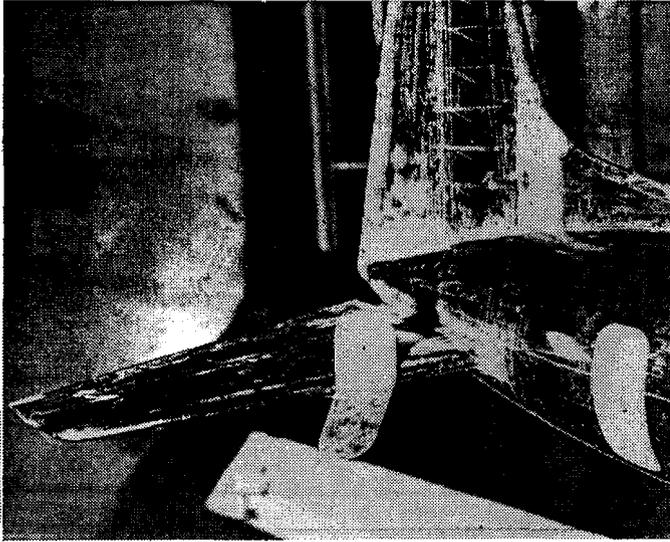
The results were as startling as they were unexpected. The tests showed that with the door in a stable position on the leading edge there was a marked discontinuity in the relationship between the pitching moment and the lift coefficient, equivalent to the instantaneous application of 7 degrees of elevator. This was accompanied by a violent shaking of the wind tunnel model. The effect would have been to produce an aircraft that was violently unstable with a reversal of elevator power; in other words a down application of elevator would have produced a pitch up. These wind tunnel test results became of acute interest when they were compared with the FDR read out which showed that such violent excursions in pitch had occurred and had continued until the aircraft broke up. There was good evidence upon which to base a conclusion that when the baggage door had come off, it had struck the leading edge of

the tailplane and become hung up. In support of this conclusion was the fact that the door was close to the main wreckage, whereas had it separated from the aircraft and fallen clear, it would have been many miles from the main impact site.

The investigation had now reached the stage where it had established, with the fair degree of certainty, what had happened. It now remained to establish why the door had come off in the first place, and this led us into a form of wreckage reconstruction which we had not previously attempted. The aft baggage door is an outward opening door secured in the closed position by four claw type catches which act on fretting pads inside the door aperture. These catches have a geometry which causes the door to be drawn into the aperture by the over-centering action of links attached to the claws. In addition to this over-centering action, movement of the claws is prevented, once the door is closed, by the engagement of secondary locks which prevent further movement of the linkage. The movement of the door lock mechanism by either the external or the internal lever moves the secondary locks and the primary locks in the correct sequence as determined by a fixed cam under the inner handle. Also integral with the door lock mechanism are two indicator drums which give a visual indication of the position of the locking mechanism. The viewing windows of these drums were installed incorrectly, inside out; the significance of this I will discuss later.

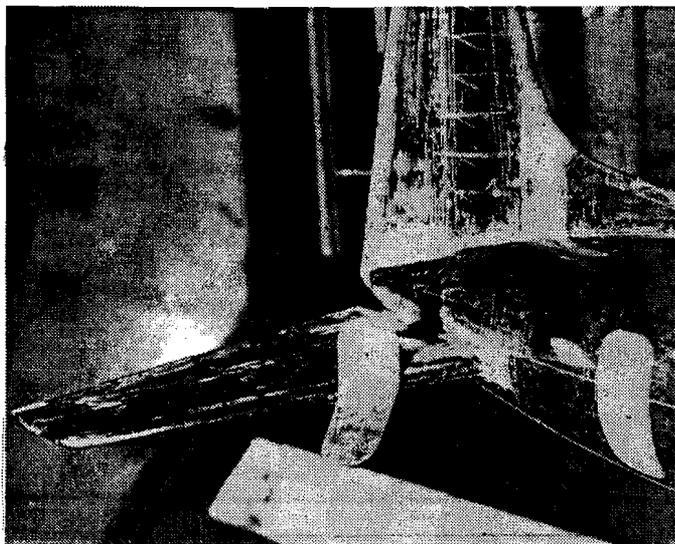
the tailplane and become hung up. In support of this conclusion was the fact that the door was close to the main wreckage, whereas had it separated from the aircraft and fallen clear, it would have been many miles from the main impact site.

The investigation had now reached the stage where it had established, with the fair degree of certainty, what had happened. It now remained to establish why the door had come off in the first place, and this led us into a form of wreckage reconstruction which we had not previously attempted. The aft baggage door is an outward opening door secured in the closed position by four claw type catches which act on fretting pads inside the door aperture. These catches have a geometry which causes the door to be drawn into the aperture by the over-centering action of links attached to the claws. In addition to this over-centering action, movement of the claws is prevented, once the door is closed, by the engagement of secondary locks which prevent further movement of the linkage. The movement of the door lock mechanism by either the external or the internal lever moves the secondary locks and the primary locks in the correct sequence as determined by a fixed cam under the inner handle. Also integral with the door lock mechanism are two indicator drums which give a visual indication of the position of the locking mechanism. The viewing windows of these drums were installed incorrectly, inside out; the significance of this I will discuss later.

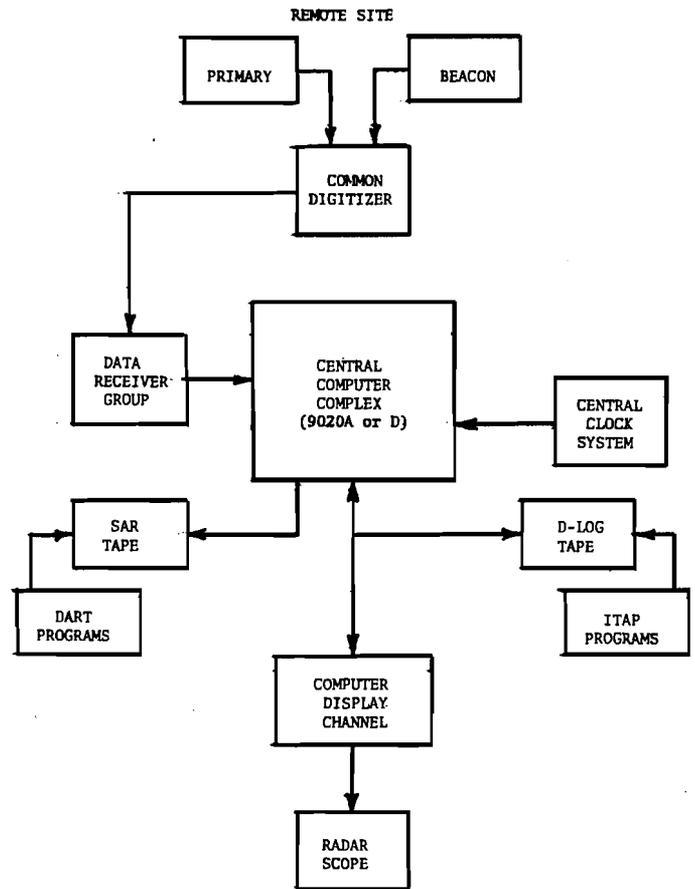
Figure 1

The FDP function of the CCC accepts, checks, processes and distributes flight data received from prefiled, pending and active flight plans. This flight information can be modified by the CCC receiving manual inputs, interfacility messages from other computer-equipped ARTCCs, or by the computer program associating flight plan position with the radar derived position of the aircraft. These features allow the computer to display the radar data with associated alphanumeric information on the radar scope and the FDP function aids in the tracking process. Multiple radar data processing and tracking are also provided. A number of radar sites might be involved in tracking a particular aircraft. Where overlap occurs, primary radar and beacon code signals from the radar site that provides the best coverage are designated as preferred signals and are used by the computer to track the aircraft. Signals received from the radar site providing the next best coverage are designated as supplementary and are stored for use as necessary. An essential function in the tracking of an aircraft is the correlation and prediction process. The tracking is either initiated automatically or manually. The radar data is examined and the

datum which corresponds to the predicted position of a track is selected for further processing. The computer uses either the flight plan route and speed or previously correlated radar data to determine the predicted position and velocity of a target. When difficulties in this tracking process are encountered, the computer track is placed in a "coast" mode. This coast track is maintained by the computer using the previous radar data derived velocity or flight plan route. After a predetermined amount of time has elapsed, the computer drops the track provided no update information is received.²

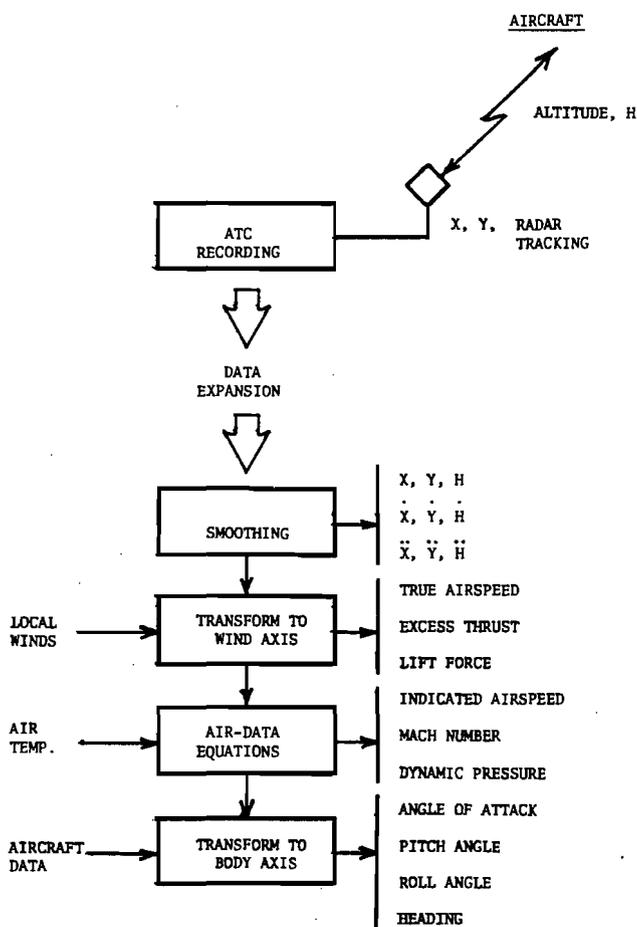
Figure 2

Primary Target	Full Data Blocks
All or Selected Beacons	Datum X, Y
Discrete or Non-discrete Beacons	Latitude, Longitude
Tracks	Time
Limited Data Blocks	Weather Outlines

EXPANSION OF ATC RADAR DATA

The objective of the NASA program is to expand the radar data to reveal the aircraft's attitude, velocity and performance. The method used involves a "smoothing" program based on a nonlinear, fixed-interval calculation. With the inclusion of meteorological data (wind and temperature) and aircraft aerodynamic data (W/S , α_o , and C_{L_o}) an expanded set of motion time-histories along the aircraft's trajectory can be derived.¹⁰ (Figure 2)

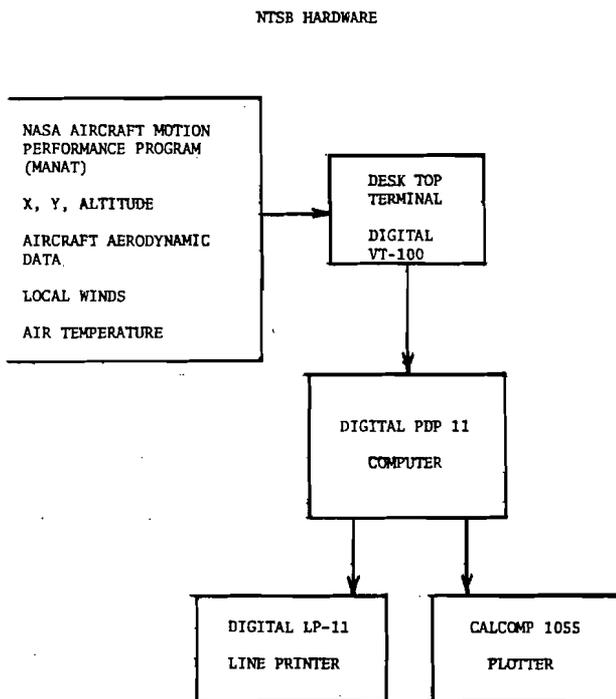
Figure 3

Our program requires two input files, and creates an output file for plotting and an output listing. The output listing can be directed to the terminal or to the line printer. The first file contains the aircraft's performance characteristics, smoothing intervals, and wind and temperature information. The second file contains the radar track information from which the aircraft performance trends are to be derived. This program data can be either Enroute or ARTS-III data. The program assumes that all the data is oriented to true north. (Figure 3)

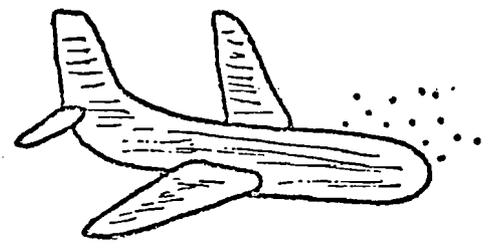
Weight Penalty

$$W = W_{a/c} + W_{rain\ on\ a/c}$$

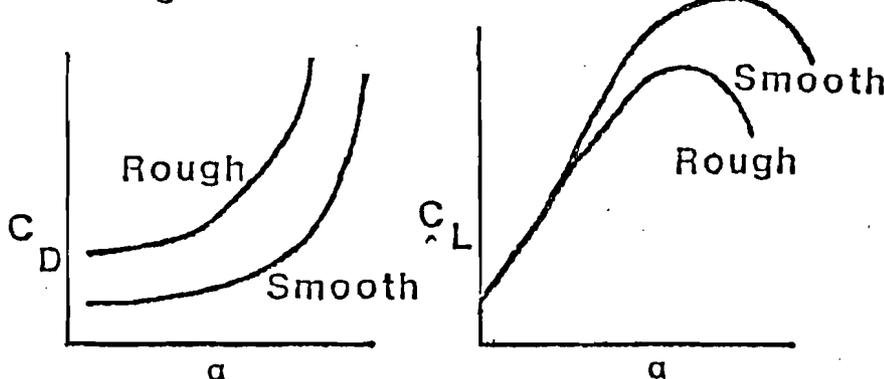
Roughness Penalty

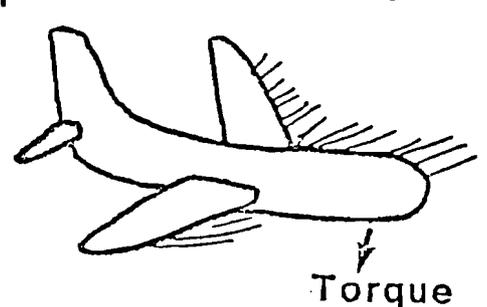
Moment Penalty

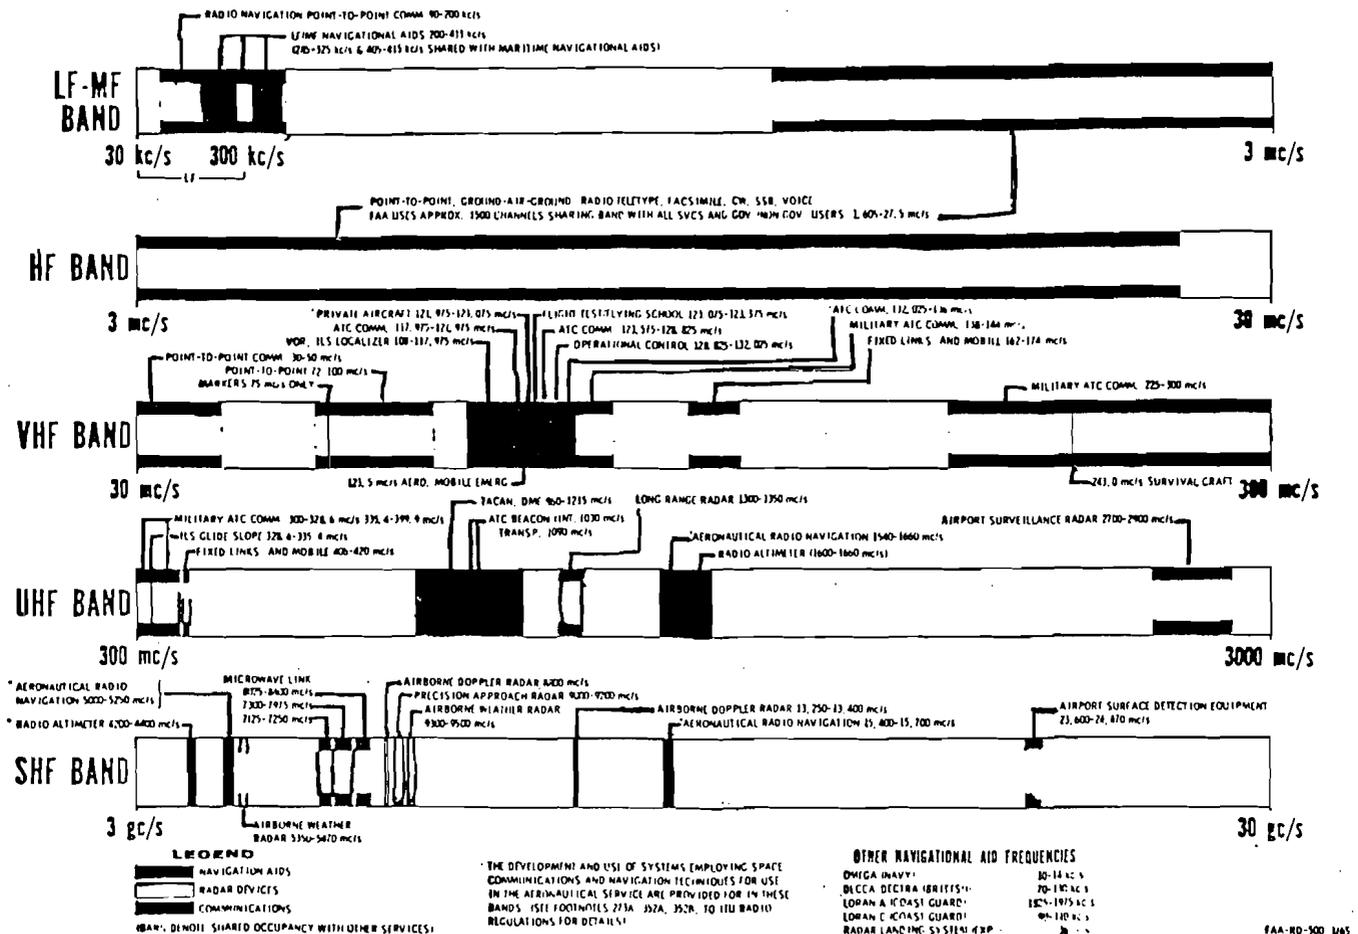
Figure 1

RADIO FREQUENCIES AVAILABLE TO THE AERONAUTICAL SERVICES

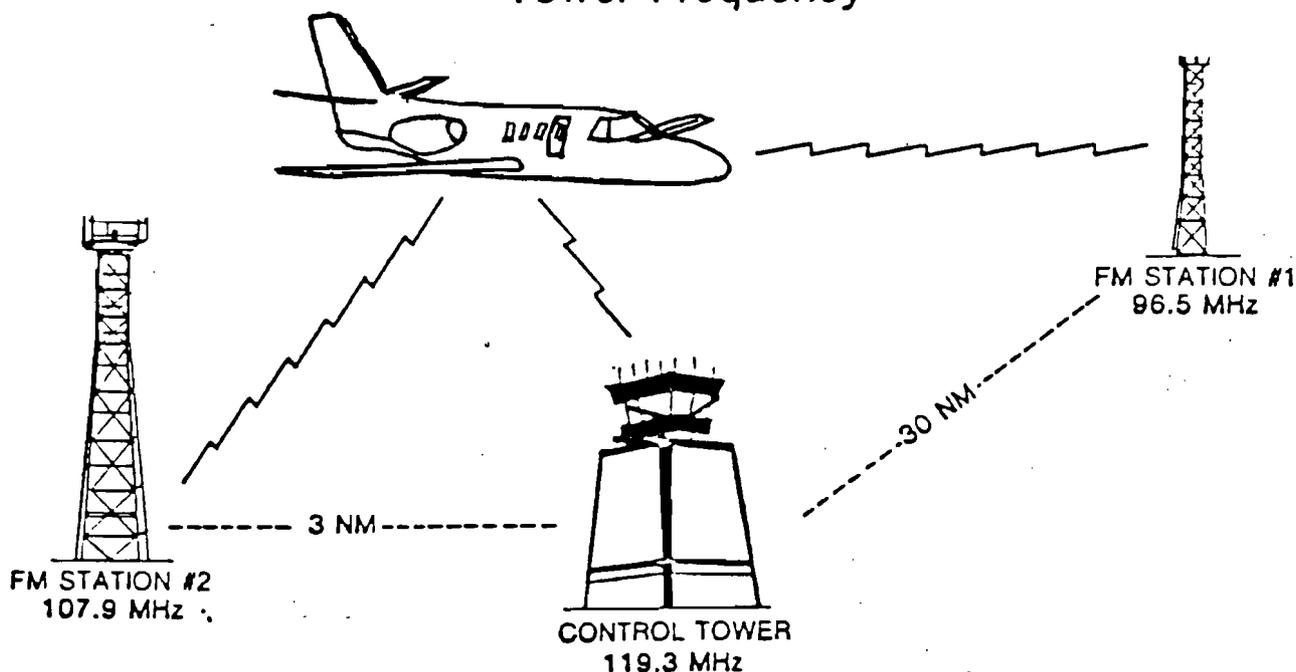
Figure 2

Intermodulation: How Two FM Stations Generate a Tower Frequency

FM Station #1, 30 nm northeast of the airport, is operating on 96.5 MHz. It may produce no interference to airborne receivers—until FM Station #2 is built 3 nm from the airport, well within the 20-mile service volume of the control tower.

As an aircraft flies near FM Station #2, its com receiver is overdriven by the 107.9 MHz signal, causing the receiver to generate a second-harmonic signal on 215.8 MHz. When the receiver is in this condition, it is susceptible to 96.5 MHz signals of FM Station #1. The airborne receiver now contains the following mixing products:

The foregoing was issued in 1982 subsequent to the accident reports quoted above. The final paragraph of the excerpt echoes the necessity for education of the members of the aviation operational community to the potential hazards of electronic generated misinformation to navigational equipment in the cockpit. Just as the NTSB Recommendations from the accidents reflected above urge notification of users of potential hazards, the purpose of this paper is to notify the international aviation community of the growth of the potential for such hazards by the expansion of the electronic media. The allocation of the radio frequency bands available is shown in Figure 1. These are normally uniform under ICAO, but may have some variations. The specific numbers are not so important as is the way different sources relate to each other; i.e., "intermodulation." This phenomenon will be examined herein in relation to FM transmission because that is where the most extensive investigation has been conducted. An illustration is shown in Figure 2.

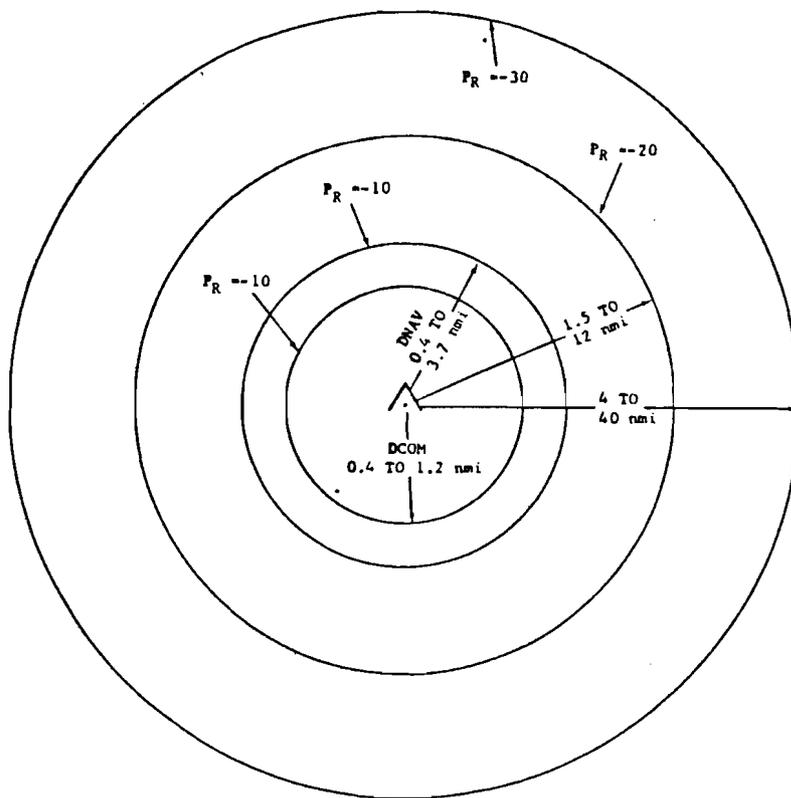
KEY:

P_R --10 WITHIN THE SIGNAL LEVEL OF P_R --10, DCOM INTERFERENCE TO COMM RECEIVERS WILL PROBABLY OCCUR WHEN ONE OR MORE OTHER STATIONS HAS A P_R --30 CIRCLE WHICH OVERLAYS IT.

P_R --10 SAME CONDITION FOR NAV RECEIVERS AS FOR COM RECEIVERS BUT CIRCLE OF GREATER RADIUS DUE TO AVIONIC ANTENNA FREQUENCY RESPONSE.

Figure 3
Receiver Signal Level Diagram for PRDCOM and PRDNAV

If (d) is used as the radii of circles, they may be presented as in Figure 3. The value of (d) will vary as a function of frequency due to the antenna response. In Figure 4 the shaded areas indicate where the conditions are met for potential interference based on power levels from FM stations A and B, where -10dBm is the prime signal level and -30dBm the secondary. In Figure 5 the prime level is reduced to -20dBm while the secondary level is held at -30dBm. The shaded area again indicates the potential area of interference.

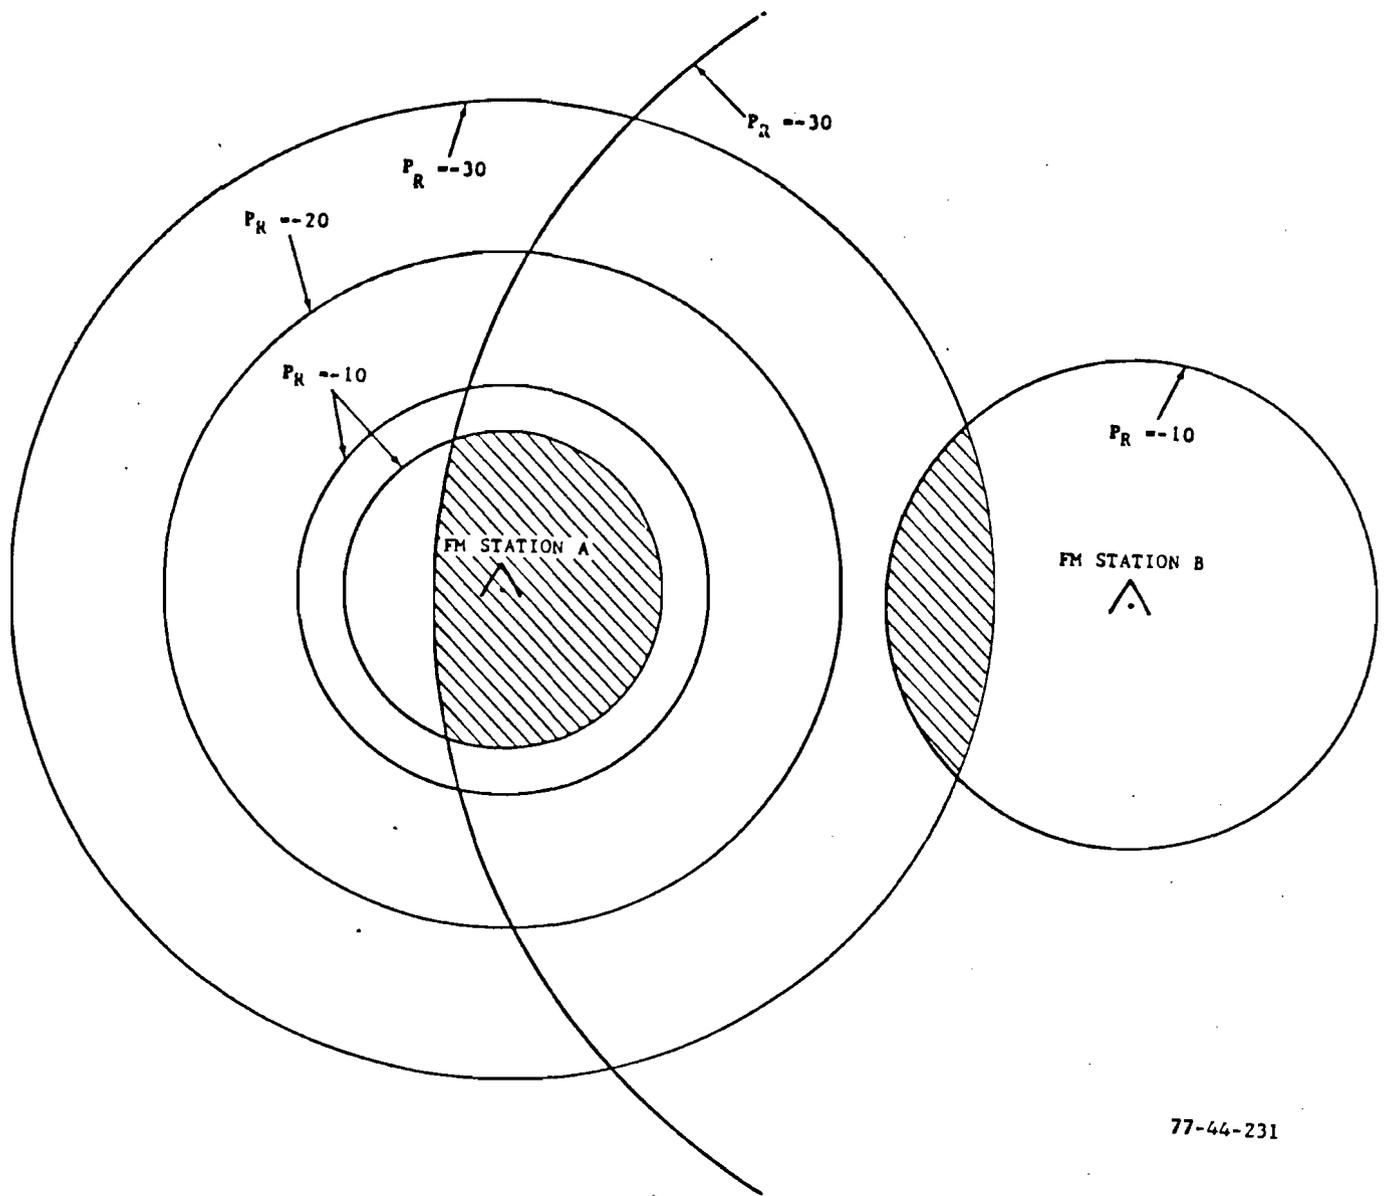
77-44-231

Figure 4
Two FM Station Interference Areas
for $PR = -10$ and $PR = -30$

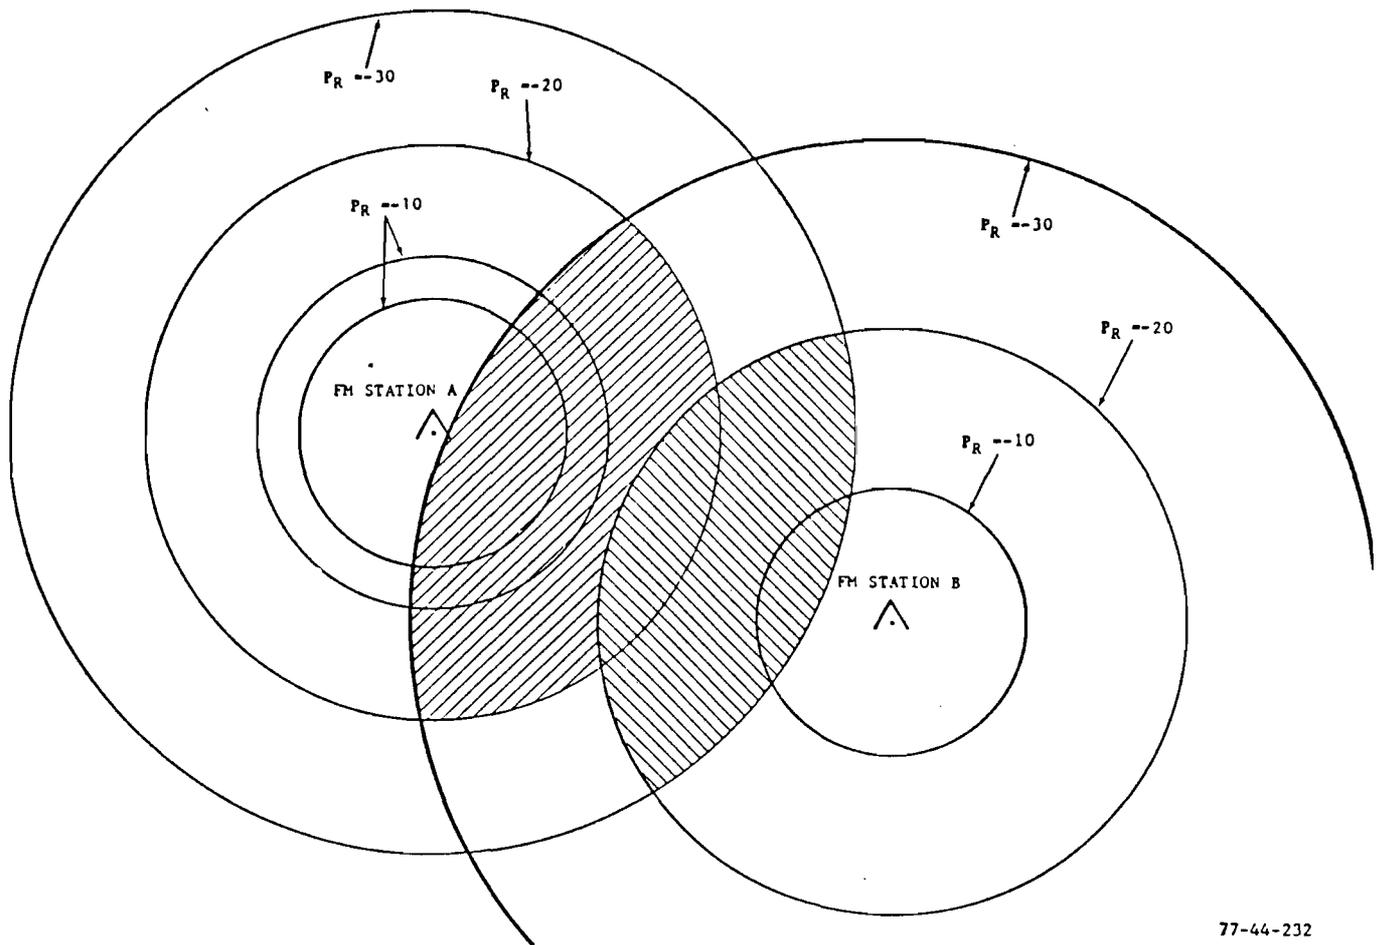
77-44-232

Figure 5
Two FM Station Interference Areas for $PR = -20$

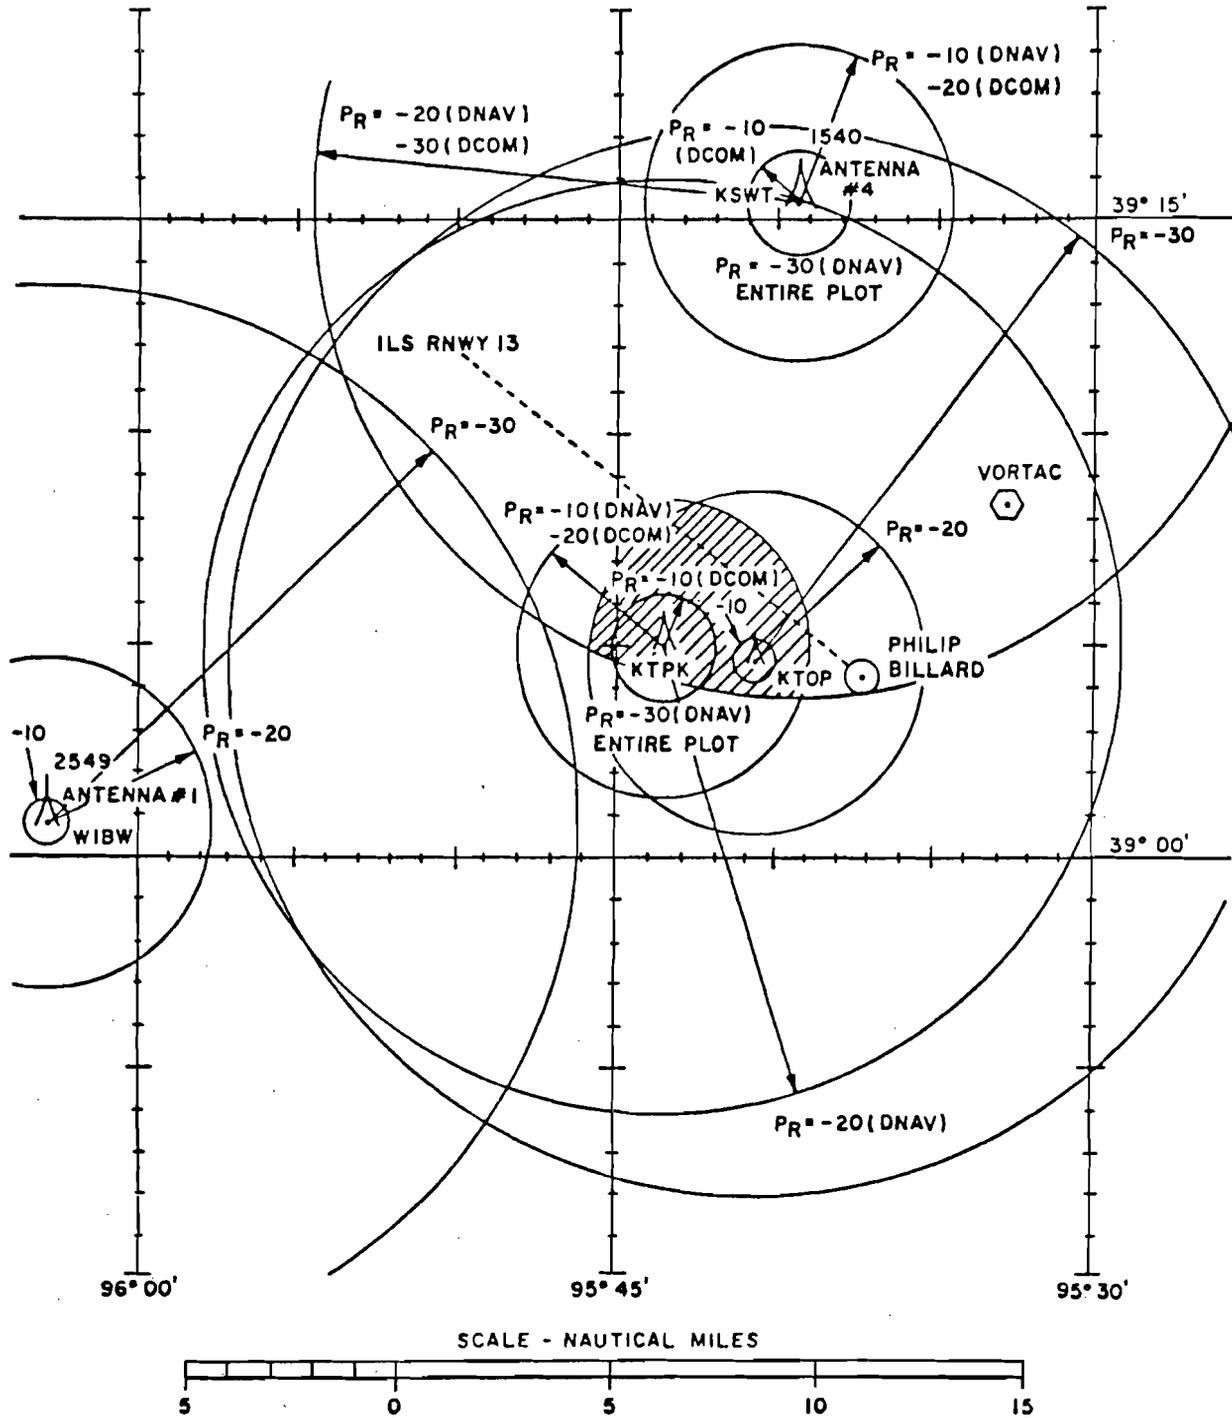
77-44-233

WIBW - 97.3 MHz, 97KW (ANTENNA #1)
 KTOP - 100.3 MHz, 5.3 KW (100KW FOR MAP)
 KTPK - 106.9 MHz, 100KW
 KSWT - 107.7 MHz, 100KW (ANTENNA #4)

PLOT OF TOPEKA AREA FM STATIONS AND
 VHF RECEIVER POWER LEVEL CIRCLES

Figure 6
 Topeka, Kansas FM Station Radiation Power Circles

Figure 6 illustrates the Topeka, Kansas, area for which power circles have been drawn around the local FM stations. Based on the required combination of KSWT, KTOP and KTPK for an intermodulation frequency of 121.7 MHz, the figures should be studied to determine the expected area of interference (crosshatched). Interference should be expected in the area common to that overlaid by the PR = -30 (DCOM) circle of KSWT, the PR = -20 (DCOM) circle of KTPK, and the PR = -20 circle of KTOP. The area defined as common to these three circles would be a conservative prediction of interference area for communication receivers. Recorded data for Topeka indicated that the predictions were substantially correct. Within the area, the effect of antenna radiation lobes causes the interference to appear to be intermittent, depending on the course the aircraft was flying through the area. The duration of interference is frequently only a few seconds, which reflects the lobe condition of radiation.

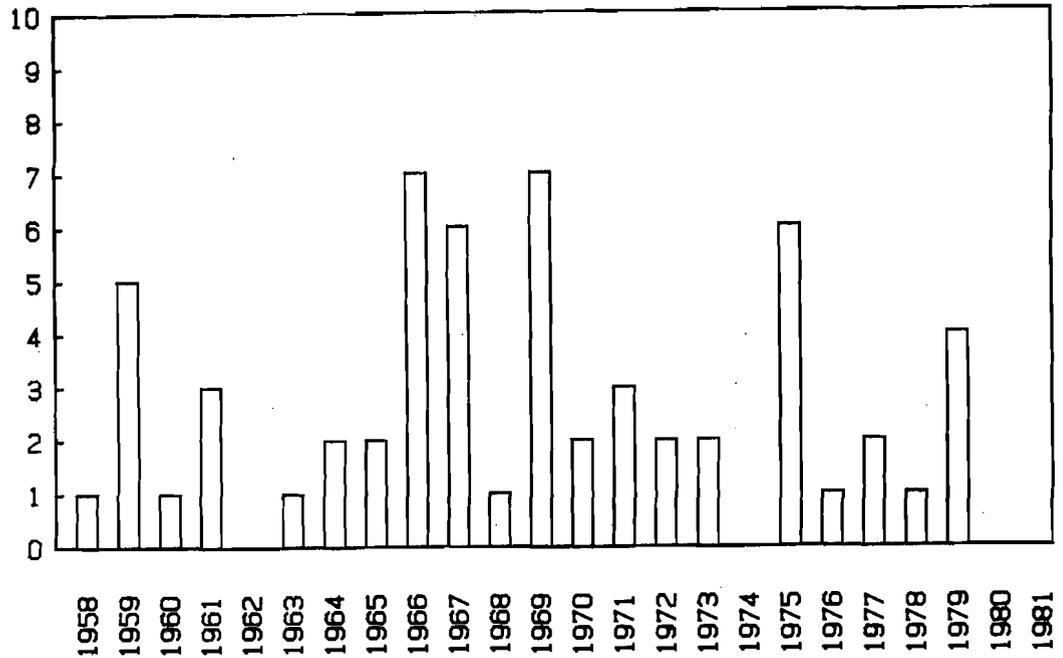
FIGURE 1

WORLDWIDE
JET AIRCRAFT
TRAINING
ACCIDENTS

During the period 1958-1980, 65 jet transport training accidents³ have occurred world-wide, (Fig. 1). Of this total, 31 have involved engine-out training, (Fig. 2). The severity of the engine-out training accidents can be seen in the data for the aircraft destroyed or the fatal accidents which have occurred in this phase of flight, (Table 4) While engine-out accidents accounted for only 46% of the total number of jet transport training accidents, the engine-out training accidents accounted for 81% of the destroyed aircraft and 83% of the fatal accidents.

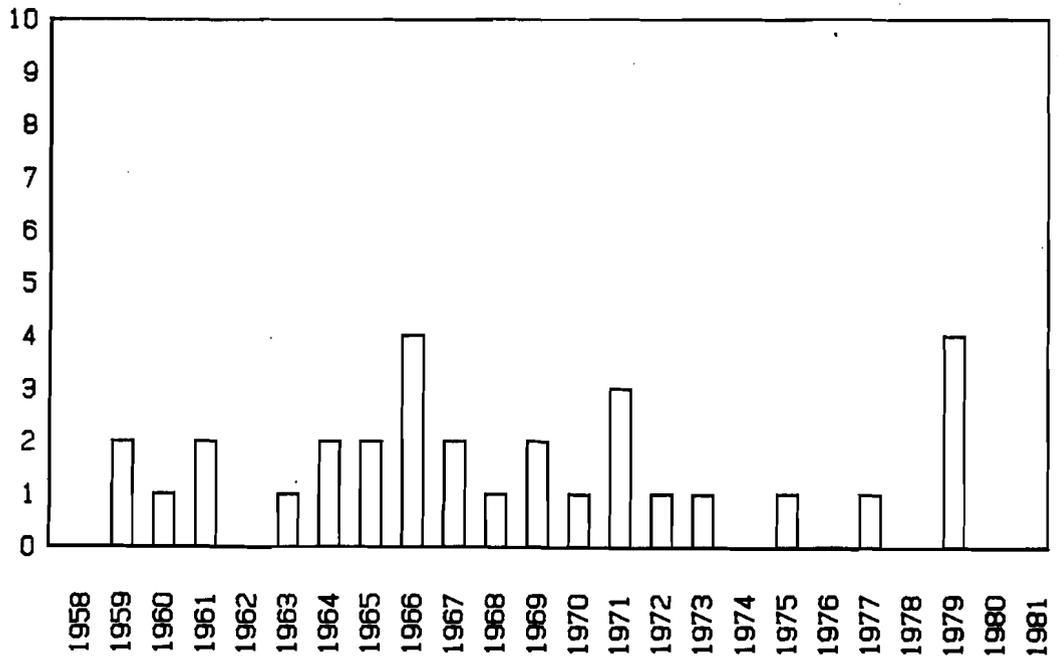
FIGURE 2

WORLDWIDE
JET AIRCRAFT
ENGINE-OUT
TRAINING
ACCIDENTS

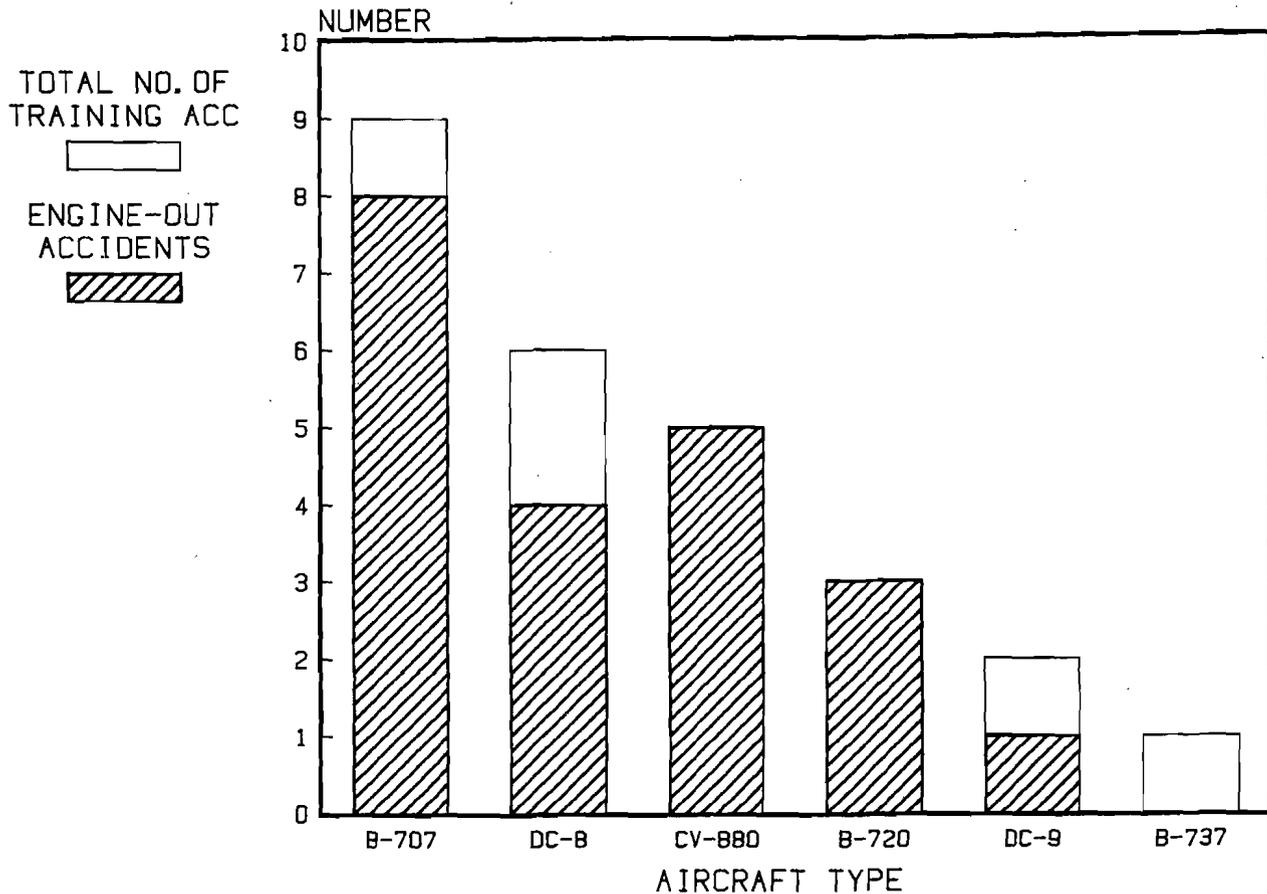
FIGURE 3

JET TRANSPORT TRAINING ACCIDENTS DESTROYED AIRCRAFT - WORLDWIDE

Because of the inherent aerodynamic characteristics of the 4-engine jet transports, they clearly accounted for the greatest number of engine-out training accidents, (Fig. 3). For the first generation of jet transports, the B-707/720, the DC-8 and the CV-880/990, there were 47 training accidents of which 29 or 62% were engine-out. Of the aircraft destroyed in training, 87% (20 of 23) involved engine-out procedures. Of the total fatal training accidents, 15 of 17 involved engine-out procedures (88%).

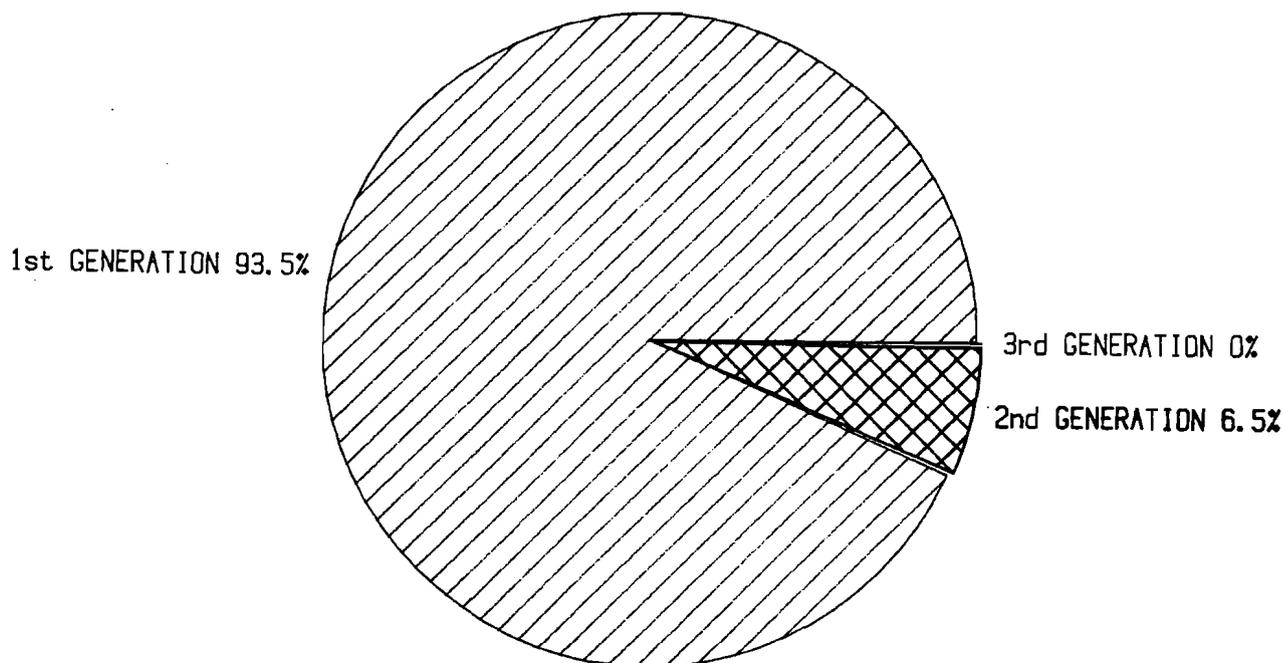
ENGINE-OUT TRAINING ACCIDENTS BY AIRCRAFT GENERATION

Figure 4 shows the engine-out training accident percentages by aircraft.

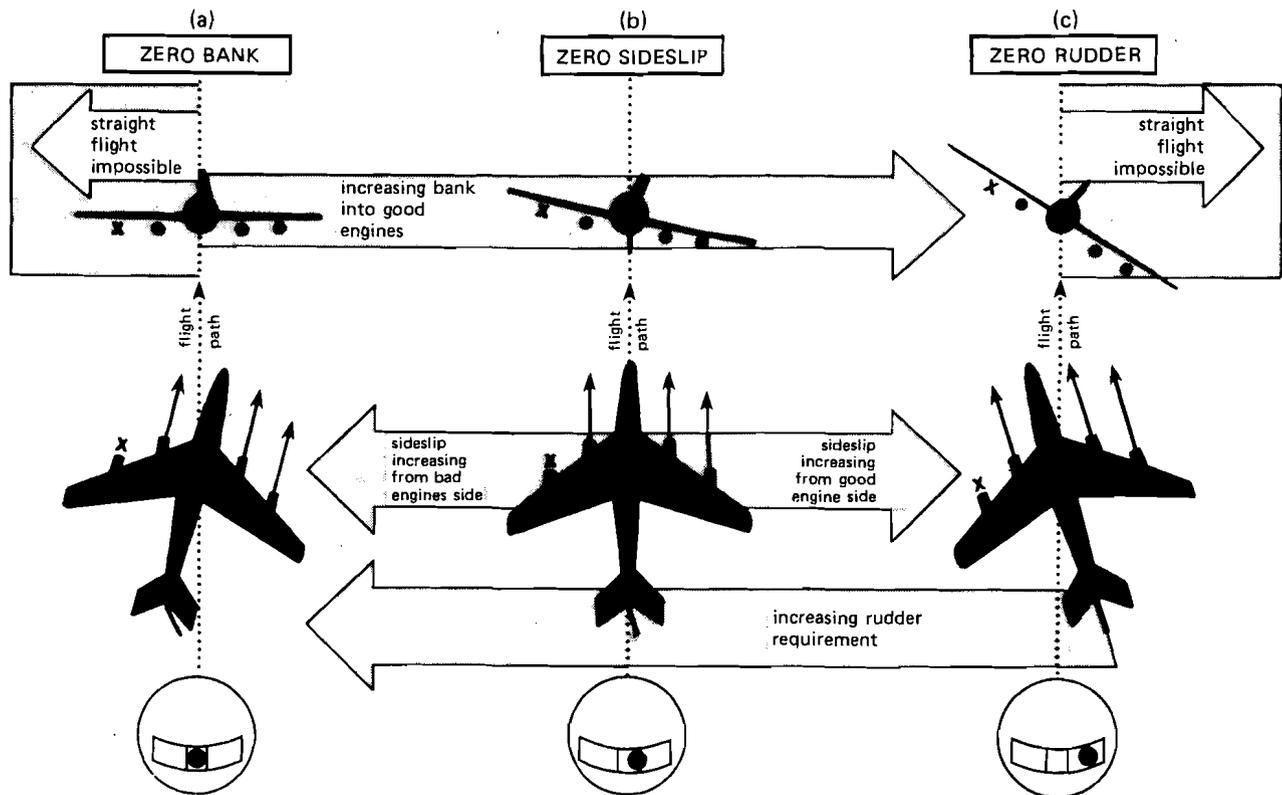
In Figure 5(c), a large amount of bank angle is being used with zero rudder deflection. The sideslip is now from the good engine side. The rudder pedals would be neutral with the yoke turned steeply toward the good engines and the ball far out to the good engines side. The fuselage side force generated by sideslip is offset by tipping the lift vector, pointing it in the opposite direction.

Figure 5 shows the possible range of conditions of bank angle, sideslip and rudder deflection under which it is possible to maintain straight flight. But note, by definition of V_{mc} , that the minimum speed is not reached until the limiting conditions of up to 5° bank angle and full rudder are reached. (A further limit is that the rudder pedal force may not exceed 150 lbs.) In certification, the tests are continued until all limitations—that is, until the lowest possible speed within these limitations is reached. It goes without saying that these tests are most demanding and are continued until the pilot cannot demonstrate a lower speed. The reason that the manufacturer attempts to push this speed as low as he possibly can is because this speed has a powerful effect on takeoff performance, since other takeoff speeds are referenced to it.

Referring once again to Figure 5, it should be pointed out that the V_{mc} determined by the manufacturer and presented in the flight manual is determined with the airplane in a steady-state condition of flight existing *between* illustrations (a) and (c). In short, the V_{mc} is determined by measuring the maximum applied yawing moment coefficient that the airplane can balance aerodynamically while using up to 5° bank to hold a constant heading. The method involves calculating C_n (the yawing moment coefficient) from the actual engine thrust at the minimum test speed and noting the bank angle. If the bank is less than 5° in a test condition, this means that the minimum authorized speed might not have been obtained, inasmuch as it would be possible to reduce the speed further while holding heading by increasing bank. Figure 8 illustrates this condition. The slowest steady speed at which equilibrium can be achieved with 5° bank and full rudder deflection is thus defined as the V_{mc} and it is this number presented in the flight manual. Note that the sideslip is from the good engine side and the ball is displaced slightly to the right. Indeed, to achieve the quoted V_{mc} , the 5° bank must be applied, and the ball displaced approximately one half width toward the good engines. During turns, the ball should be held in the *same* location, or perhaps returned toward dead center, but never should it diverge more-off-center.

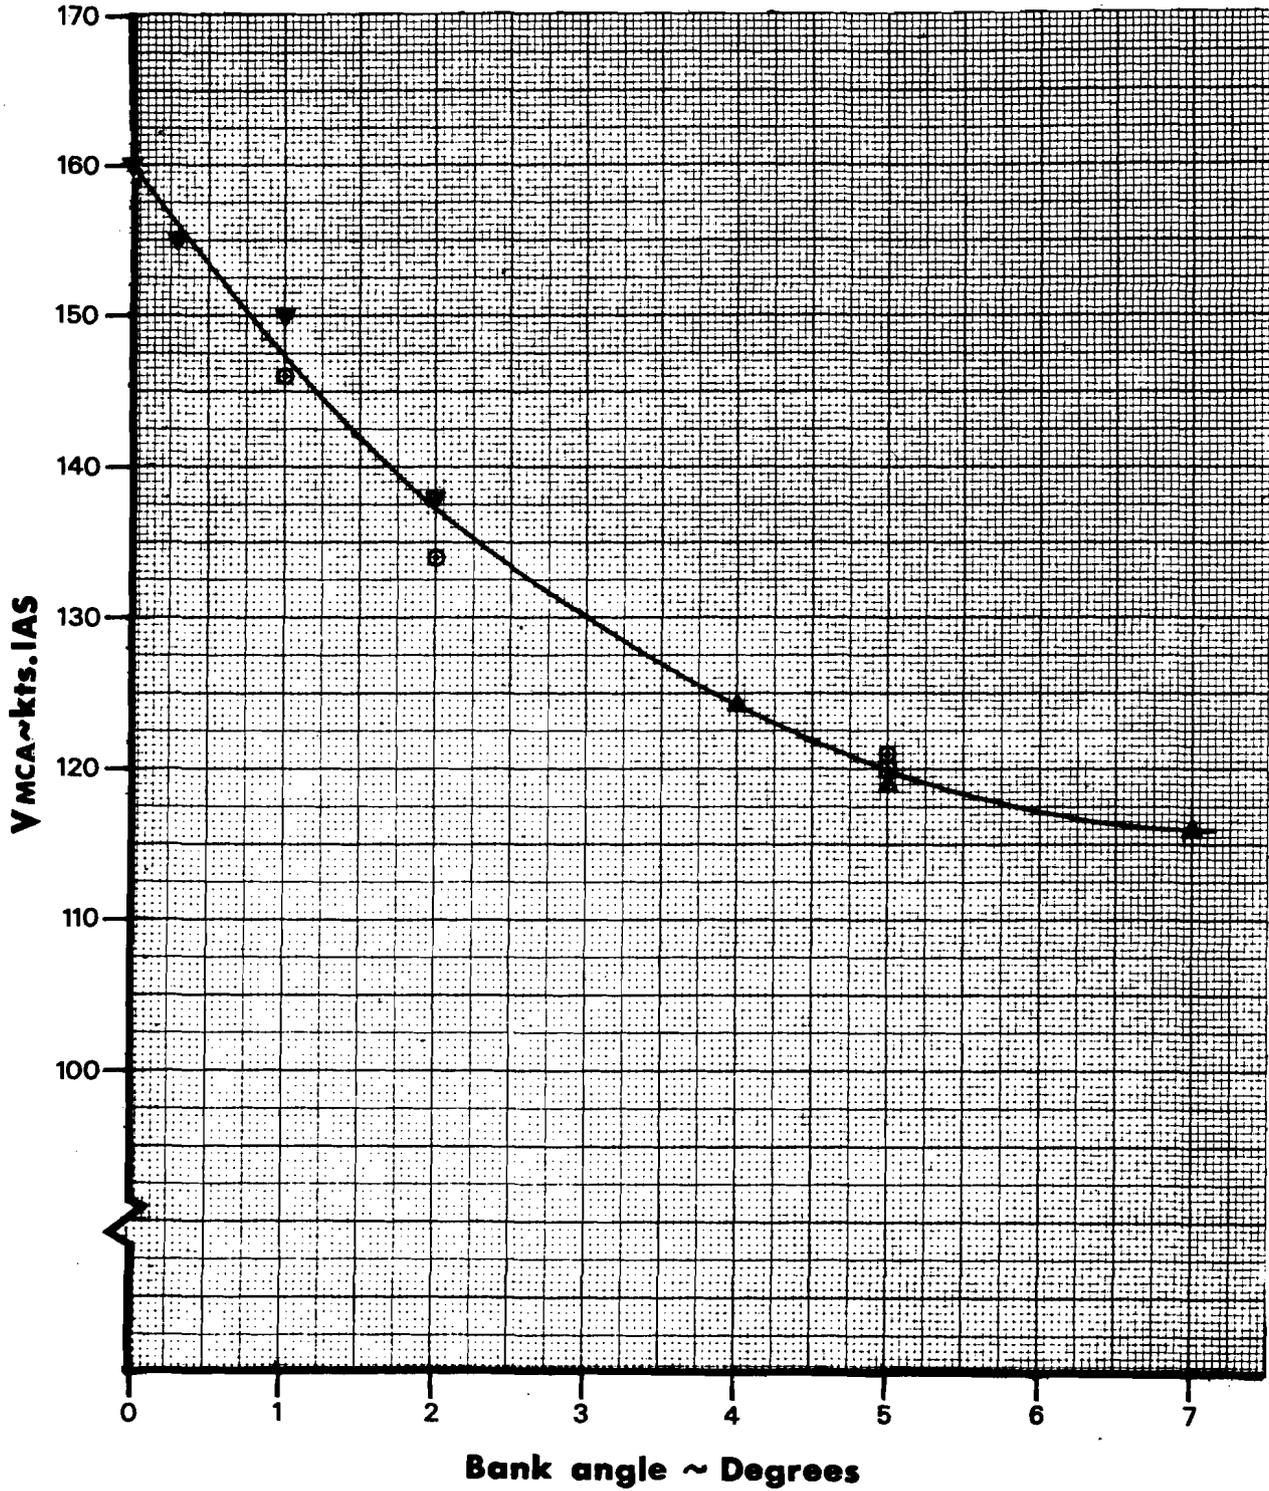
Figure 8

Effect of Bank Angle on VMCA B707-436

Reduced to ISA Sea Level Conditions

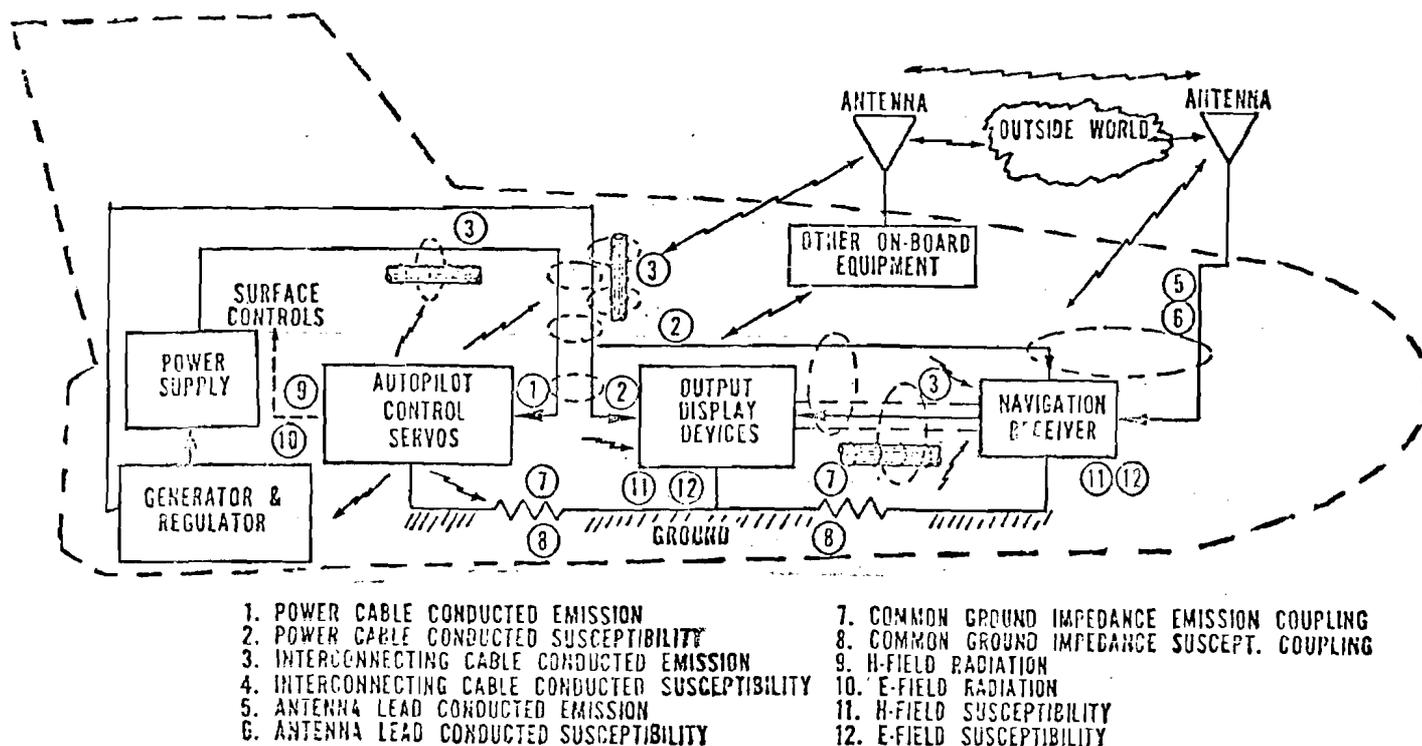
FIGURE 1.
Example of Inter-Aircraft Interference Problems

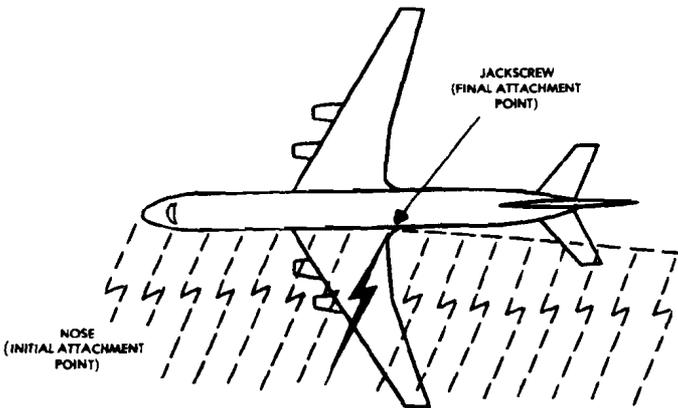
Figure 4
Swept-stroke attachment and inboard flap jackscrew attachment.

Wherever poor electrical contact exists between two mating surfaces, such as a control surface hinge or bearing across which lightning current may flow, melting and pitting of these surfaces may occur. In one incident, for example, the jackscrew of an inboard trailing edge flap of a jet transport was so damaged by a lightning flash that the flap could not be extended past 15°. Since this jackscrew is located on the inboard side of the flap, the flash must have reached it after sweeping along the fuselage from an earlier attachment point near the nose, as shown of Figure 4. Instead of continuing to sweep aft along the fuselage, the flash apparently hung on to the jackscrew long enough to melt a spot on it.
