forum

*Proceedings
of the
Thirteenth International
Seminar
of the
International Society of
Air Safety Investigators*

October 11-October 15, 1982

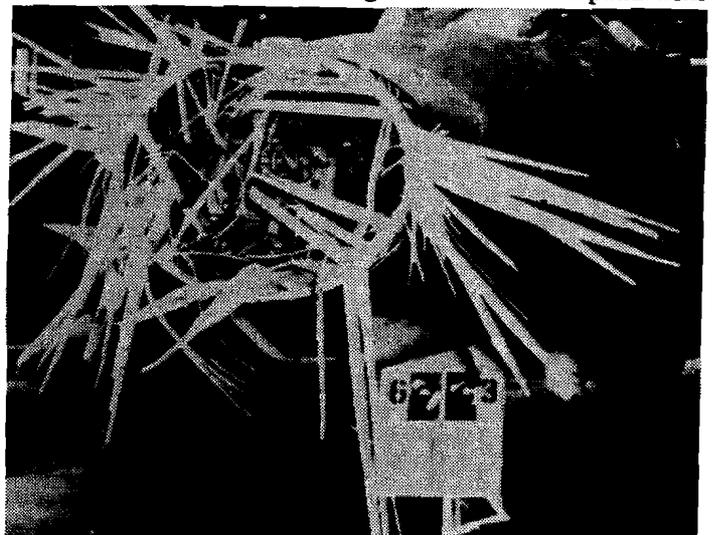
Figure 6
Lightning damage to radome—probably as a result of exploding pitot tube ground wire. (USAF photo)

supersonic speed. Its temperature has been measured by spectroscopy techniques to be 30000°K and the channel pressure (before expansion) about 10 atmospheres². The cylinder shock wave propagates radically outward from the center of the arc, and, if a hard surface is intercepted, the kinetic energy in the shock wave is transformed into a pressure rise over and above that in the shock wave itself. This results in a total overpressure of several times in the free shock wave at the surface. If an arc is contained inside a structure, such as would occur when a nonmetallic assembly is punctured, its overpressure may cause additional damage to the structure. This may have been responsible for some of the damage to the radome shown in Figure 6.

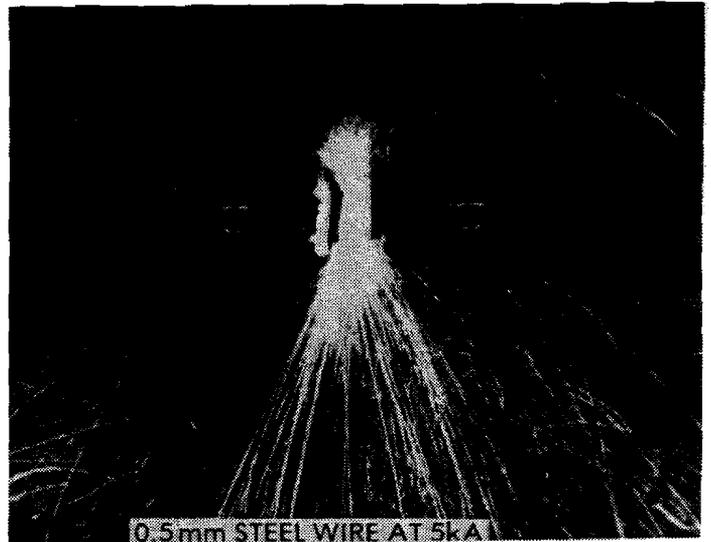
Figure 7
Resistive heating and explosive vaporization of conductors. (USAF photo)

When the resistivity of a conductor is too high or its cross-sectional area too low for adequate current conductance, lightning current flowing in it may deposit appreciable energy in the conductor and cause an appreciable temperature rise. Resistive energy deposition is proportional to the lightning current action integral ($\int i^2 dt$), and for any conductor there is an action integral value at which the metal will melt and vaporize, as shown in Figure 5. Consequences of resistive heating and explosive vaporization of conductors are shown in Figures 6 and 7. The damage is usually most severe when the exploding conductor is within an enclosure, which contains the explosion until the pressure has built up to a level sufficient to rupture the container.

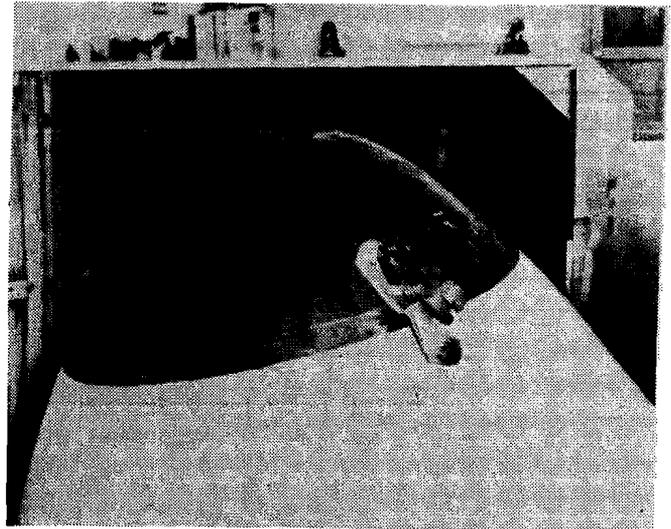
Figure 8
Puncture of a fiberglass-honeycomb radome. (UAL photo)

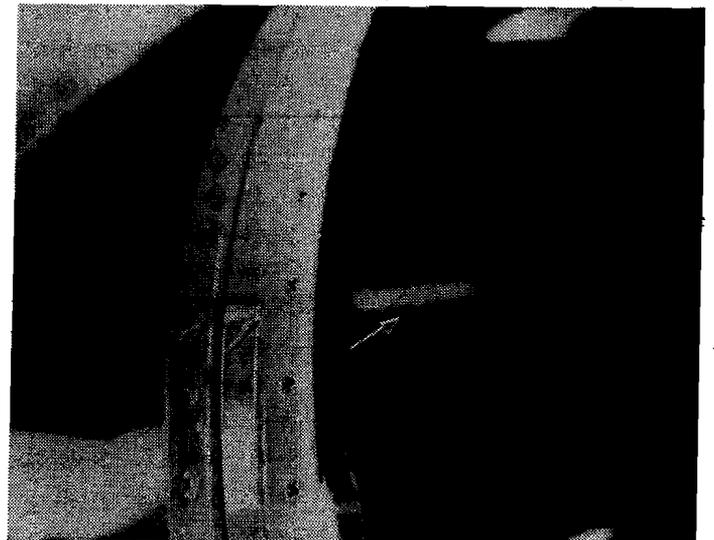
Figure 9
Evidence of lightning attachment to canopy fastener and scorching of canopy. (GE photo)

Nonmetallic material is nonconducting. Electric fields may penetrate it and initiate streamers from metallic objects inside. These streamers may puncture the nonmetallic material as they propagate outward to meet an oncoming lightning leader. This puncture begins as a pinhole, but as soon stroke currents and accompanying blast and shock waves follow, much more damage occurs. An example of a puncture of a fiberglass-honeycomb radome is shown on Figure 8. Transparent acrylics and polycarbonate resins are utilized for canopies, windows and windshields. These materials are usually found in zone 1 and zone 2³ locations, where either direct or swept-lightning flashes may occur. Most of these materials are very good insulators, however, and so will successfully resist punctures by lightning or streamers. An example is shown on Figure 9.

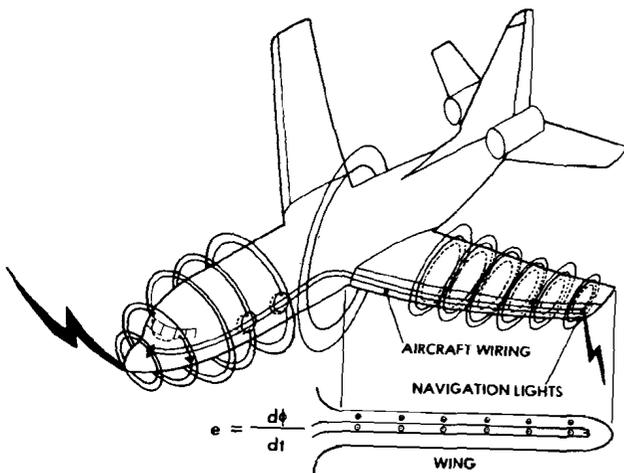
Figure 10

Magnetic flux penetration and induced voltages in electrical wiring.

Even if the lightning flash does not directly contact the aircraft's electrical wiring, strikes to the airframe are capable of causing voltage and current surges in the wiring which may be damaging to aircraft electronics. The mechanism whereby lightning currents induce voltages in aircraft electrical circuits is illustrated in Figure 10. As lightning current flows through an aircraft, strong magnetic fields which surround the conducting aircraft and change rapidly in accordance with the fast-changing lightning-stroke currents are produced. Some of this magnetic flux may leak inside the aircraft through apertures such as windows, radomes, canopies, seams and joints. Other fields may arise inside the aircraft when lightning current diffuses to the inside surfaces of skins. In either case these internal fields pass through aircraft electrical circuits and induce voltages in them proportional to the rate of change of the magnetic field. These magnetically induced voltages may appear between both wires of a two-wire circuit, or between either wire and the airframe. In addition to these induced voltages, there may be resistive voltage drops along the airframe as lightning current flows through it. If any part of an aircraft circuit is connected anywhere to the airframe, these voltage drops may appear between circuit wires and the airframe, as shown in Figure 10.

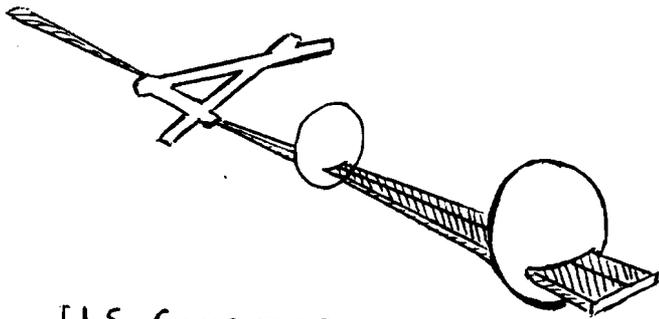
ILS Coverage

jects is the need for establishing a large area of well-controlled terrain conditions around the ILS antennas, especially for the glide slope which provides the critical beams in elevation. This requirement often necessitates extensive and costly site preparation before the facility can be commissioned. In some cases an adequate area cannot be made available at all. This can severely limit facility performance to less than that desired or preclude a facility altogether.

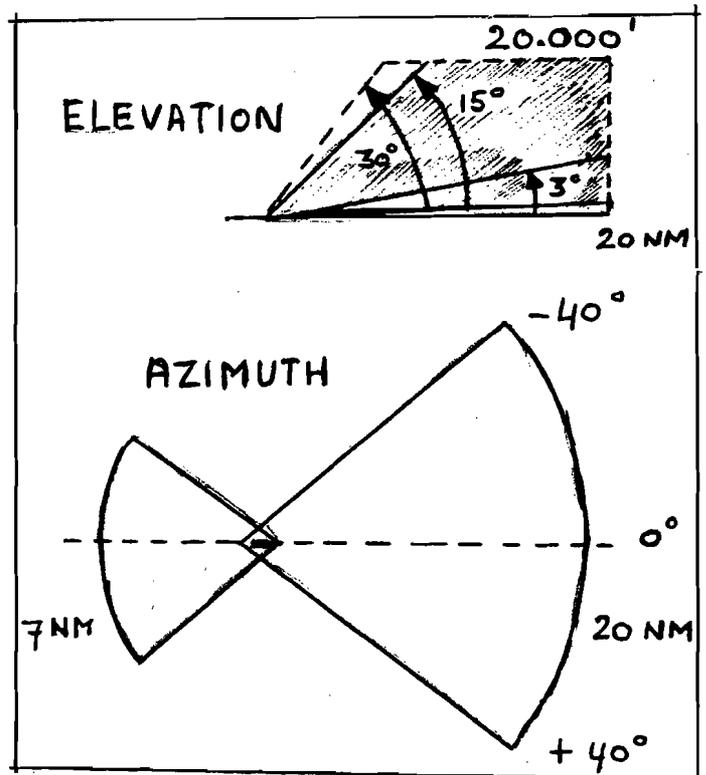
Ground Equipment

The antennas for approach and back azimuth guidance each produce a fan-shaped beam which is narrow in the horizontal plane and broad in the vertical plane. This beam is scanned clockwise, then counter-clockwise between the horizontal coverage limits at a precise rate, filling the entire coverage volume. The azimuth coverage volume is 40° left and right of runway centreline and 20 n.m. in distance. Each angle transmission consists of a TO (clockwise) scan followed by a FRO (counter-clockwise) scan. The elapsed time between reception of the TO scan and the FRO scan is directly related to the azimuth angle of the receiving antenna with respect to the line of zero azimuth angle. Where the proportional guidance provided is less than ± 40 degrees with respect to the runway centreline, clearance guidance is provided to extend the coverage sector out to that value by the transmitted fly left/right signals in the signal format for the azimuth functions. Proportional guidance is available in a minimum sector of ± 10 degrees.

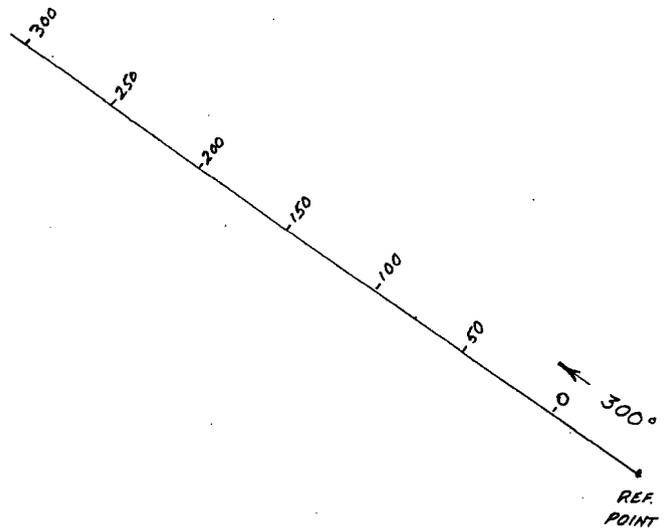
FIGURE 1
Start the diagram with the reference line.

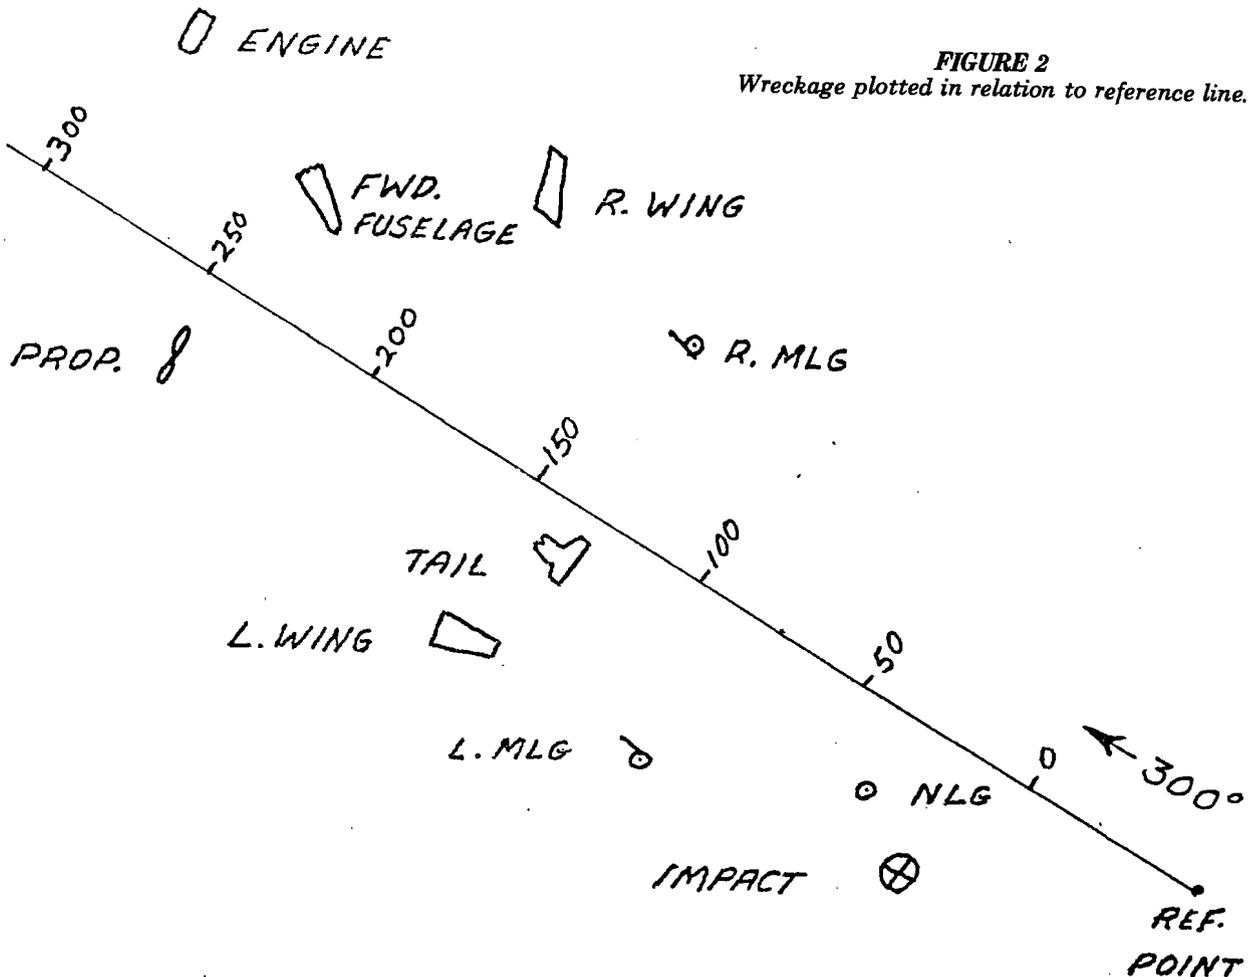
FIGURE 2
Wreckage plotted in relation to reference line.

2. Using the reference notes from your notebook, plot the wreckage parts on the diagram. This is shown in Figure 2.

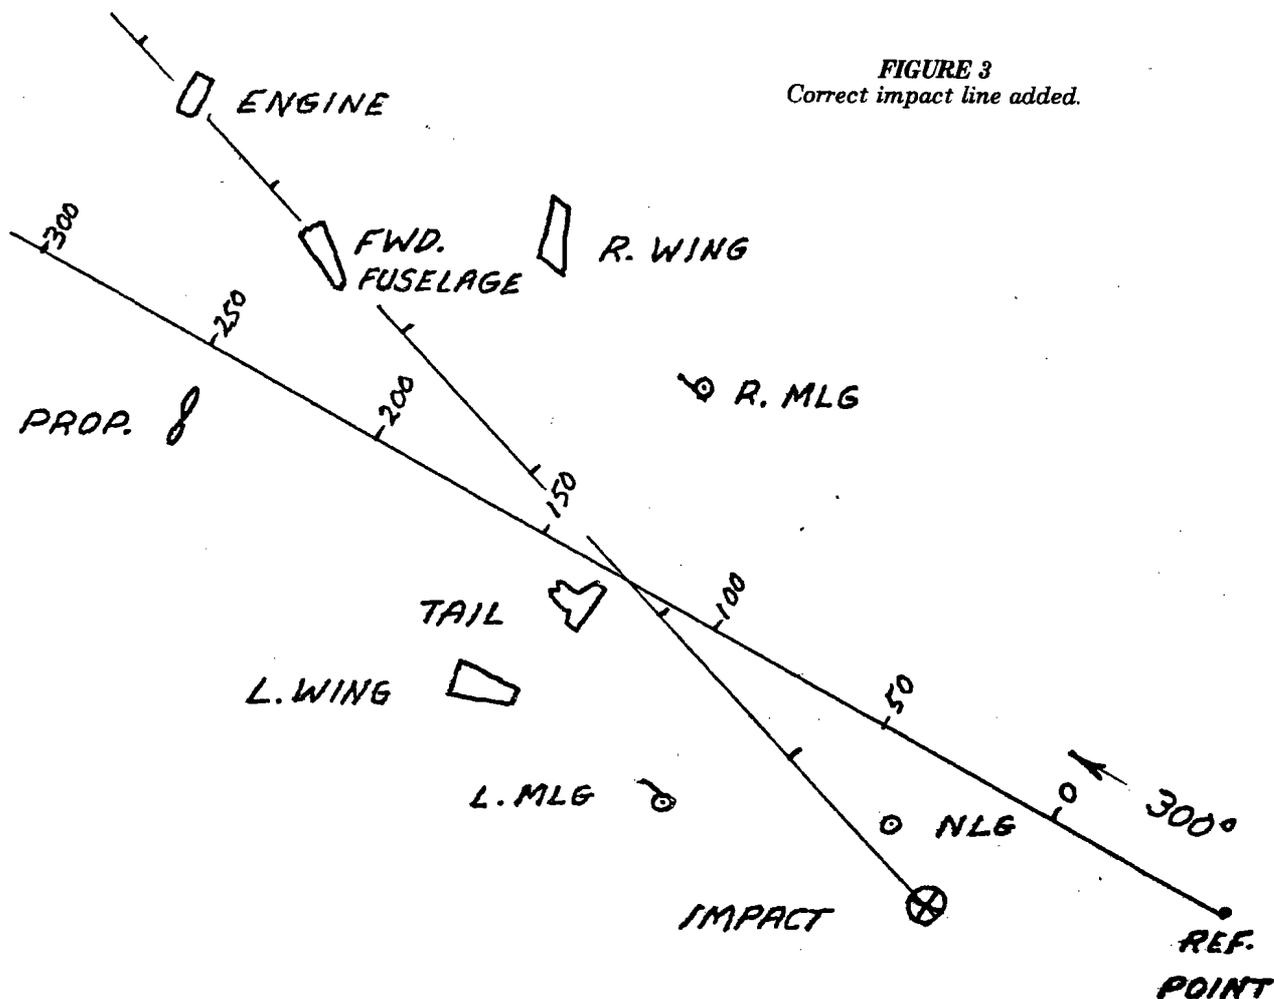
FIGURE 3
Correct impact line added.

3. Examine the diagram and determine what the actual line of impact (flight path of the aircraft) was. In the sample accident shown, the impact line was most likely from the impact crater through the center of the wreckage pattern to the engine. Here, you are determining impact heading from the diagram. This is just as accurate and, in some cases, more accurate than trying to do it at the wreckage scene. If, of course, you had positive evidence of impact heading (aircraft struck a tree prior to impact, for example) then you would use that as your impact line drawn from the impact crater. Figure 3 shows the impact line added to the diagram.

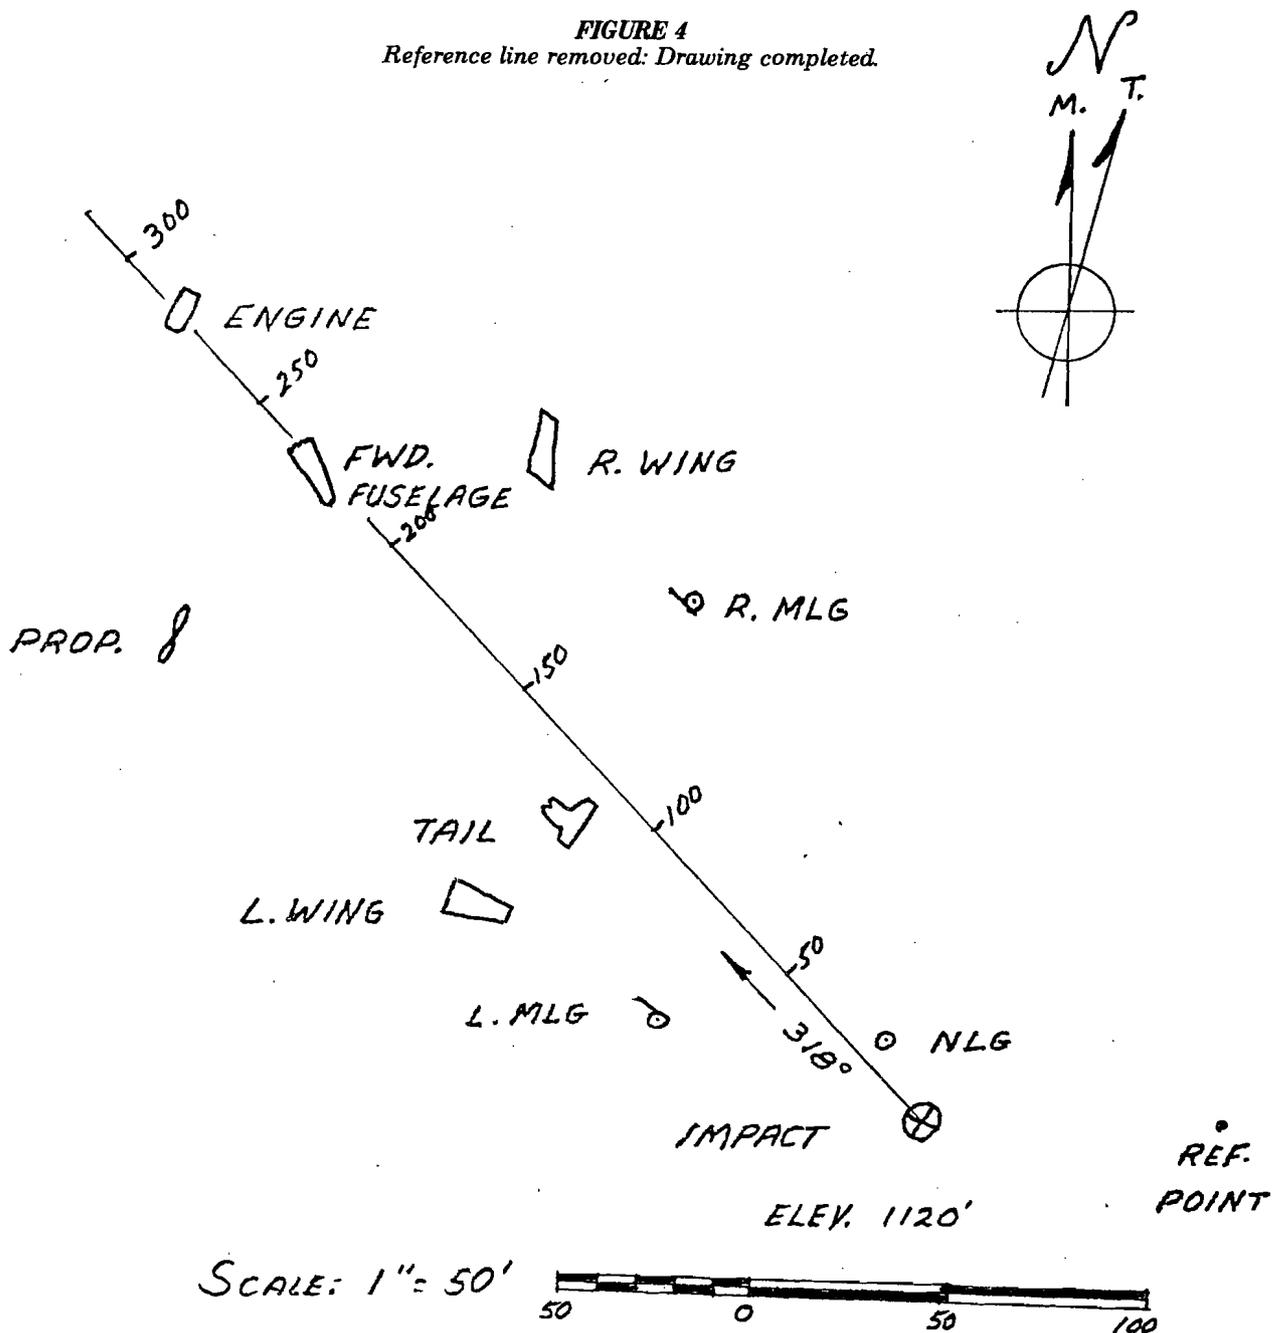
FIGURE 4
Reference line removed: Drawing completed.

Figure 4 shows the completed diagram with some of this information added and the reference line removed.
