INVESTIGATING EN-ROUTE TURBULENCE INJURY EVENTS

Captain Ed Pooley (mo5563) The Air Safety Consultancy

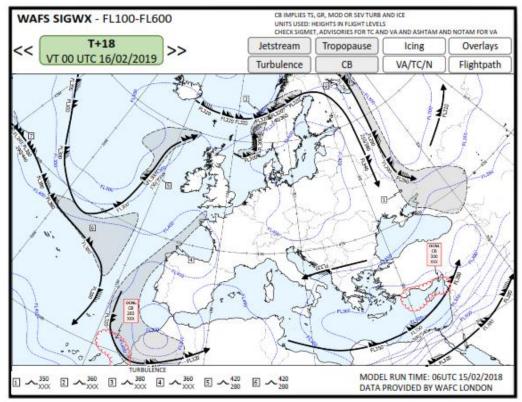
An example of the new SIGWX Chart Format [source: ICAO Meteorological Panel WAFS SIGWX Novembver 24 Upgrade Briefing]

Finally, to end on a positive note, next month will see the first appearance of thoroughly tested major improvements to WAFS¹³ SIGWX forecasts which are to be introduced by the two WAFCs¹⁴ (London and Washington). They have announced that they are both intending to file a difference against ICAO Annex 3 to enable earlier implementation of changes which are currently planned worldwide for November 2025. The current T+24 only fixed format analogue charts will be replaced with a new digitally-based system providing user-configurable charts spanning which will span FL100 to FL600 for T+6 to T+48 at 3 hourly intervals. An example of one of these charts configured to show Tropopause, Jetstream, Turbulence and CB¹⁵ is shown below (note that indicated CB will continue to imply associated turbulence both within and in the vicinity).
