*forum*

*The International Society of Air Safety Investigators*

Volume 18, #3  
October 1986

*Proceedings  
of the  
Sixteenth International  
Seminar  
of the  
International Society of  
Air Safety Investigators*

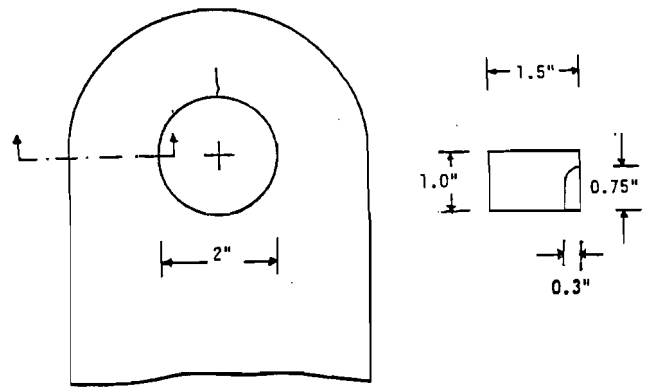
Figure 7: Cracked Lug Under Stress Corrosion Cracking Conditions

The example to be considered is failure of a lug under stress corrosion conditions (figure 7)

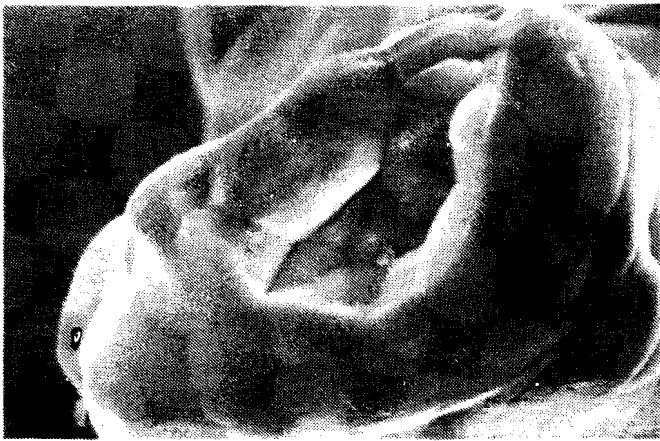
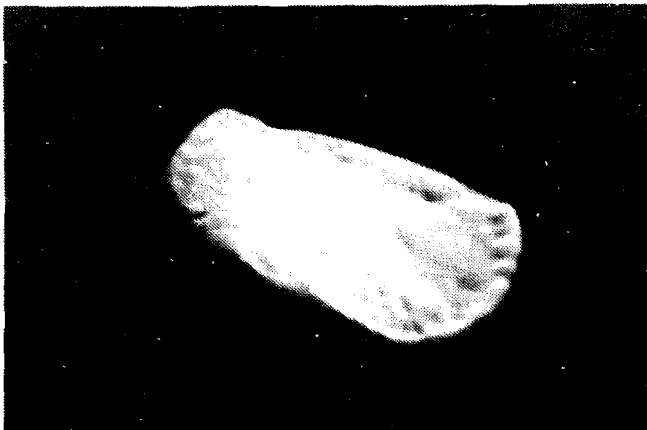
FIGURE 11 — Cold fractures in an unnotched filament (a), notched filament (b), and a hot fracture (c).

ing cause the microstructure to continually change, not necessarily in a uniform manner. Because of the non-uniform microstructure development it is not uncommon to observe different fracture characteristics in the same bulb. Figure 11a shows a fracture surface typical of a cold break in an unnotched filament, while figure 11b shows a cold fracture in a notched filament that appears smooth and featureless.

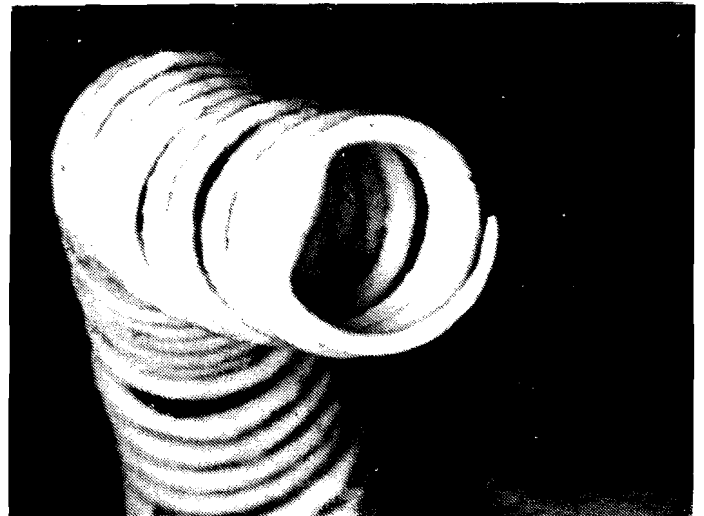
FIGURE 12 — Hot filament subjected to severe impact (a), and resulting fracture area (b).

When a hot filament is subjected to severe impact, the ductile state of the filament allows it to deform and uncoil without necessarily breaking. As the hot filament stretches, the probability of the filament crossing together and shorting itself out increases. Very often, the failure mode during a hot impact is burn-out due to this shorting. The fracture does not necessarily occur at the point of contact, but usually somewhere in the length of filament that was short circuited. Figure 12a shows a hot filament (aged 210 hours) that was subjected to approximately 1700 g half-sine impact over 1.4 milliseconds. Fracture did not occur until a few seconds after impact, when the bulb was observed to glow brighter than normal and then burn out. Figure 12b shows in detail the fracture area which is characterized by an 'aneurysm' effect or widening of the filament near the final fracture. This widening is also evident in bulbs that have failed due to excessive voltage, such as when an entire system gets shorted and bulbs see high voltages. Bulbs fractured due to high voltage alone however, do not exhibit the filament deformation found as a result of impact.

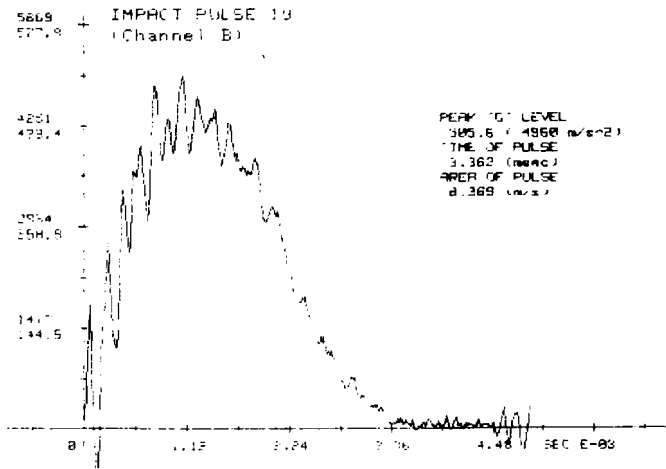
Figure 16

FIGURE 16 — Typical acceleration-time curve as processed by computer.

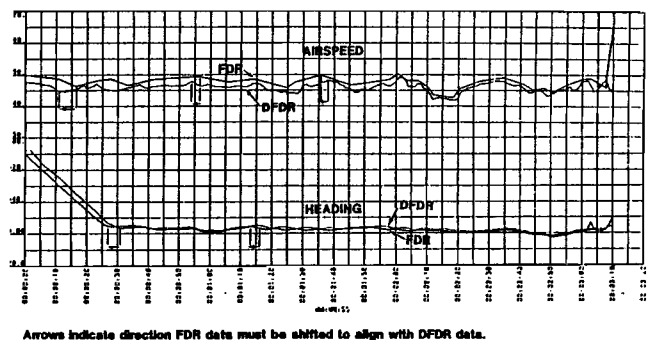
Figure 1.

The Controlled Impact Demonstration (CID) where a Boeing 720 [4] was remotely piloted into the lake bed at Edwards AFB on December 1, 1984, also provided a very good example of a short-term timing error. The 720 comparison of the data recorded on the FDR and the digital records demonstrates this problem quite clearly. The plot of the digital and the FDR data in Figure 1 shows a clear match between the two recordings for airspeed and heading for the last 50 seconds. Then the data begins to show timing disparities in some cases as large as 4 seconds. A similar match in the data can be made if the data is shifted so as to align the first seconds of the plotted data. Clearly in this instance the minute marks recorded by the FDR were inadequate to detect the short term timing variations.

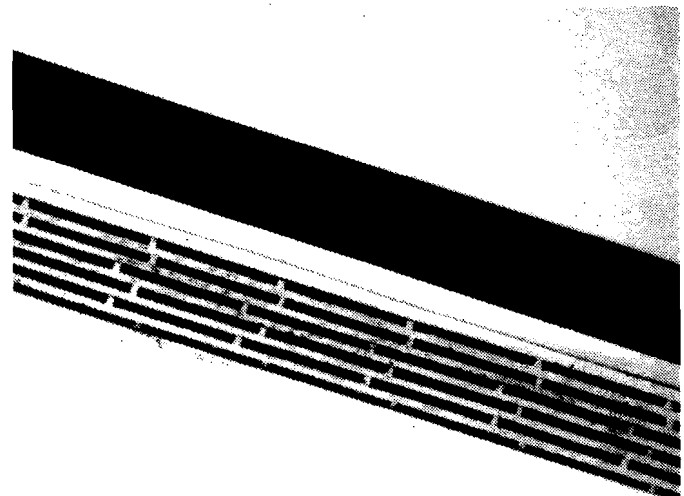
Figure 13

An actual recording is shown in Figure 13. The Magnasee process was used. The recording shows 1 second data bursts separated by a blank word. Data is recorded sequentially on the 6 tracks. The data rate is 10 words of 12 bits or 120 bits/second, the Harvard Bi-phase encoding techniques is used, resulting in 664 flux reversals per inch. See Figure 14. Further explanation of WORD length and BIT values are given in Figure 15.

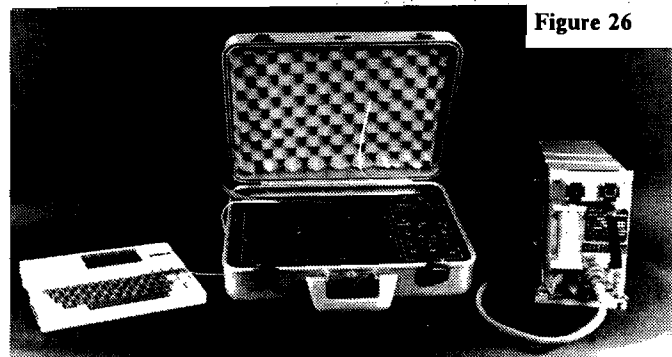
Figure 26

Helicopters record rotor speed data on the Cockpit Voice Recorder (CVR). An external data encoder module Rotor Speed Encoder (RSE) is used for this purpose (Figure 26). A 4600 Hz precision tone is phase encoded (180° phase change) providing for

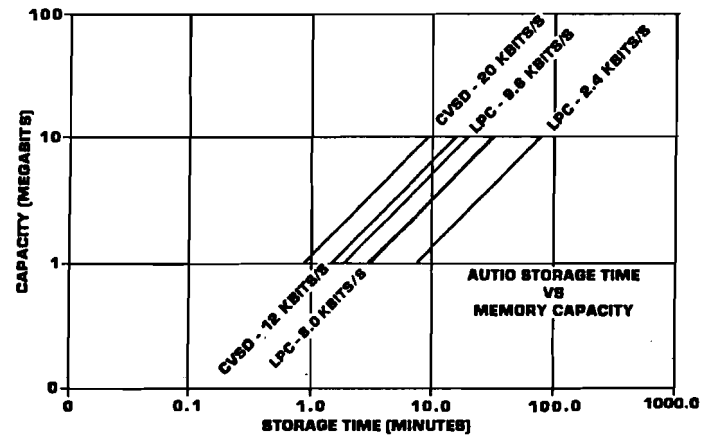
Figure 2

A graph illustrating the relationship between the recording bit rate of various digitization schemes, the digital capacity of the recorder and the recording time is illustrated in figure 2. Typical values for these relationships are shown in table 3 for different quantities of available memory. This data can be used to determine system performance objectives for the cockpit voice recorder. Further information about the relative cost, complexity and versatility of waveform and voice coders is included in table 4.
